# Annual Inspection Report **2025**

# ANNUAL INSPECTION REPORT 2025

## ANNUAL INSPECTION REPORT

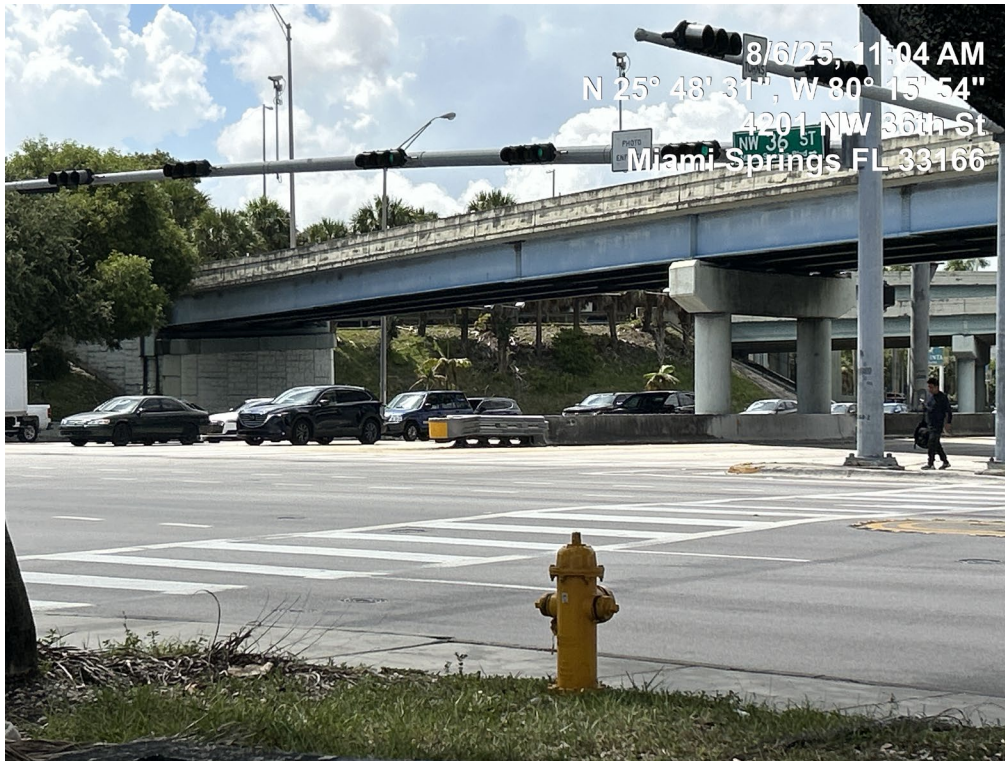
**EASTBOUND ON-RAMP FROM NW 36<sup>TH</sup> St.**

**DETERIORATED PAINT ON STEEL BRIDGE/ CLASS V COATING ON CONCRETE  
SURFACES  
(BRIDGE 870962)**

**ITEMS NOTED TO BE ADDRESSED BY GMX WORK PROGRAM TBD**

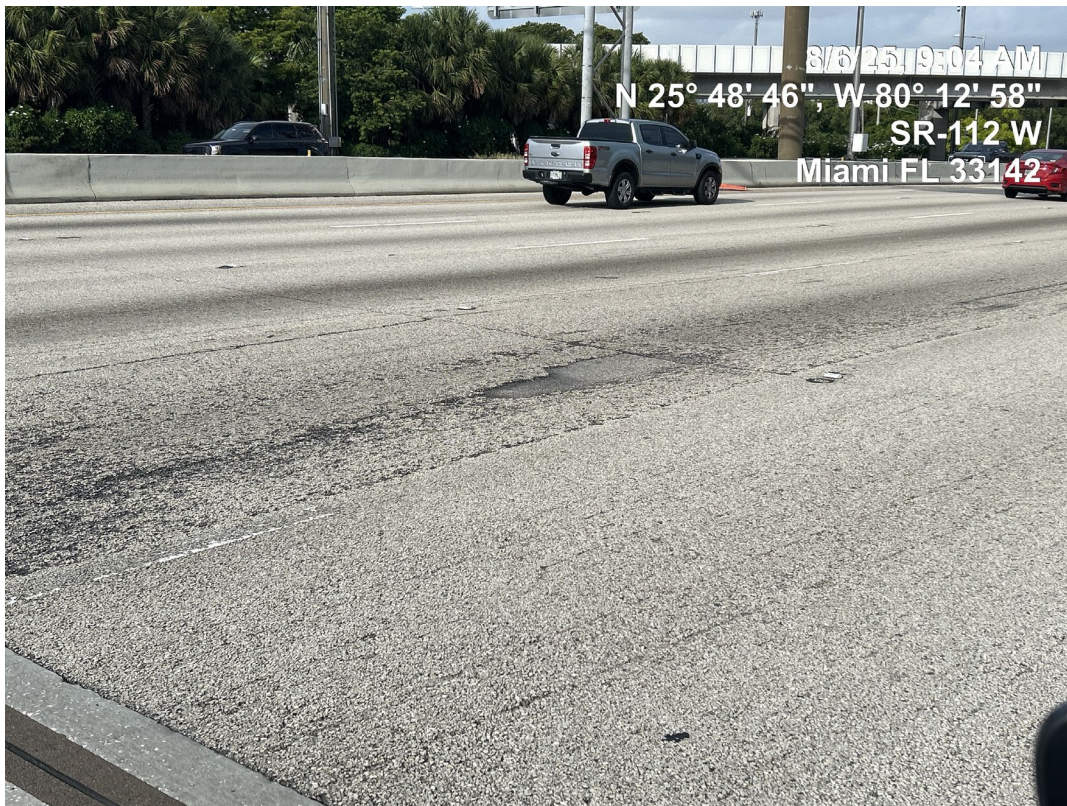
**ROADWAY INSPECTION  
LOCATION: MILE MARKER MP 3.95  
WESTBOUND MAINLINE**

**DETERIORATED ASPHALT PAVEMENT**

**ITEM NOTED TO BE ADDRESSED BY GMX WORK PROGRAM 30044**

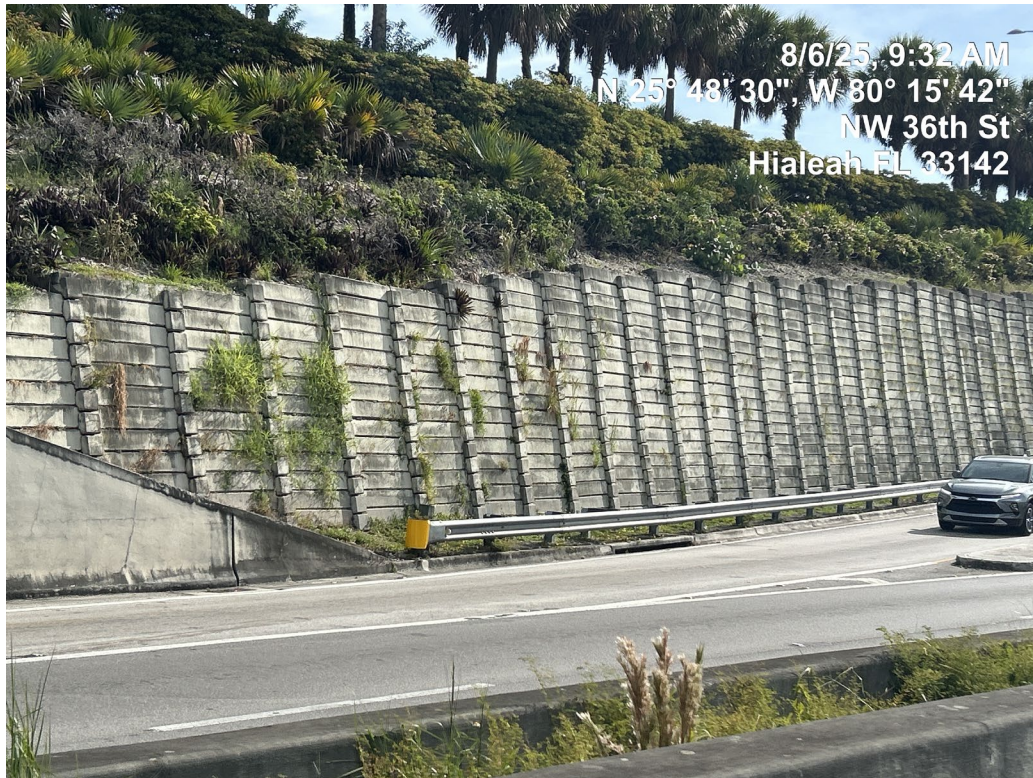
**ROADWAY INSPECTION  
LOCATION: MILE MARKER MP 1.1  
WESTBOUND OFF-RAMP TO NW 36<sup>th</sup> St.**

**OVERGROWN VEGETATION/ DETERIORATED CLASS V COATING  
ON RETAINING WALL**

**ITEM NOTED TO BE ADDRESSED BY GMX MAINTENANCE RFP-23-01  
& WORK PROGRAM TBD**

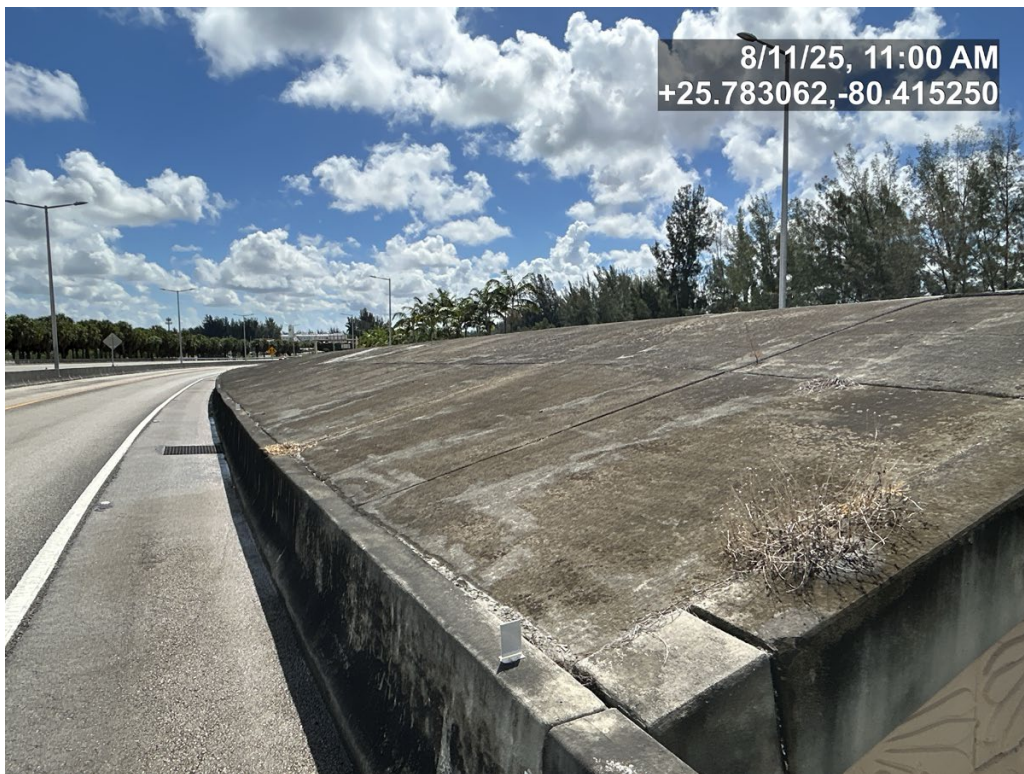
**ROADWAY INSPECTION  
LOCATION: MILE MARKER 0.7  
EASTBOUND MAINLINE**

**DETERIORATED CLASS V COATING**

**ITEM NOTED TO BE ADDRESSED BY GMX WORK PROGRAM TBD**

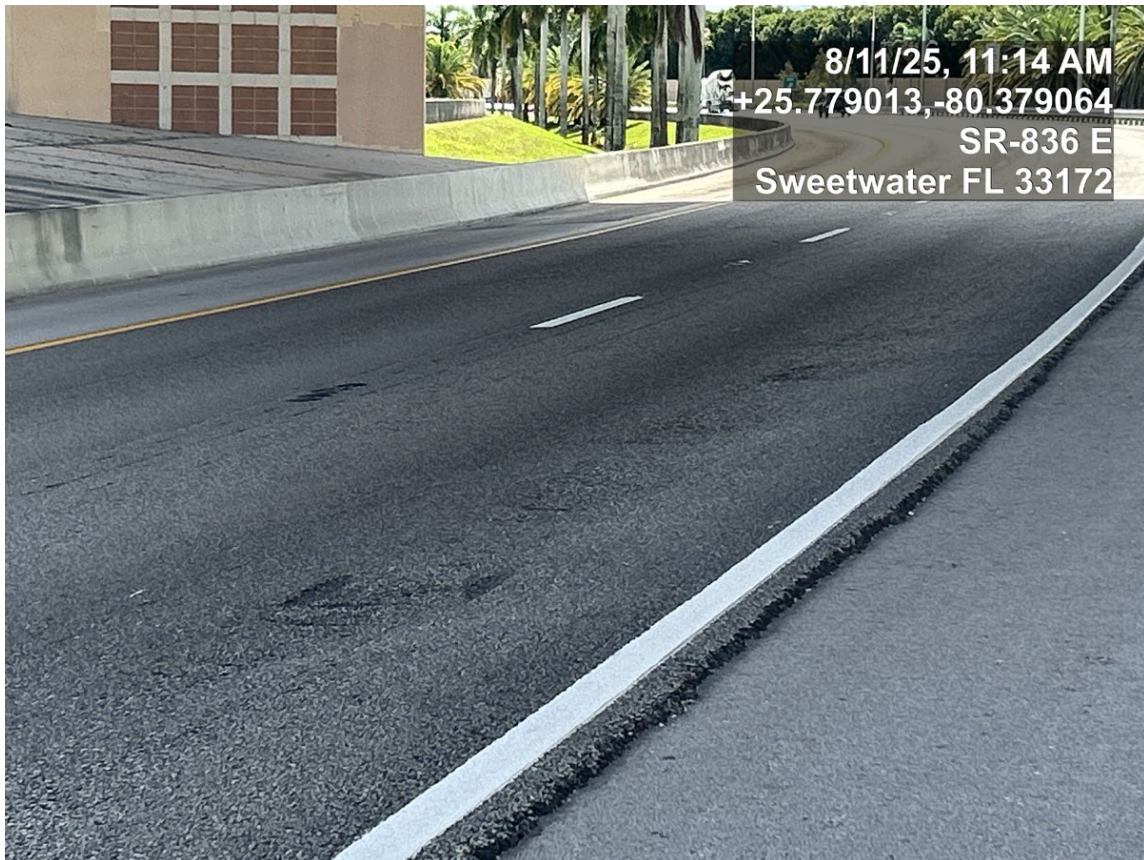
**ROADWAY INSPECTION  
LOCATION: MILE MARKER 3.0  
EASTBOUND MAINLINE**

**DAMAGED PAVEMENT**

**ITEM NOTED TO BE ADDRESSED BY GMX WORK PROGRAM 30044**

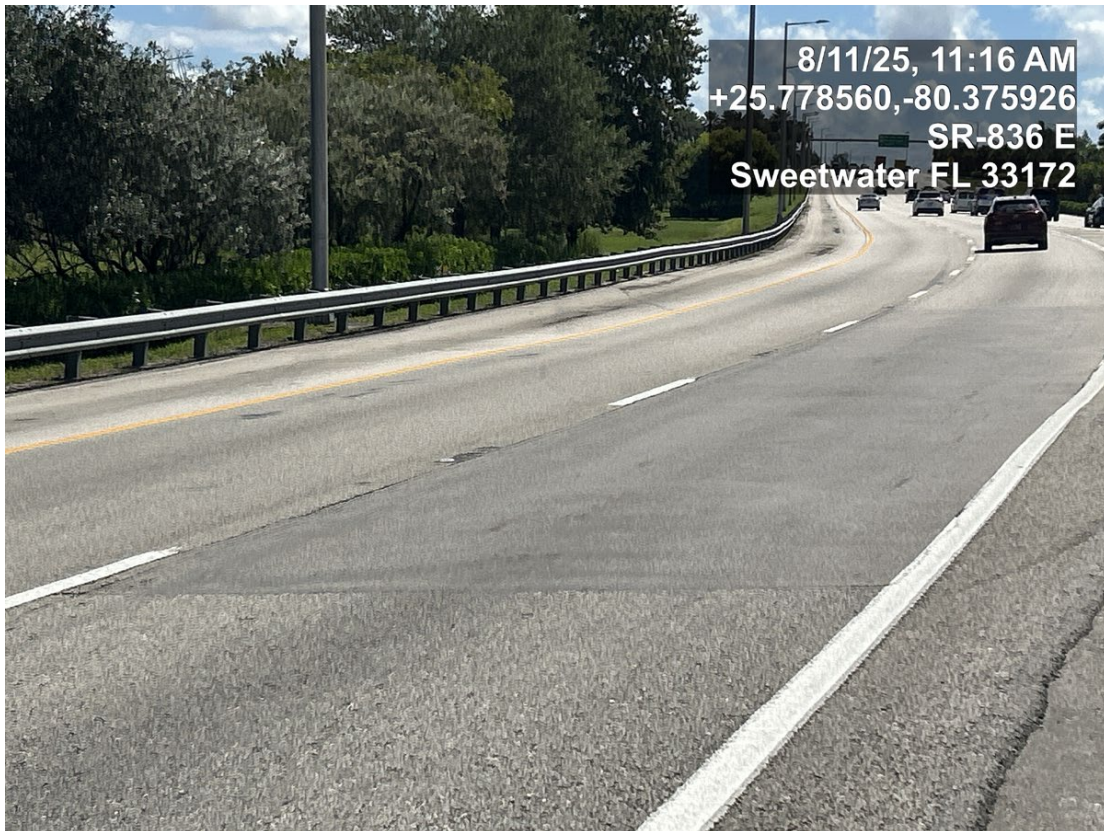
**ROADWAY INSPECTION  
LOCATION: MILE MARKER 3.2  
EASTBOUND MAINLINE**

**UNEVEN PAVEMENT**

**ITEM NOTED TO BE ADDRESSED BY GMX WORK PROGRAM 30044**

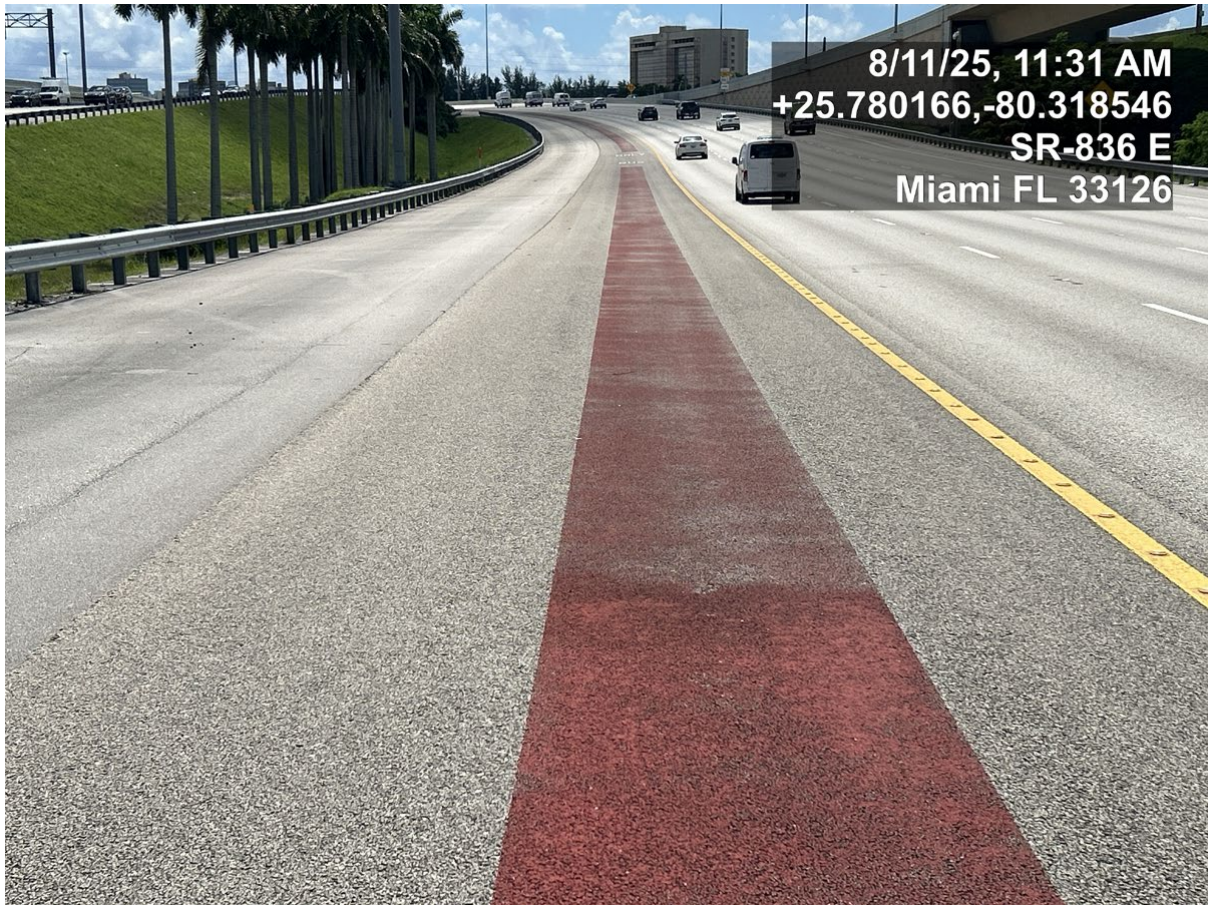
**ROADWAY INSPECTION  
LOCATION: MILE MARKER 6.8  
EASTBOUND MAINLINE**

**DETERIORATED BUS LANE STRIPING**

**ITEM NOTED TO BE ADDRESSED BY GMX MAINTENANCE TBD**

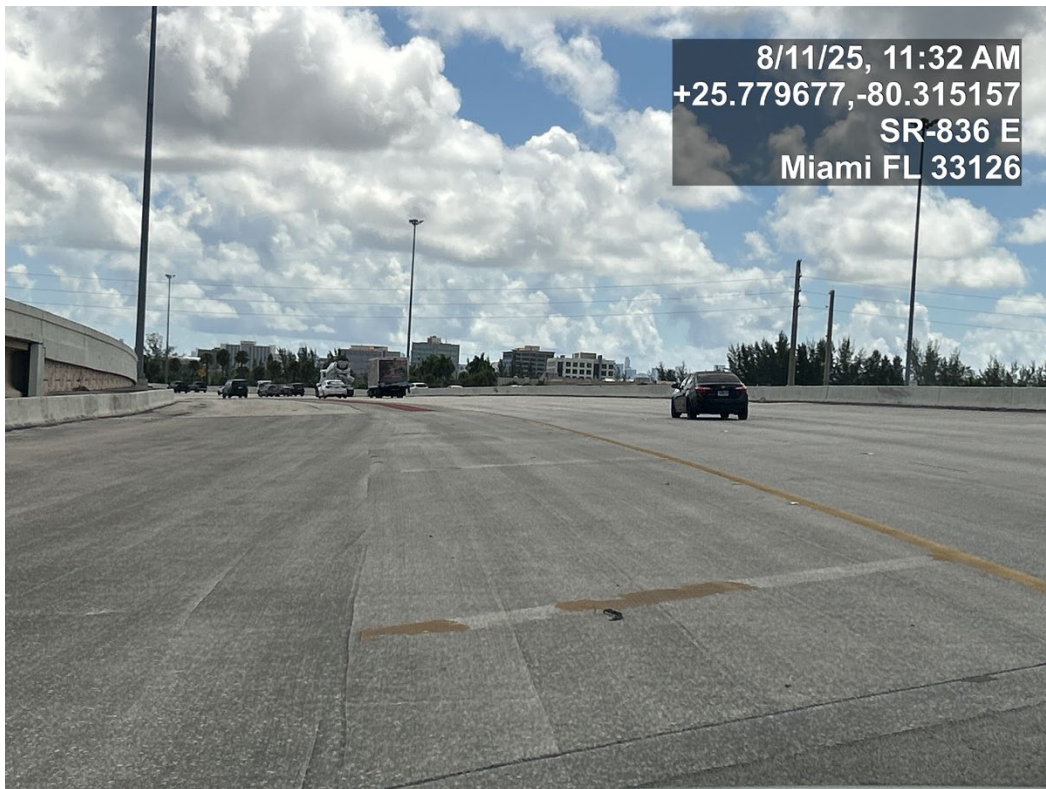
**ROADWAY INSPECTION  
LOCATION: MILE MARKER 7.0  
EASTBOUND MAINLINE**

**DETERIORATED CHEVRON STRIPING AND ROADWAY STRIPING  
ITEM NOTED TO BE ADDRESSED BY GMX WORK PROGRAM 30033**

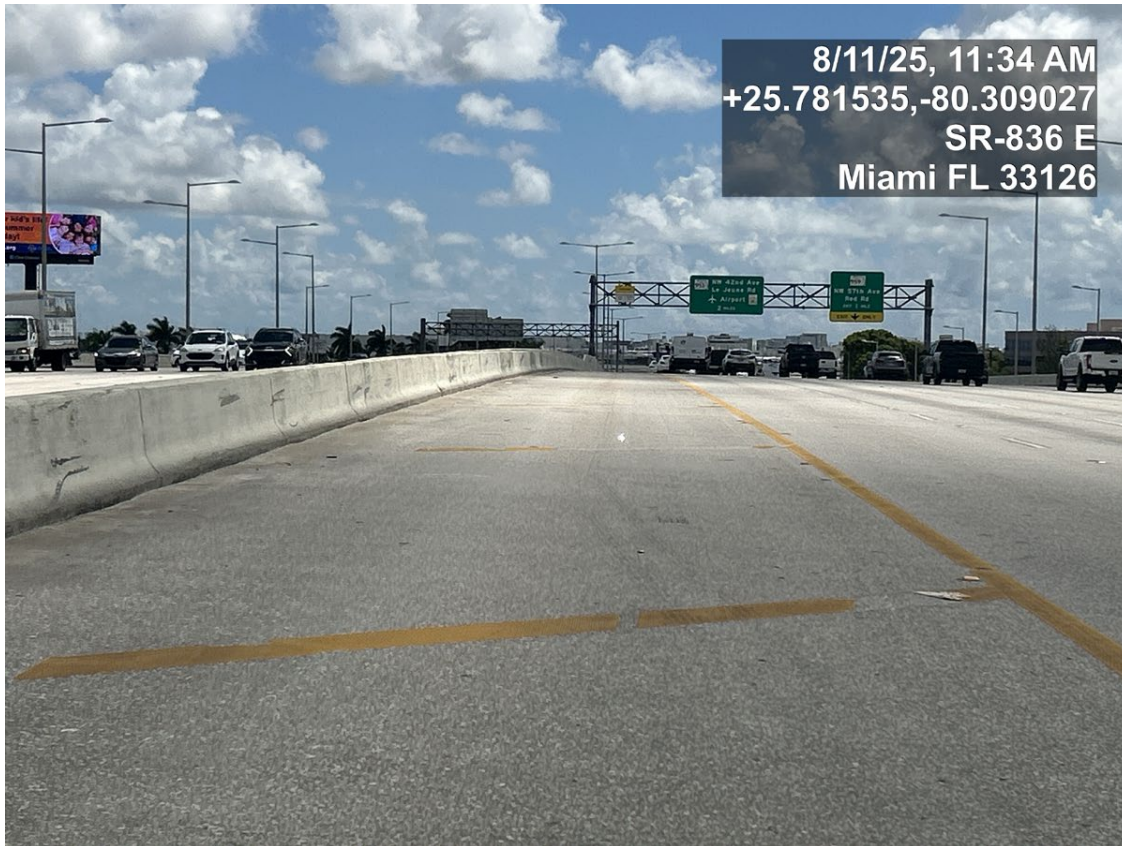
**ROADWAY INSPECTION  
LOCATION: MILE MARKER 7.4  
EASTBOUND MAINLINE**

**DETERIORATED CHEVRON STRIPING  
(BRIDGE # 870098)**

**ITEM NOTED TO BE ADDRESSED BY GMX WORK PROGRAM 30033**

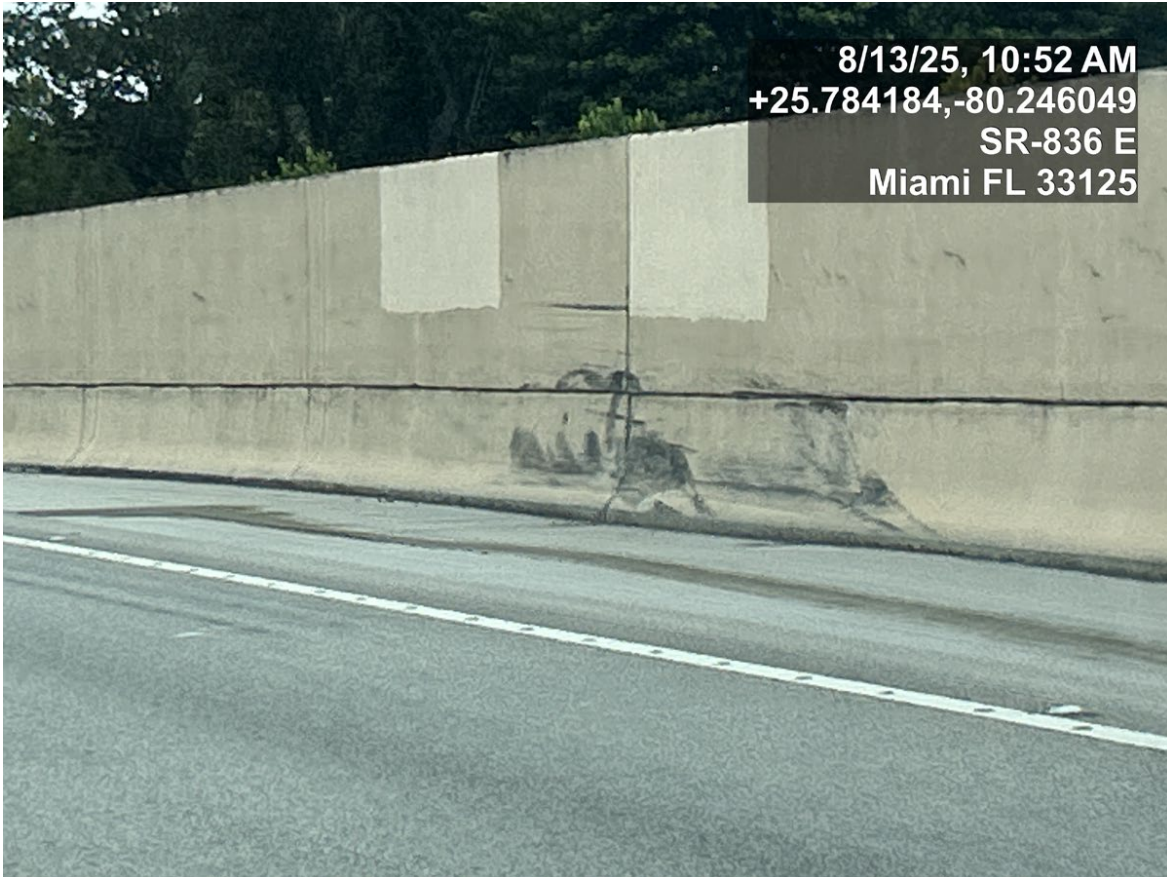
**ROADWAY INSPECTION  
LOCATION: MILE MARKER 11.9  
EASTBOUND MAINLINE**

**SKUFF MARKS ON BARRIER WALL**

**ITEM NOTED TO BE ADDRESSED BY GMX WORK PROGRAM TBD**

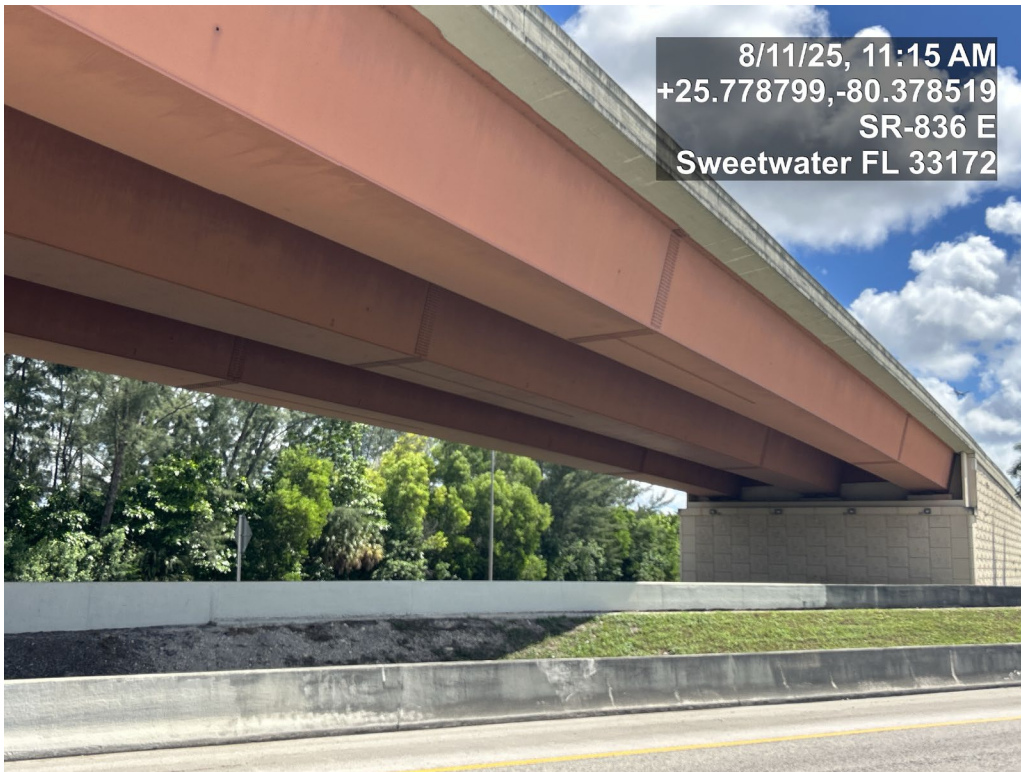
**ROADWAY INSPECTION  
LOCATION: MILE MARKER 3.0  
EASTBOUND MAINLINE**

**DETERIORATED PAINT ON STEEL BRIDGE/ CLASS V COATING ON CONCRETE  
SURFACES  
(BRIDGE 870996)**

**ITEM NOTED TO BE ADDRESSED BY GMX WORK PROGRAM 30064**

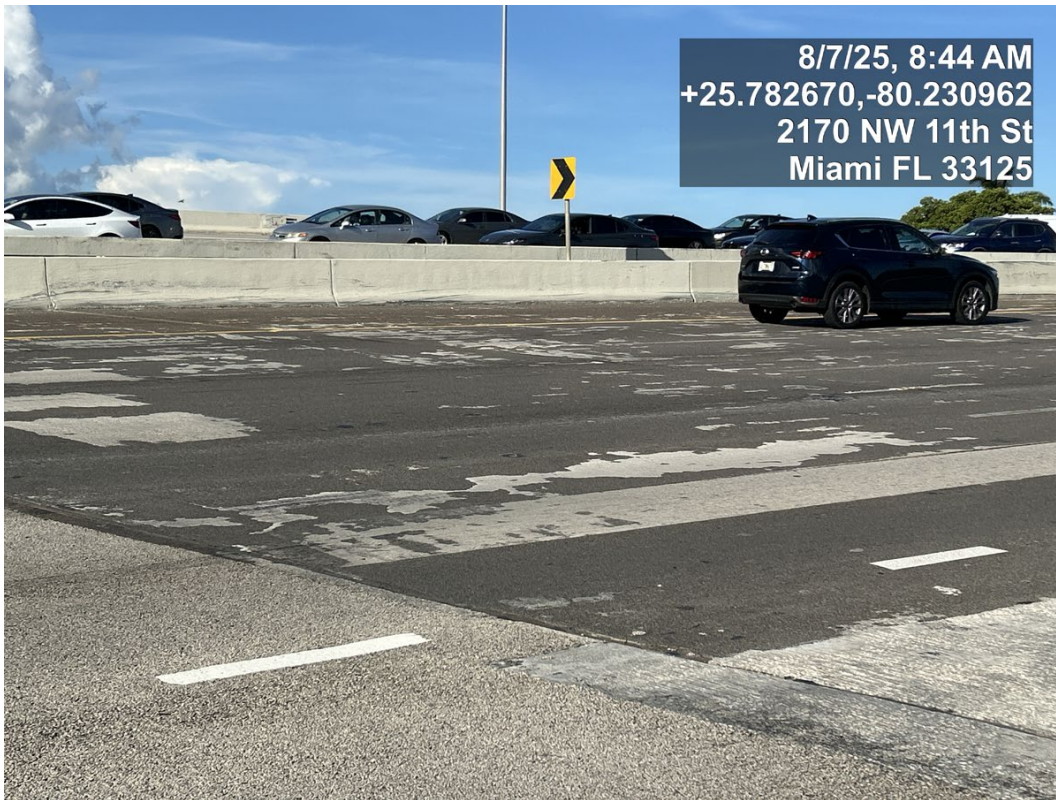
**ROADWAY INSPECTION  
LOCATION: MILE MARKER 12.4  
WESTBOUND MAINLINE**

**DETERIORATED SURFACE OVERLAY**

**ITEM NOTED TO BE ADDRESSED BY GMX WORK PROGRAM 30044**

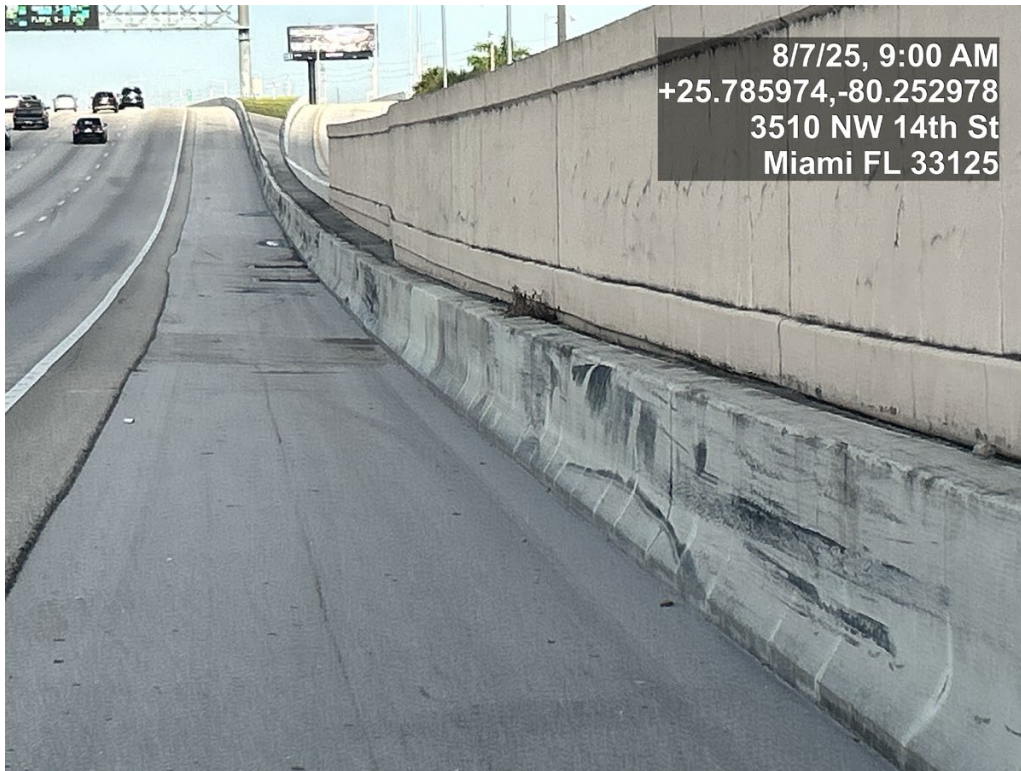
**ROADWAY INSPECTION  
LOCATION: MILE MARKER 10.9  
WESTBOUND MAINLINE**

**SKUFF MARKS ON BARRIER WALL**

**ITEM NOTED TO BE ADDRESSED BY GMX WORK PROGRAM TBD**

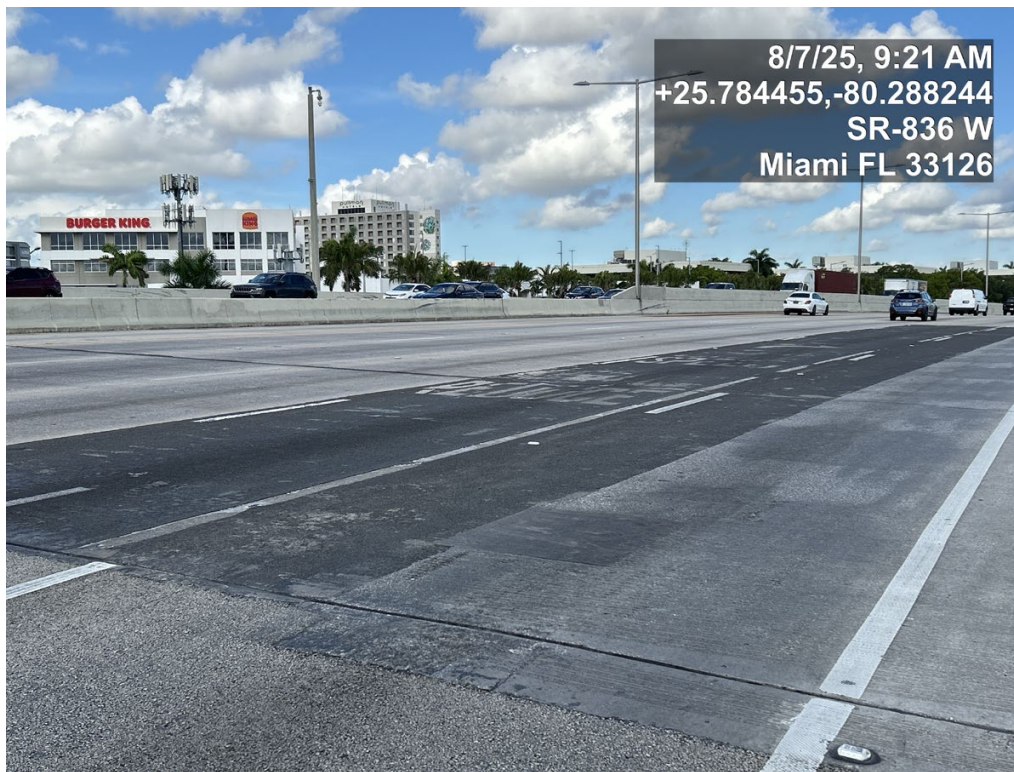
**ROADWAY INSPECTION  
LOCATION: MILE MARKER 8.7  
WESTBOUND MAINLINE**

**DETERIORATED SURFACE OVERLAY**

**ITEM NOTED TO BE ADDRESSED BY GMX WORK PROGRAM 30044**

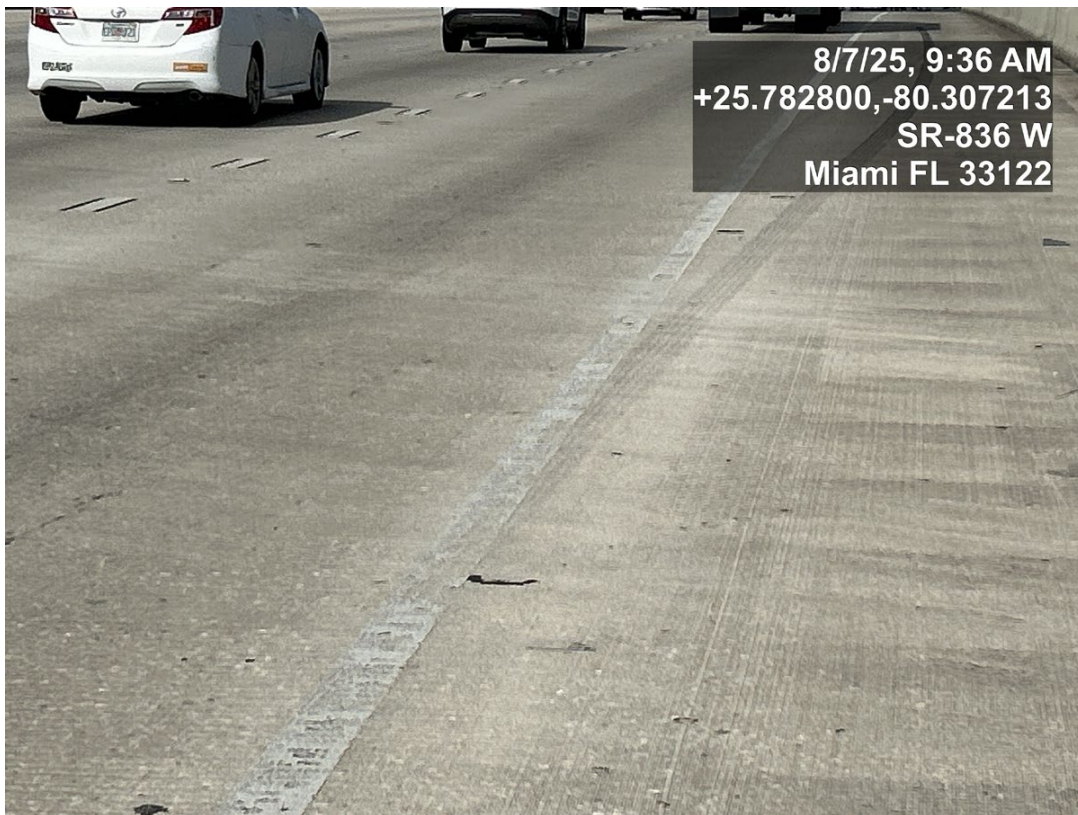
**ROADWAY INSPECTION  
LOCATION: MILE MARKER 7.45  
WESTBOUND MAINLINE**

**DETERIORATED STRIPING  
(BRIDGE # 871074)**

**ITEM NOTED TO BE ADDRESSED BY GMX WORK PROGRAM 30033**

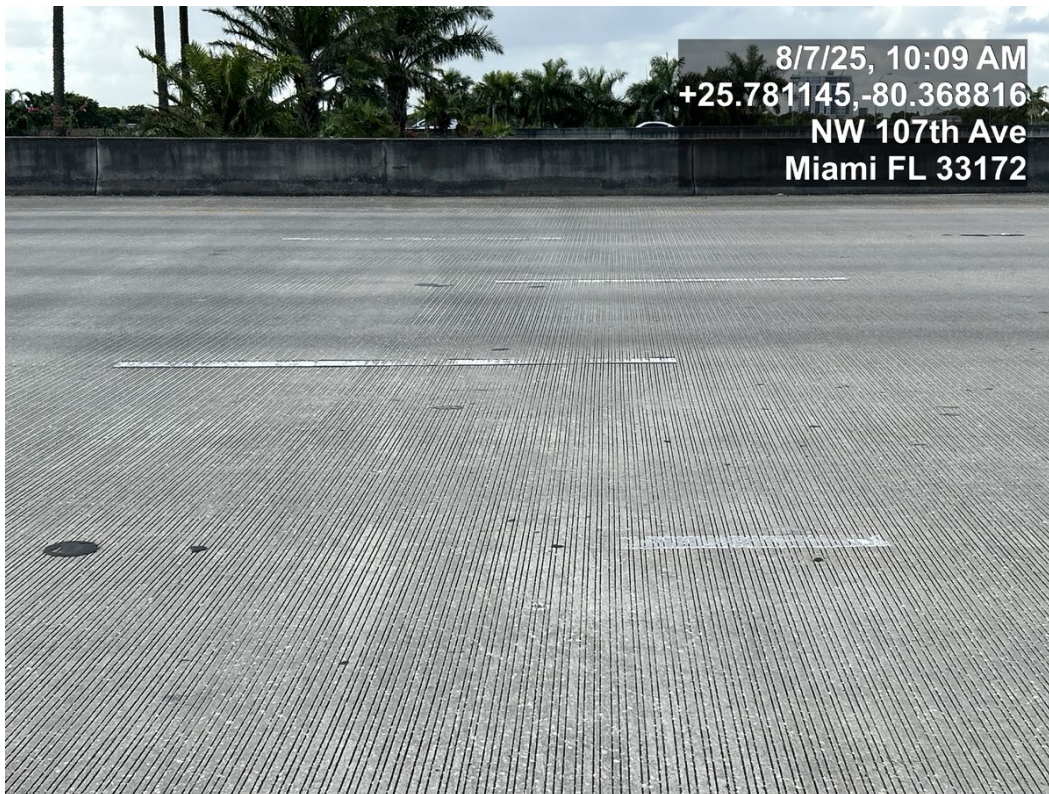
**ROADWAY INSPECTION  
LOCATION: MILE MARKER 3.6  
WESTBOUND MAINLINE TO FLA'S TURNPIKE**

**DETERIORATED SKIP LINE  
(BRIDGE # 870997)**

**ITEM NOTED TO BE ADDRESSED BY GMX WORK PROGRAM 30033**

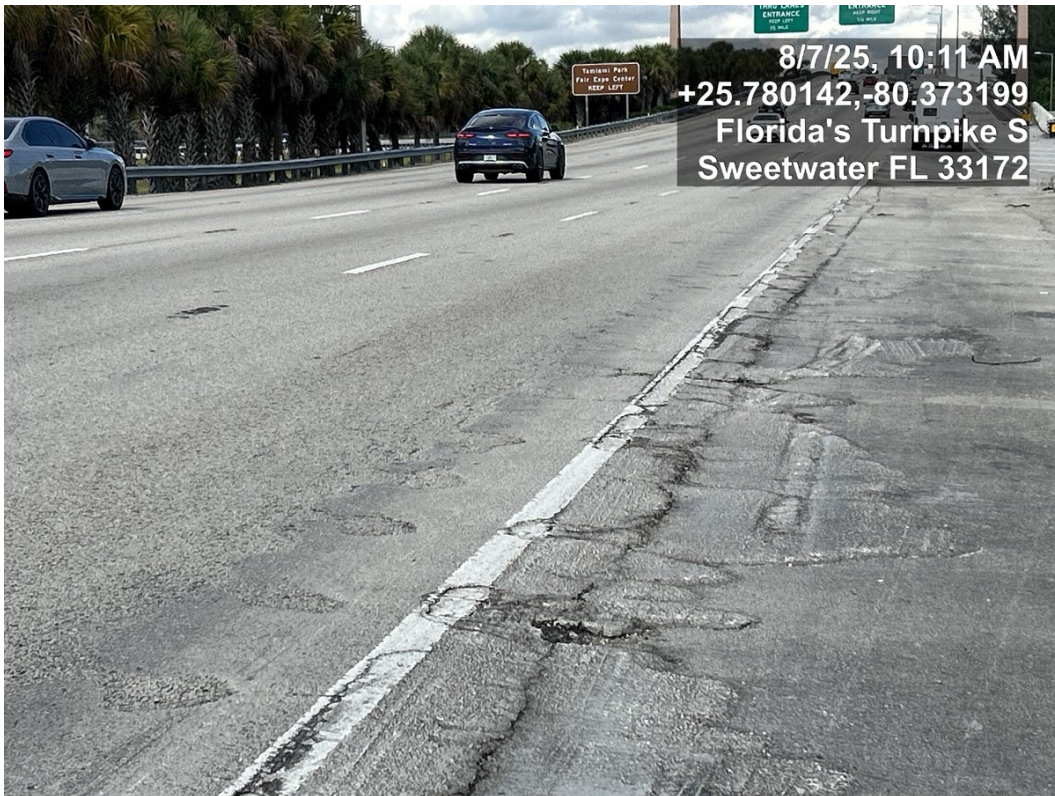
**ROADWAY INSPECTION  
LOCATION: MILE MARKER 3.4  
WESTBOUND MAINLINE TO FLA'S TURNPIKE**

**DAMAGED PAVEMENT DUE TO CONCRETE SPILLAGE**

**ITEM NOTED TO BE ADDRESSED BY GMX WORK PROGRAM 30044**

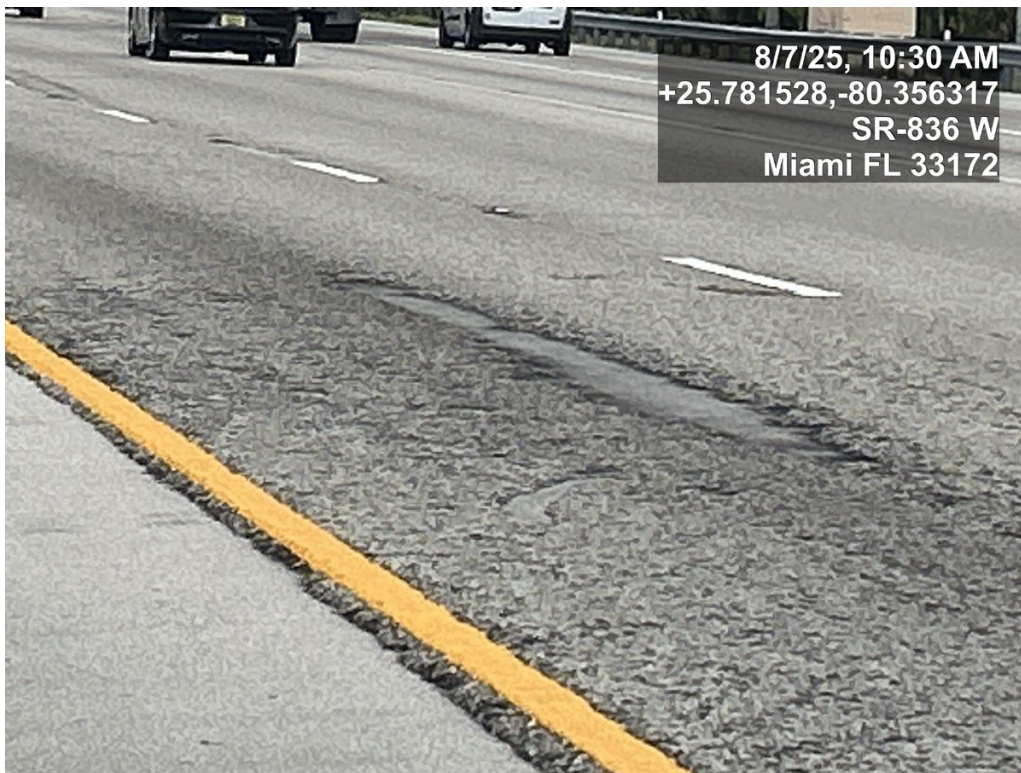
**ROADWAY INSPECTION  
LOCATION: MILE MARKER 4.4  
WESTBOUND MAINLINE**

**DETERIORATED PAVEMENT**

**ITEM NOTED TO BE ADDRESSED BY GMX WORK PROGRAM 30044**

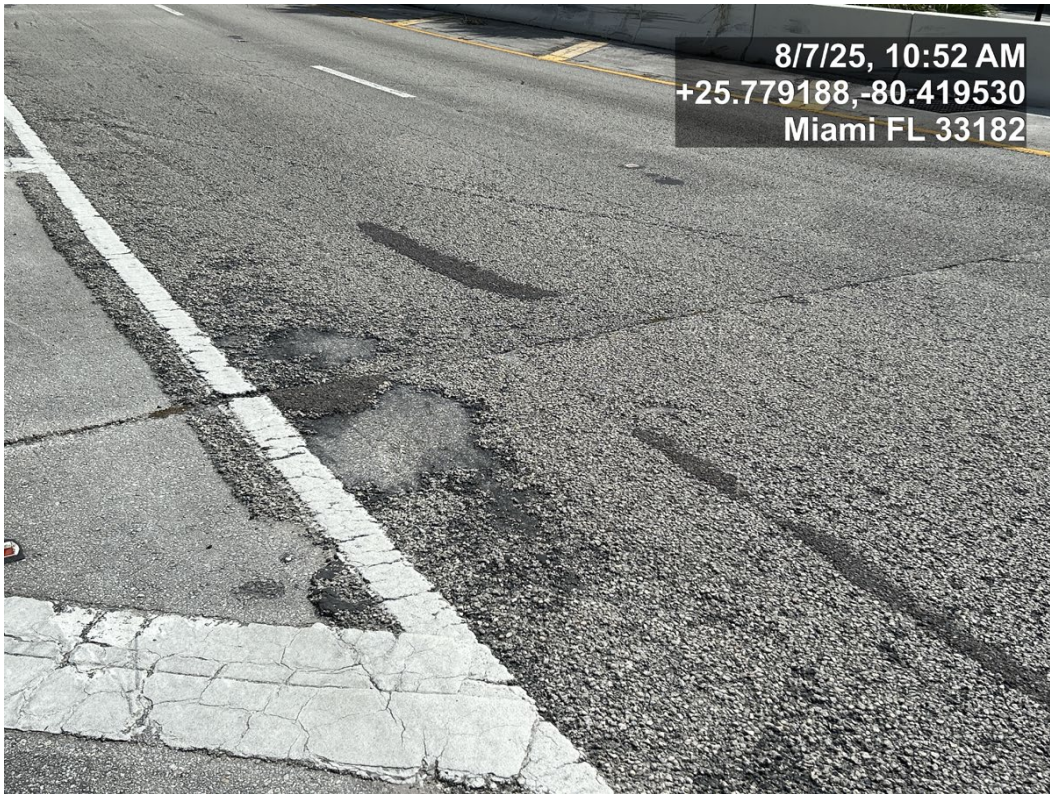
**WESTBOUND OFF-RAMP TO SB NW 137<sup>TH</sup> AVE.**

**DETERIORATED PAVEMENT**

**ITEM NOTED TO BE ADDRESSED BY GMX WORK PROGRAM 30044**

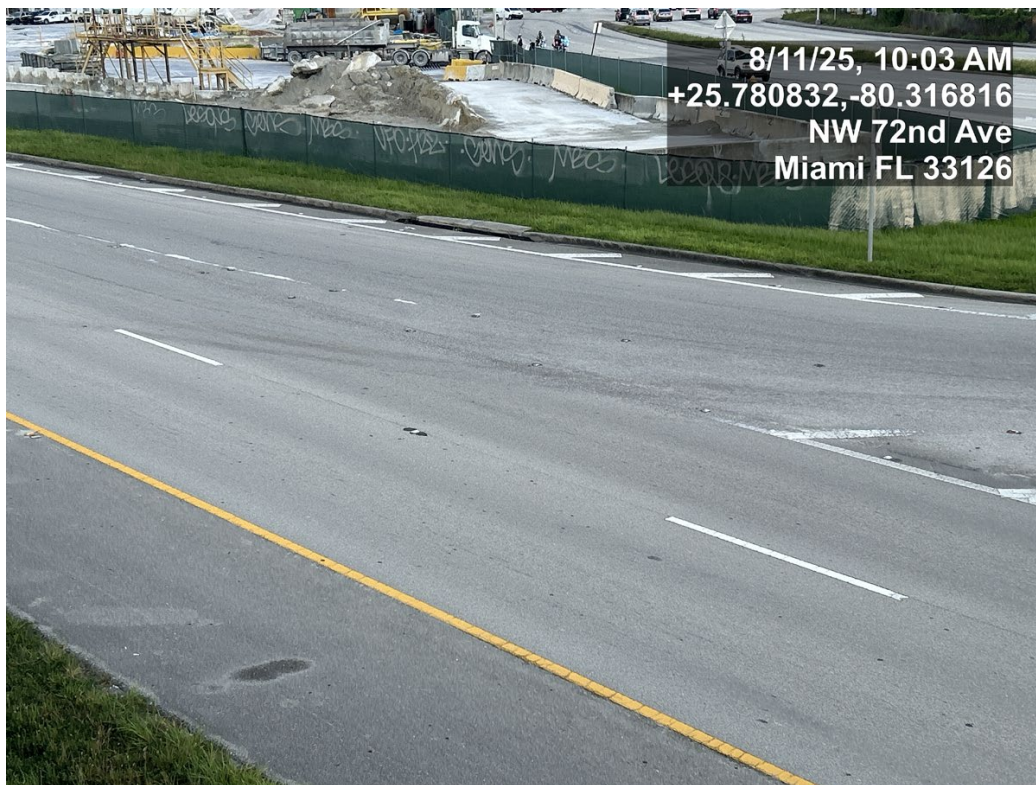
**ROADWAY INSPECTION  
LOCATION: MILE MARKER 6.8  
WESTBOUND ON-RAMP FROM NW 72<sup>nd</sup> AVE.**

**DETERIORATED STRIPING ON GORE AND OUTSIDE LANE**

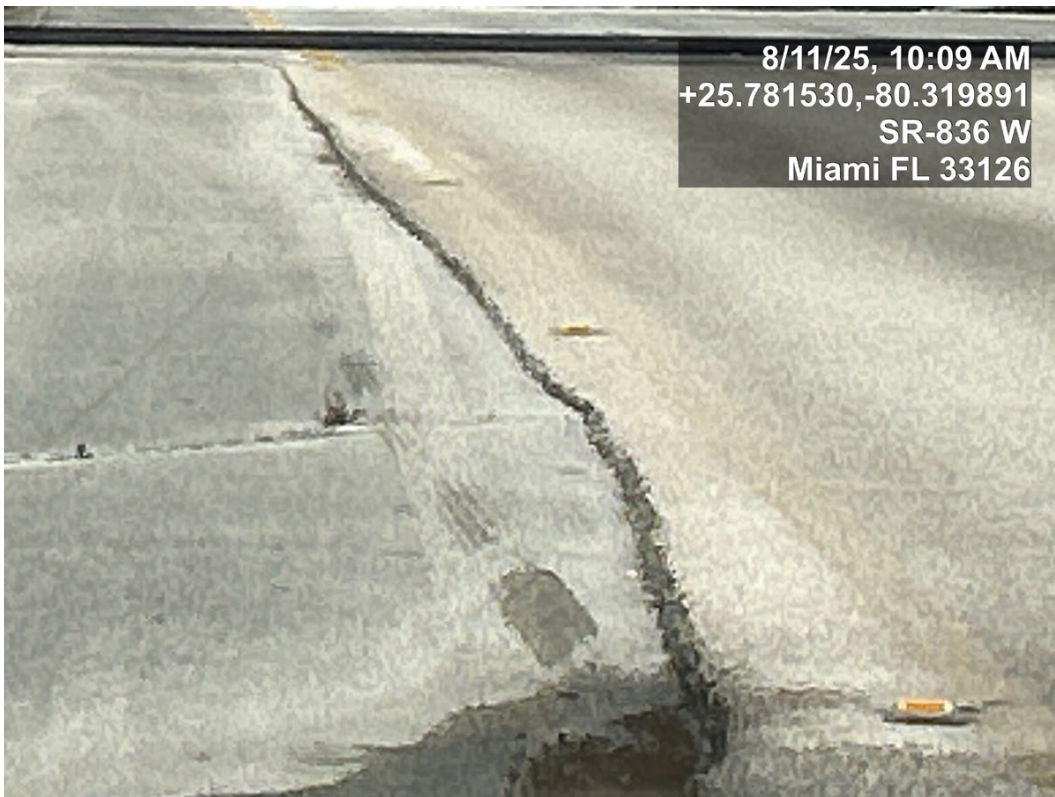
**ROADWAY INSPECTION  
LOCATION: MILE MARKER 6.7  
WESTBOUND CD**

**DETERIORATED STRIPING  
(BRIDGE # 871081)**

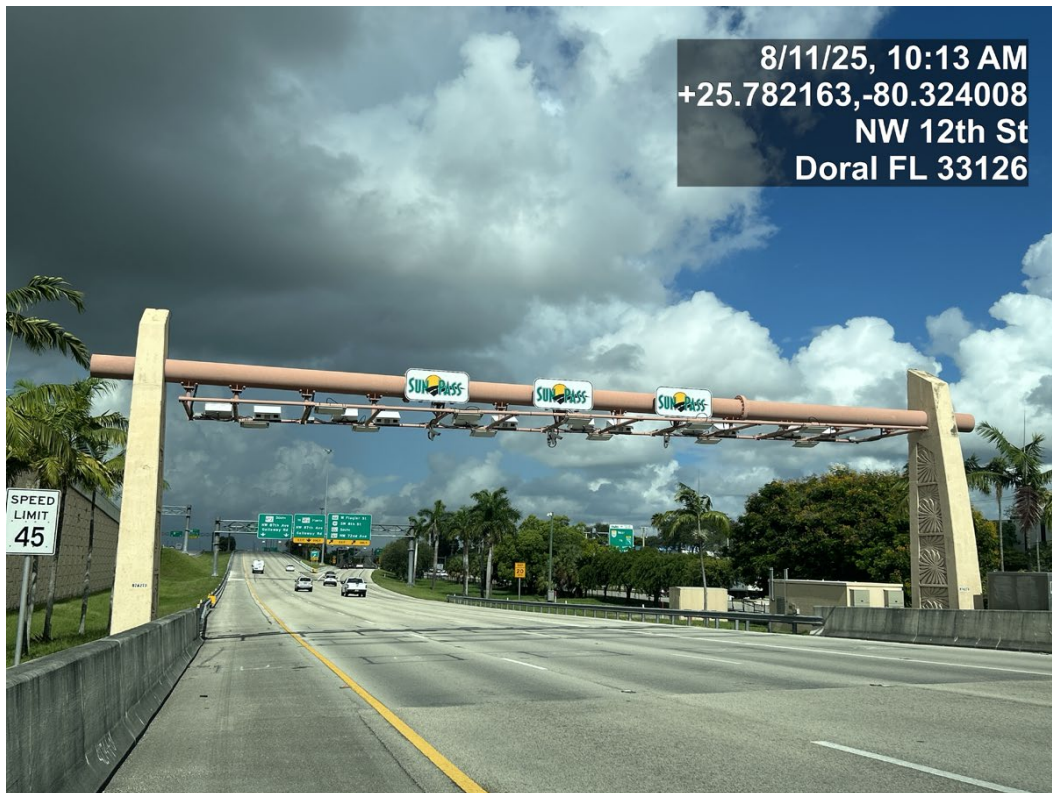
**ROADWAY INSPECTION  
LOCATION: MILE MARKER 6.4  
WESTBOUND CD**

**DETERIORATED PAINT ON MONOTUBE/CLASS V COATING  
ON STRUCTURE UPRIGHT  
(STRUCTURE #87A273)**

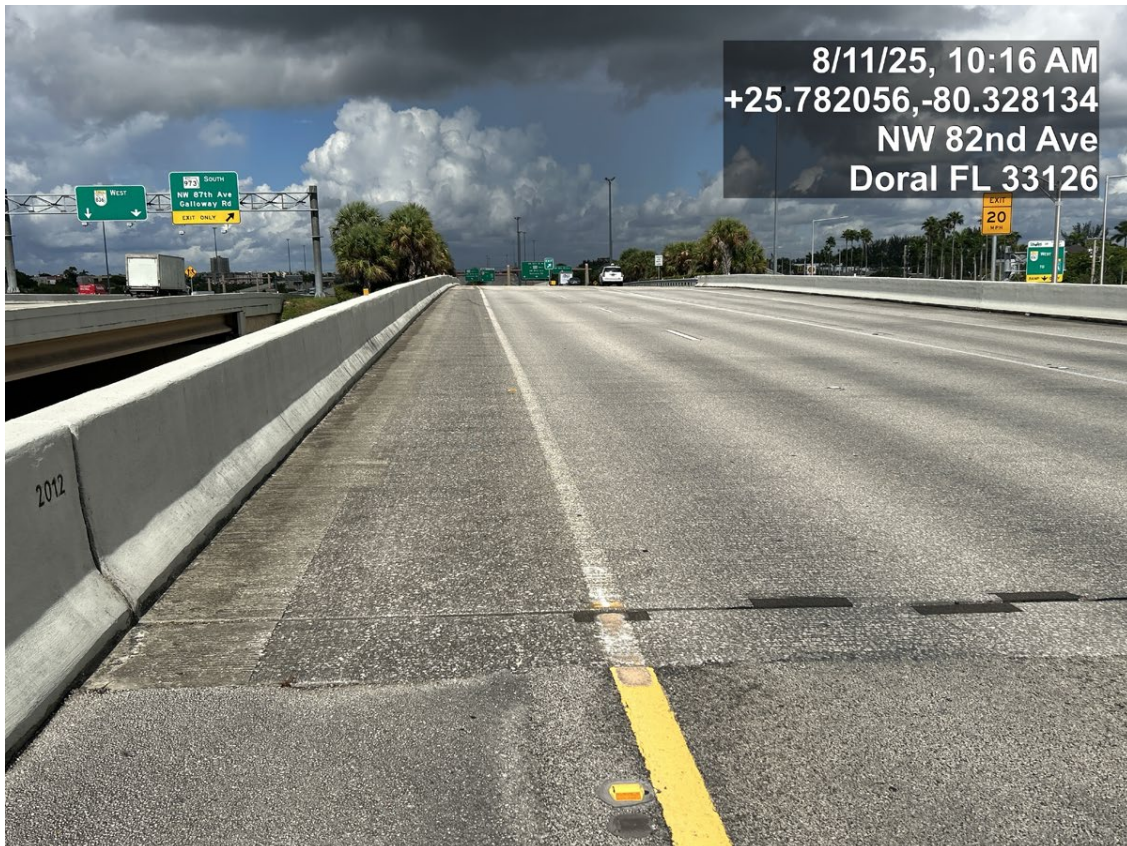
**ROADWAY INSPECTION  
LOCATION: MILE MARKER 6.2  
WESTBOUND CD**

**DETERIORATED EDGE LINE  
(BRIDGE # 871083)**

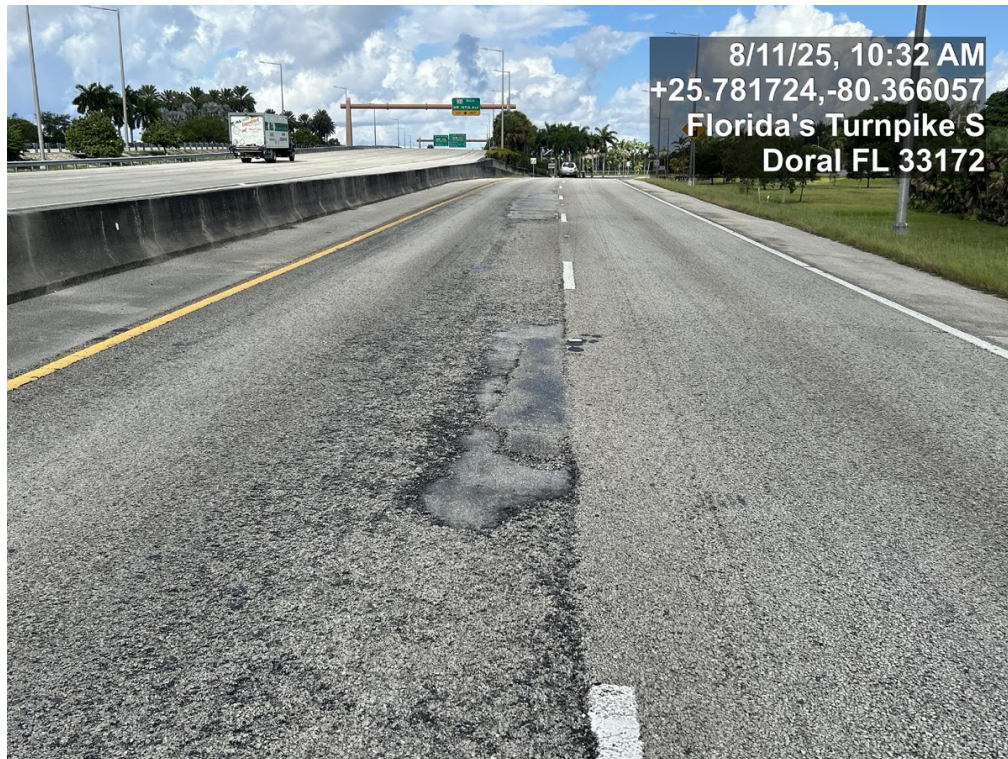
**ROADWAY INSPECTION  
LOCATION: MILE MARKER 3.8  
WESTBOUND OFF-RAMP TO NB NW 107<sup>TH</sup> AVE.**

**DETERIORATED PAVEMENT**

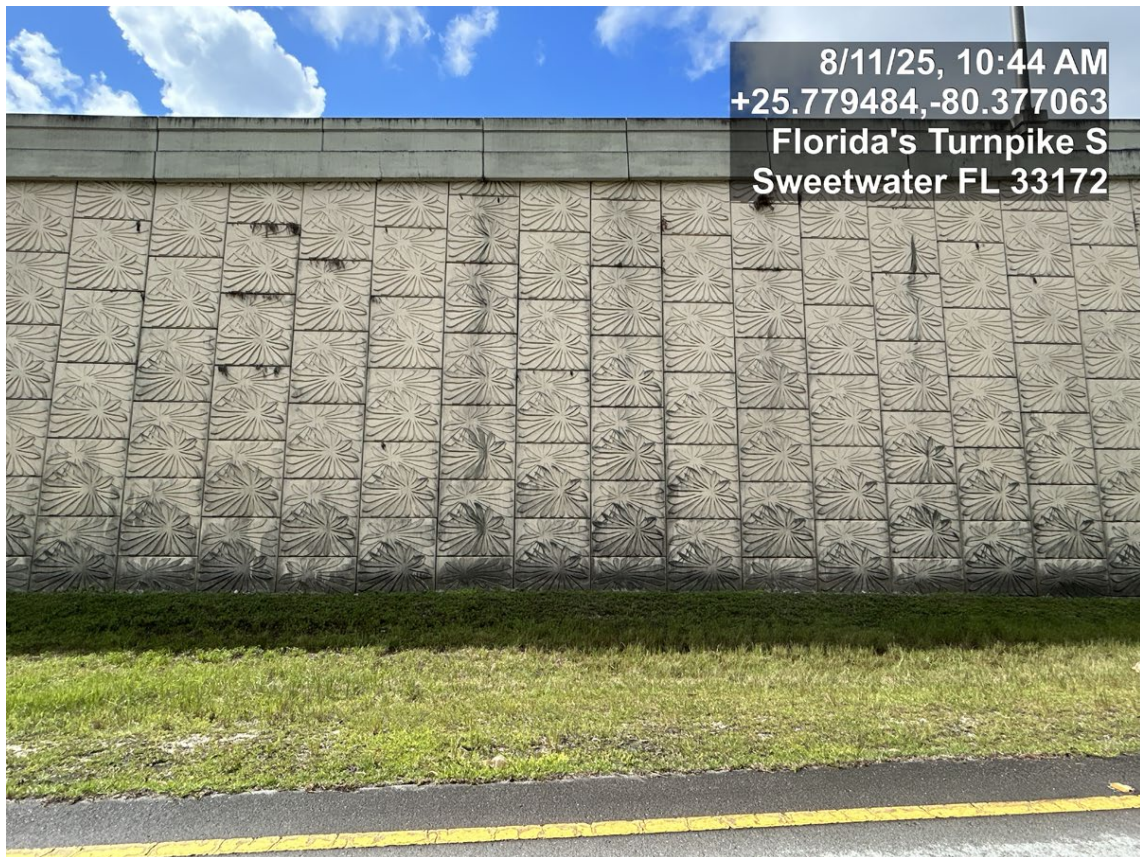
**WESTBOUND ON-RAMP FROM NW 107<sup>TH</sup> AVE.**

**DETERIORATED CLASS V COATING ON MSE WALL**
