# Annual Inspection Report **2025**

# ANNUAL INSPECTION REPORT 2025

## ANNUAL INSPECTION REPORT

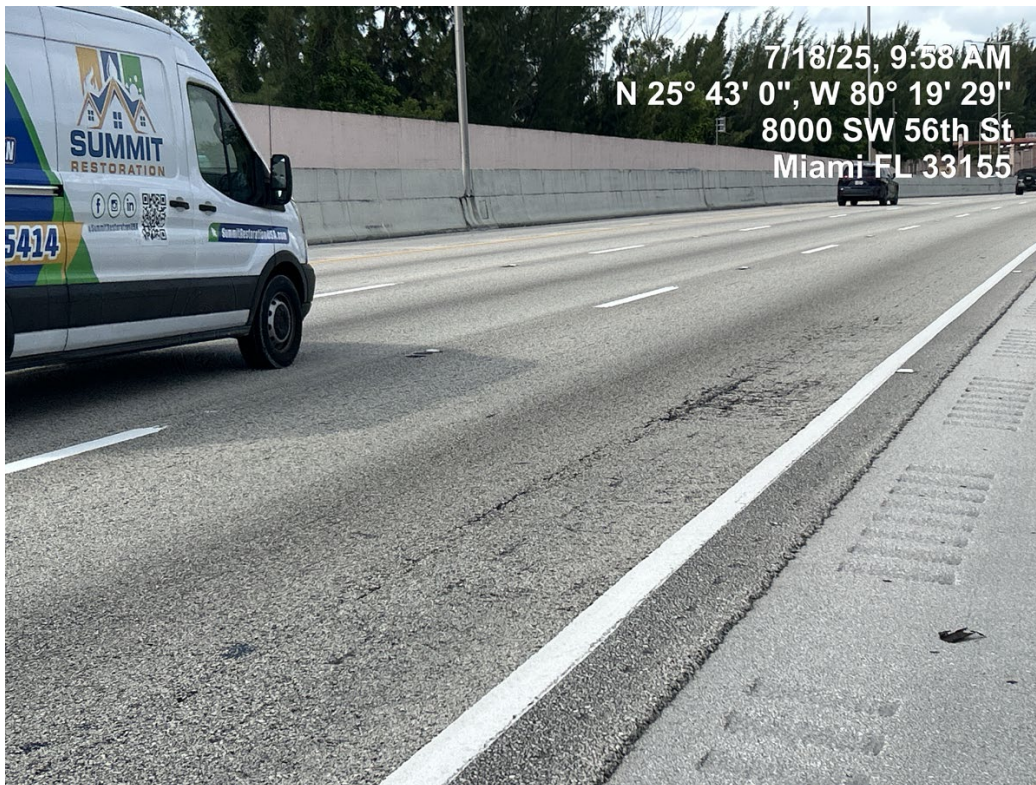
**ROADWAY INSPECTION  
LOCATION: MILE MARKER 6.28  
SOUTHBOUND MAINLINE**

**DETERIORATED PAVEMENT**

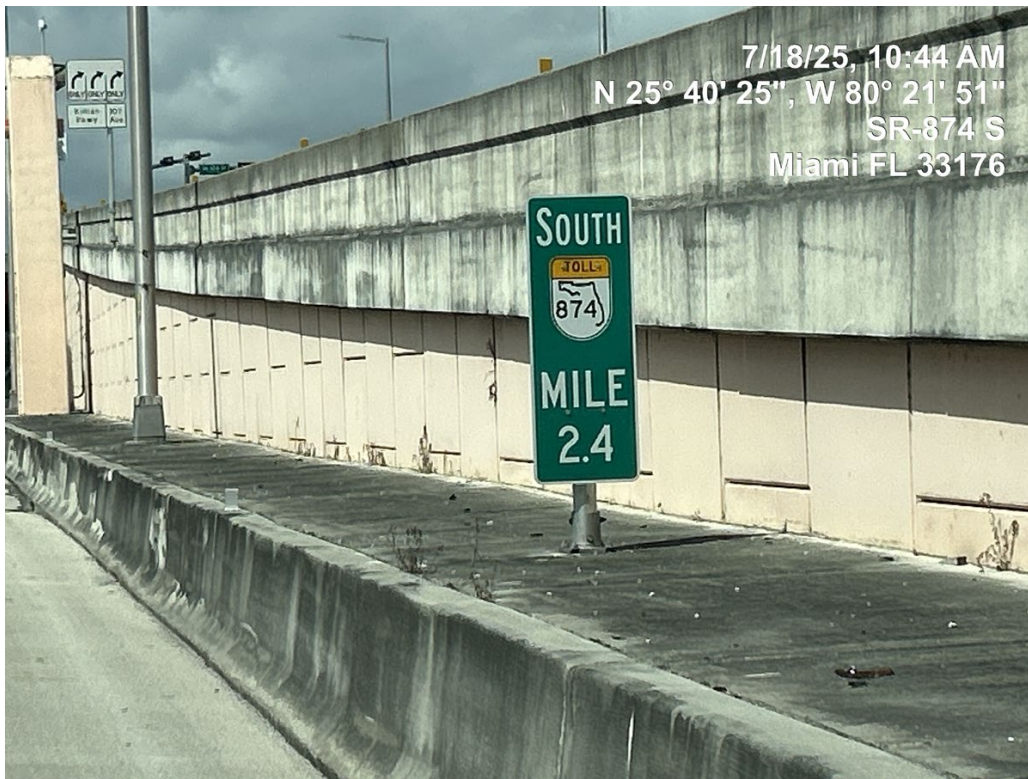
**ROADWAY INSPECTION  
LOCATION: MILE MARKER 2.4  
SOUTHBOUND MAINLINE**

**DETERIORATED CLASS V COATING ON BARRIER AND MSE WALLS**

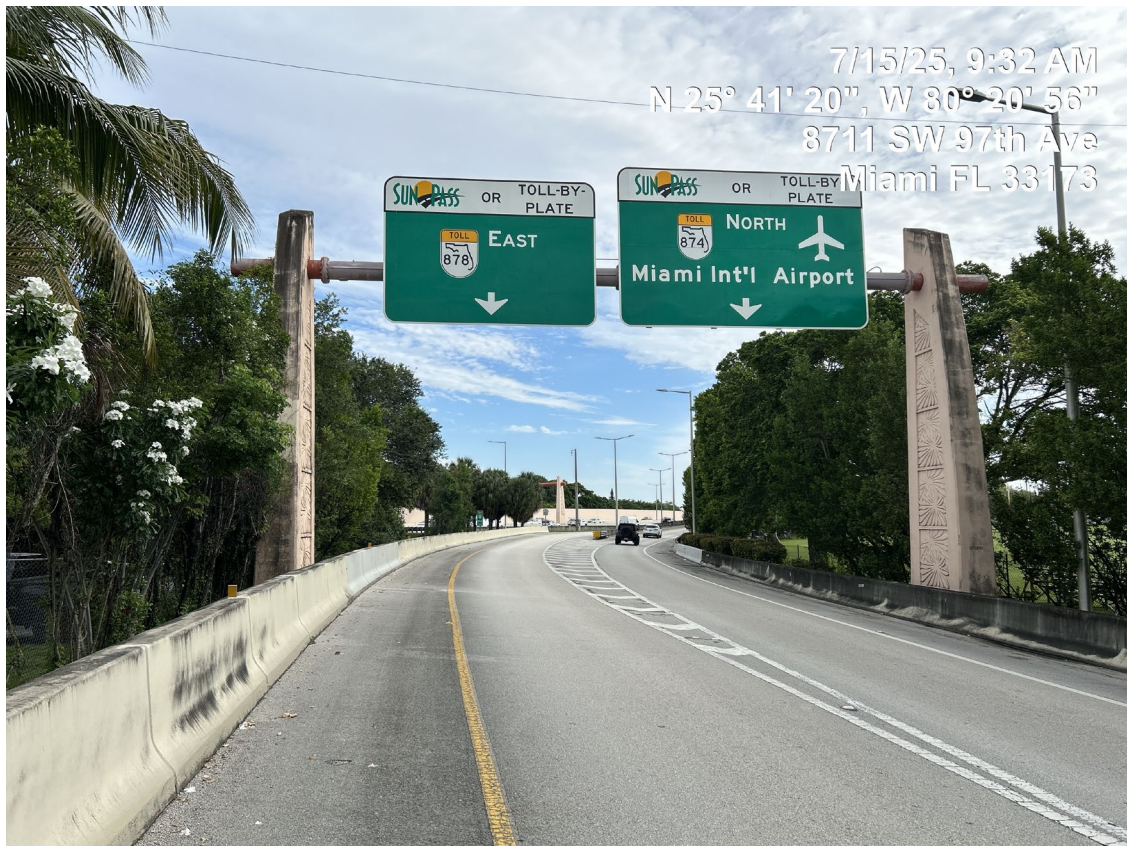
**ROADWAY INSPECTION**  
**LOCATION: MILE MARKER 0.9**  
**EASTBOUND ON-RAMP**

**DETERIORATED PAINT ON MONOTUBE AND CLASS V ON UPRIGHT**

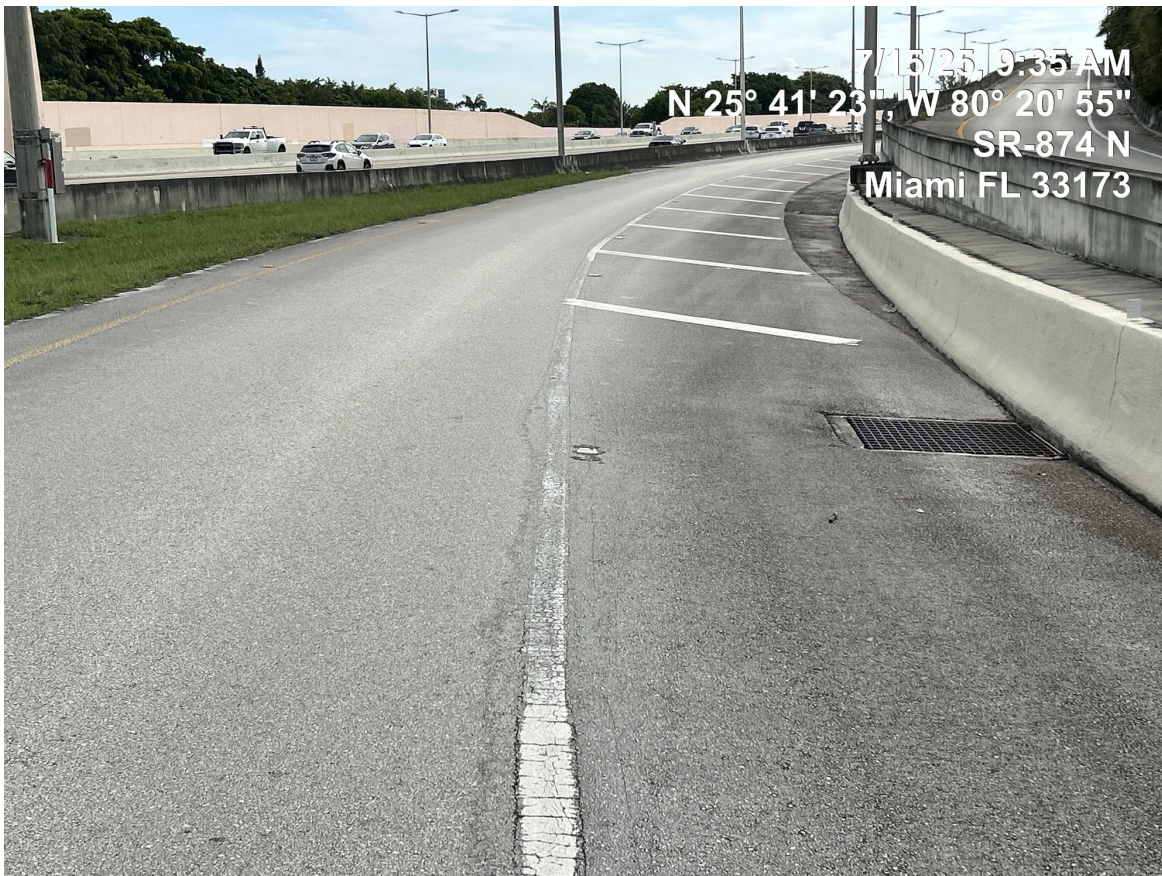
**ROADWAY INSPECTION  
LOCATION: MILE MARKER 3.90  
EASTBOUND ON-RAMP**

**DETERIORATED PAVEMENT MARKINGS**

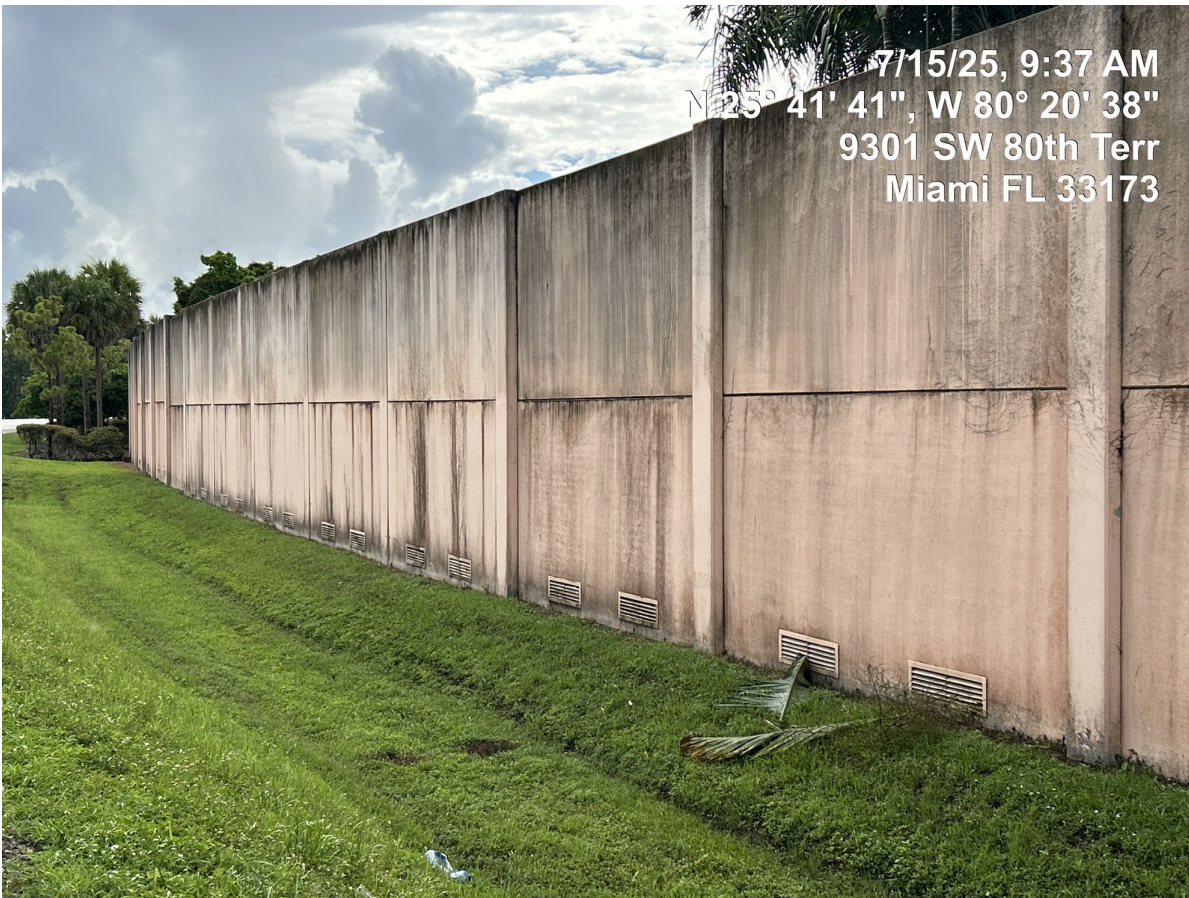
**ROADWAY INSPECTION  
LOCATION: MILE MARKER 0.7  
EASTBOUND MAINLINE**

**DETERIORATED CLASS V COATING ON SOUND WALL**

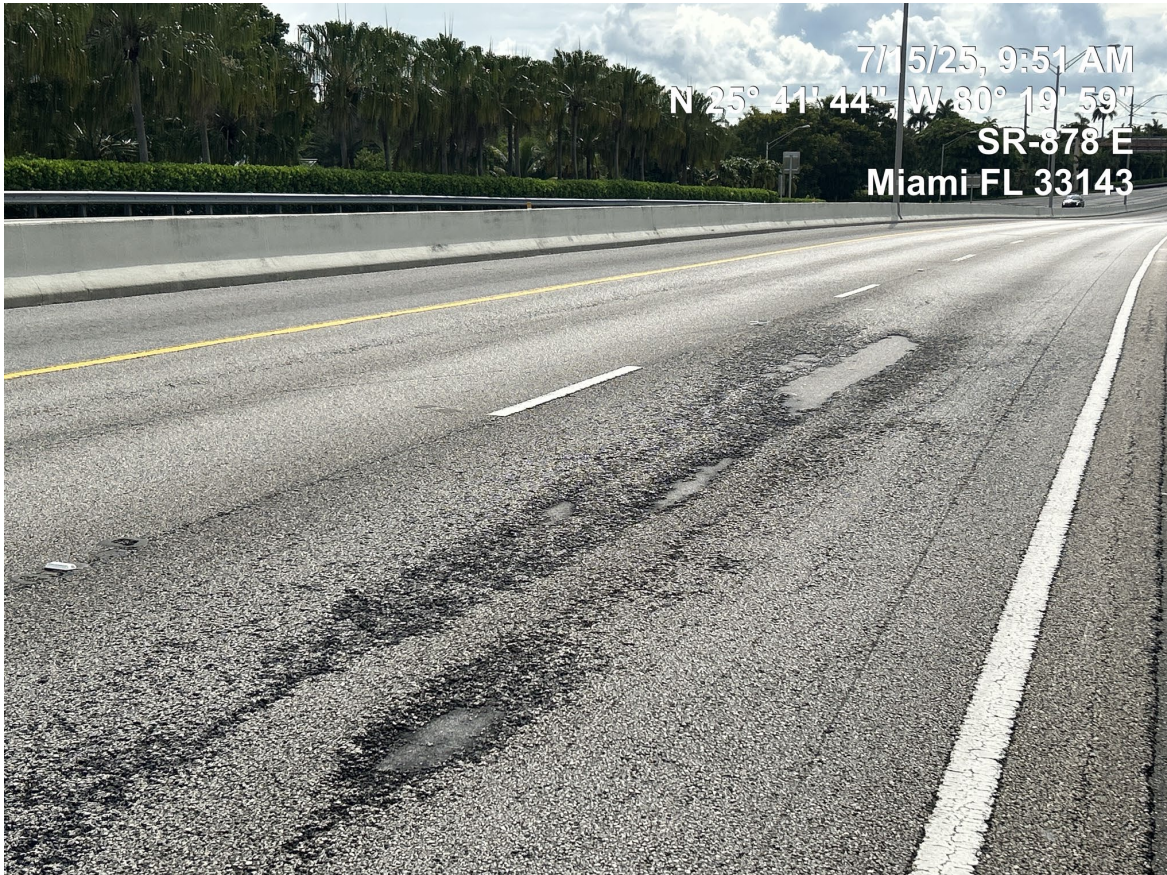
**ROADWAY INSPECTION  
LOCATION: MILE MARKER 1.4  
EASTBOUND MAINLINE**

**DETERIORATED PAVEMENT**

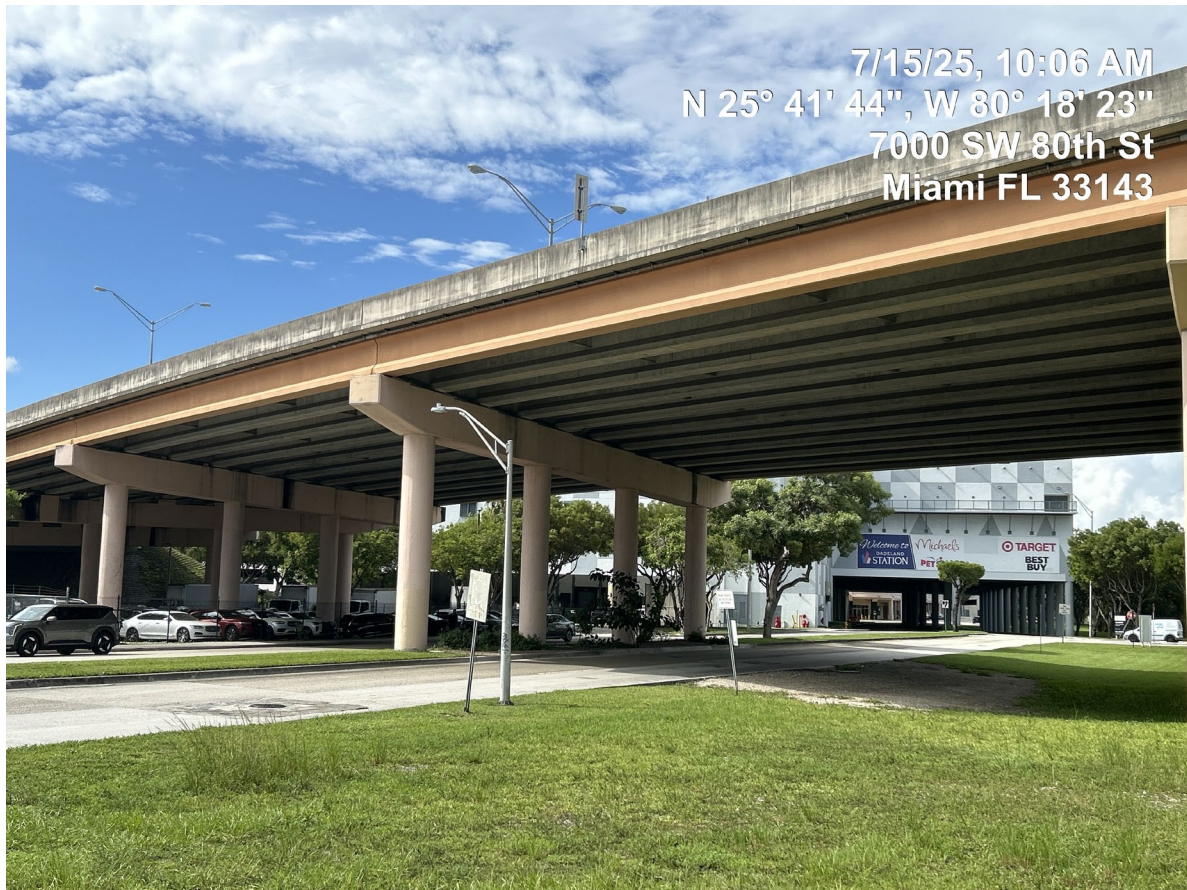
**ROADWAY INSPECTION  
LOCATION: MILE MARKER 3.0 MILES  
EASTBOUND MAINLINE**

**DETERIORATED CLASS V COATING ON BRIDGE (STRUCTURE # 870599)  
(TYPICAL THROUGHOUT THIS CORRIDOR)**

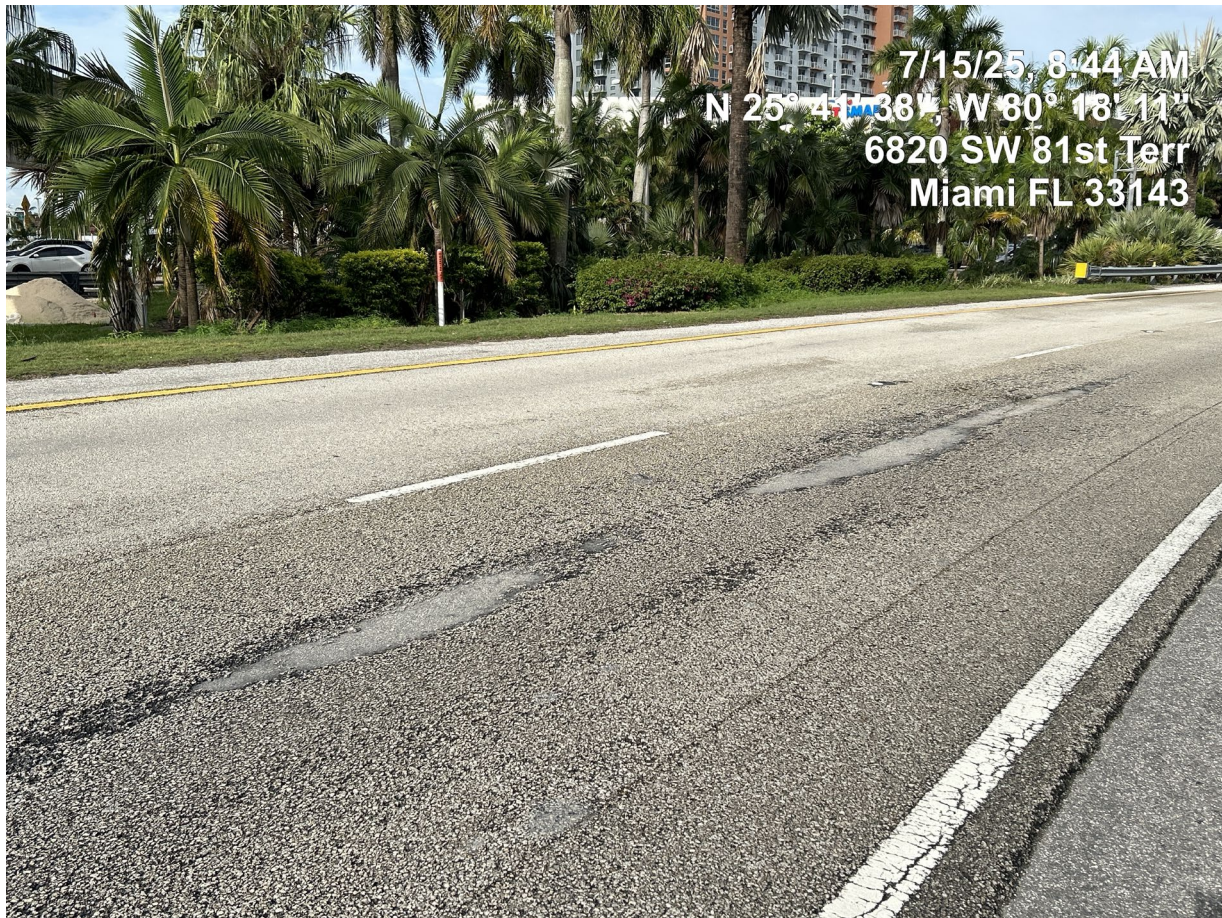
**ROADWAY INSPECTION  
LOCATION: MILE MARKER 3.2  
WESTBOUND MAINLINE**

**DETERIORATED PAVEMENT**

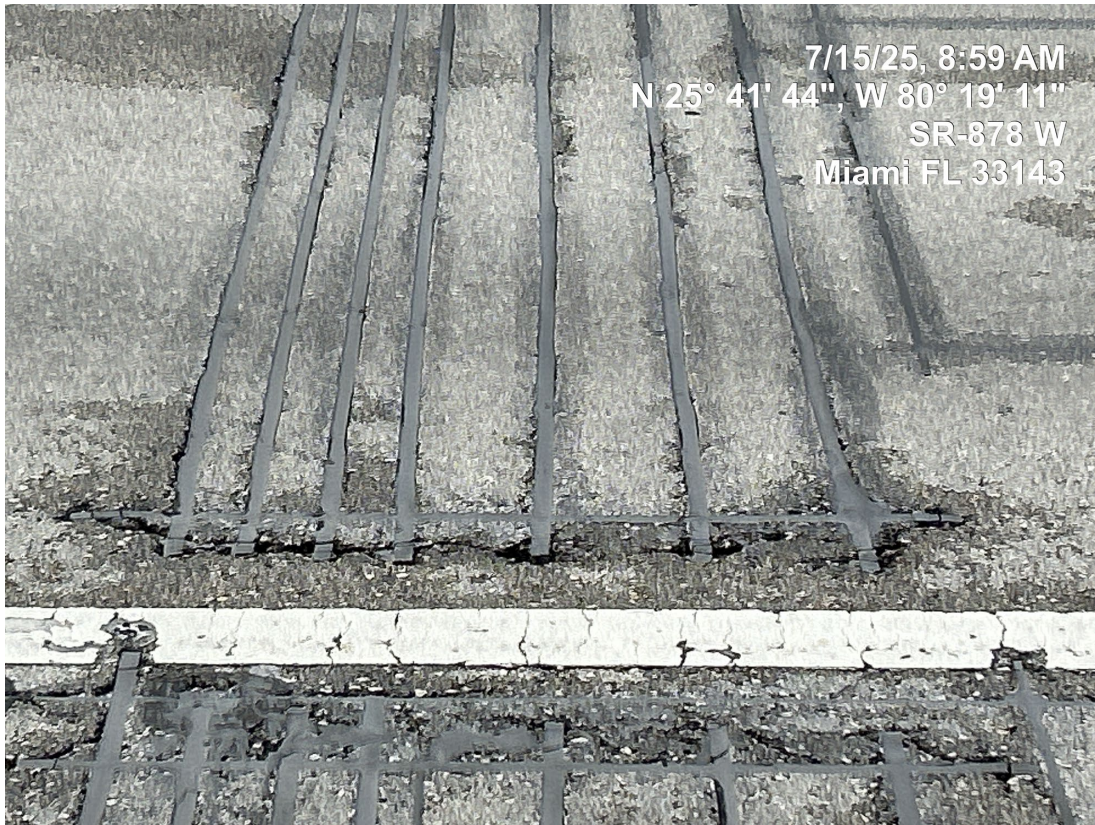
**ROADWAY INSPECTION  
LOCATION: MILE MARKER 2.12  
WESTBOUND MAINLINE**

**DETERIORATED SEALANT ON GANTRY LOOP DETECTORS**

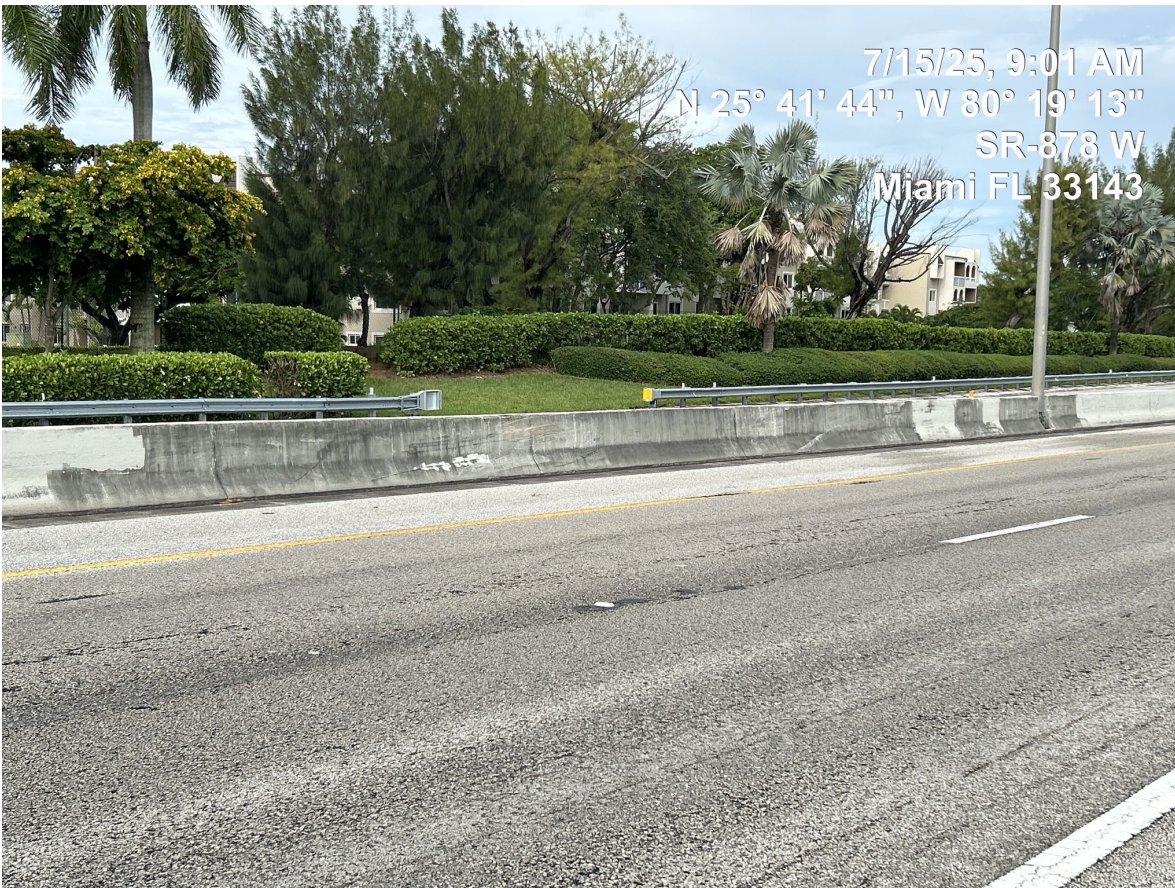
**ROADWAY INSPECTION  
LOCATION: MILE MARKER 2.0  
WESTBOUND MAINLINE**

**DETERIORATED CLASS V COATING ON BARRIER WALL**

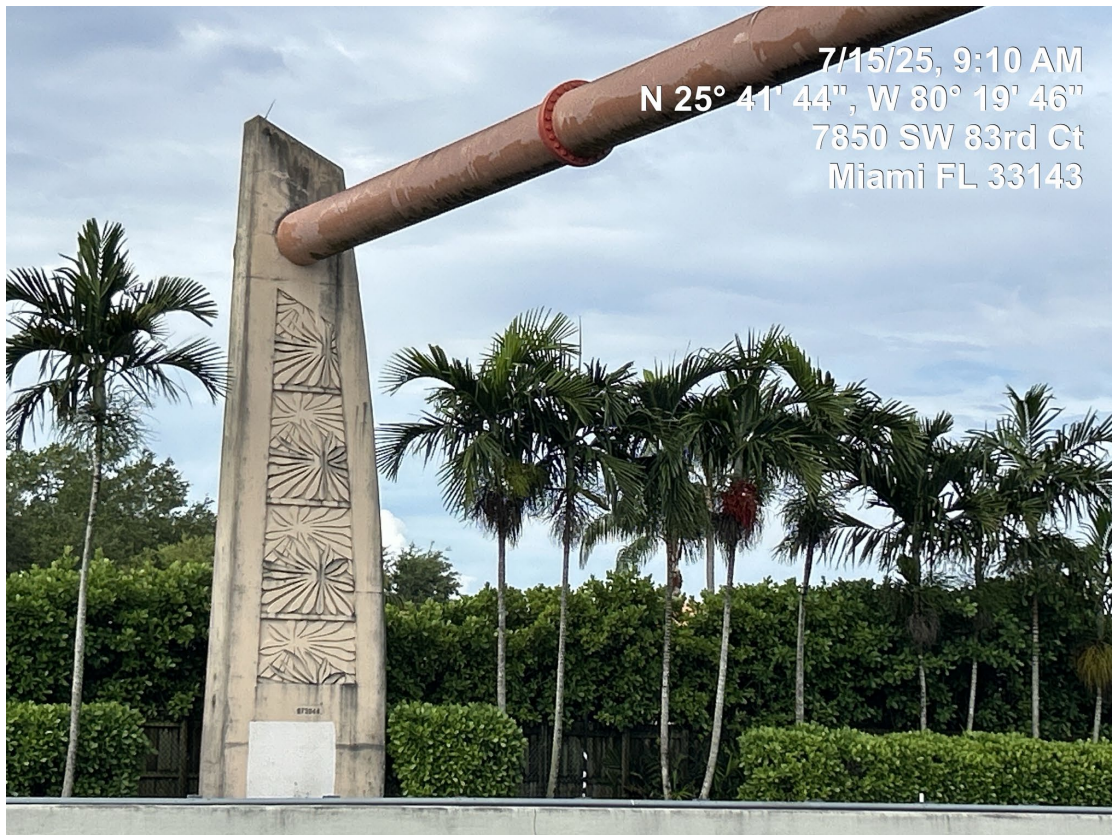
**ROADWAY INSPECTION  
LOCATION: MILE MARKER 1.53  
WESTBOUND MAINLINE**

**DETERIORATED CLASS V COAT PAINTING ON SIGN STRUCTURE UPRIGHT & PAINT  
ON MONOTUBE (STRUCTURE #87S944)**

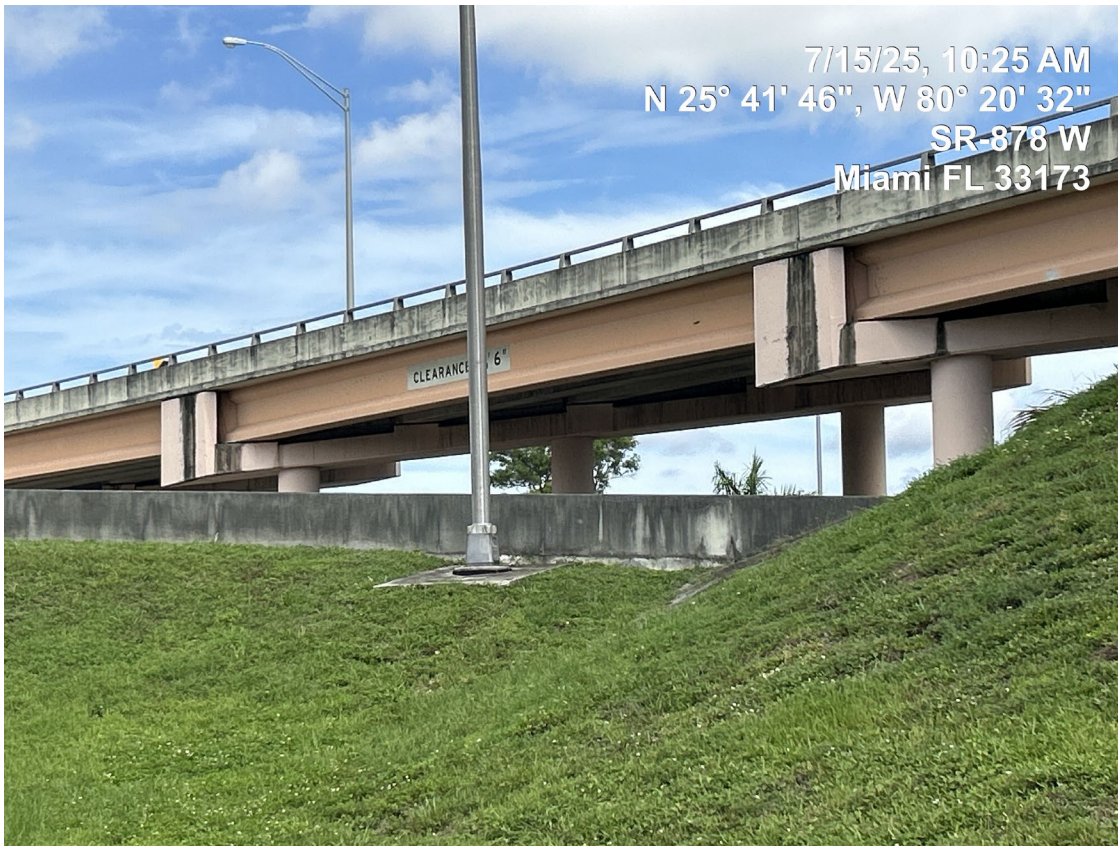
**ROADWAY INSPECTION  
LOCATION: MILE MARKER 0.7  
WESTBOUND MAINLINE**

**DERIORATED CLASS V COATING ON BRIDGE #870521  
(TYPICAL THROUGHOUT THIS CORRIDOR)**

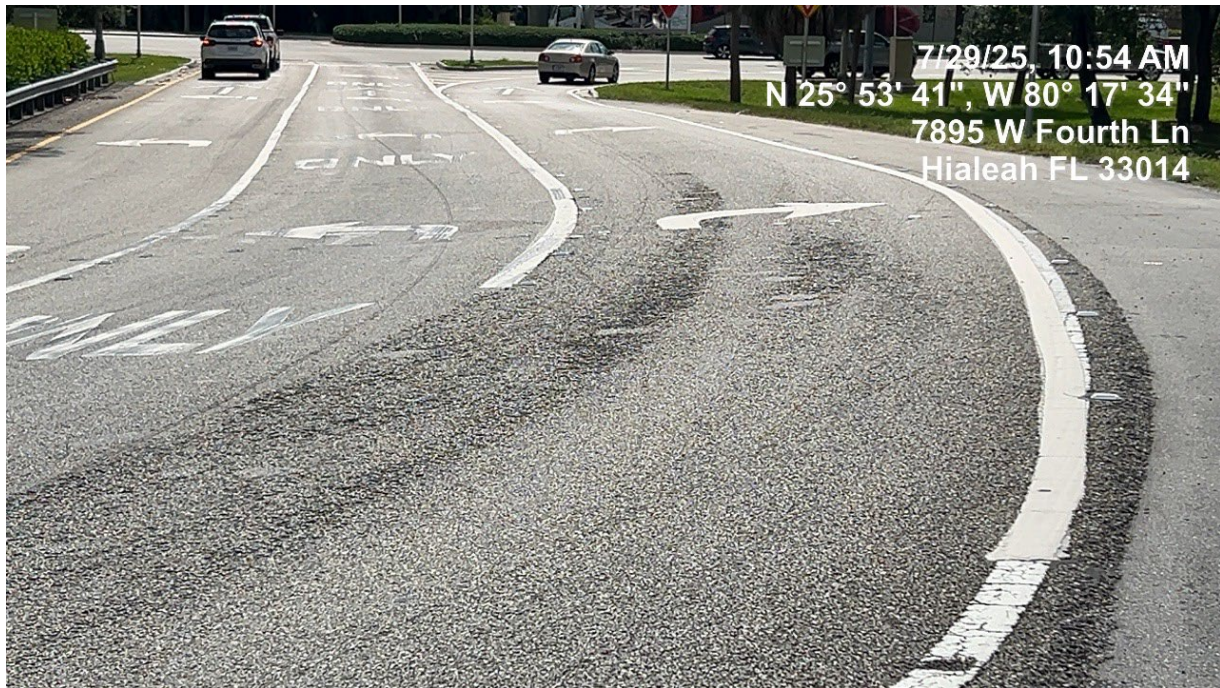
**ROADWAY INSPECTION  
LOCATION: MILE MARKER 2.0  
EASTBOUND OFF-RAMP TO NW 57<sup>th</sup> Ave.**

**DETERIORATED PAVEMENT**

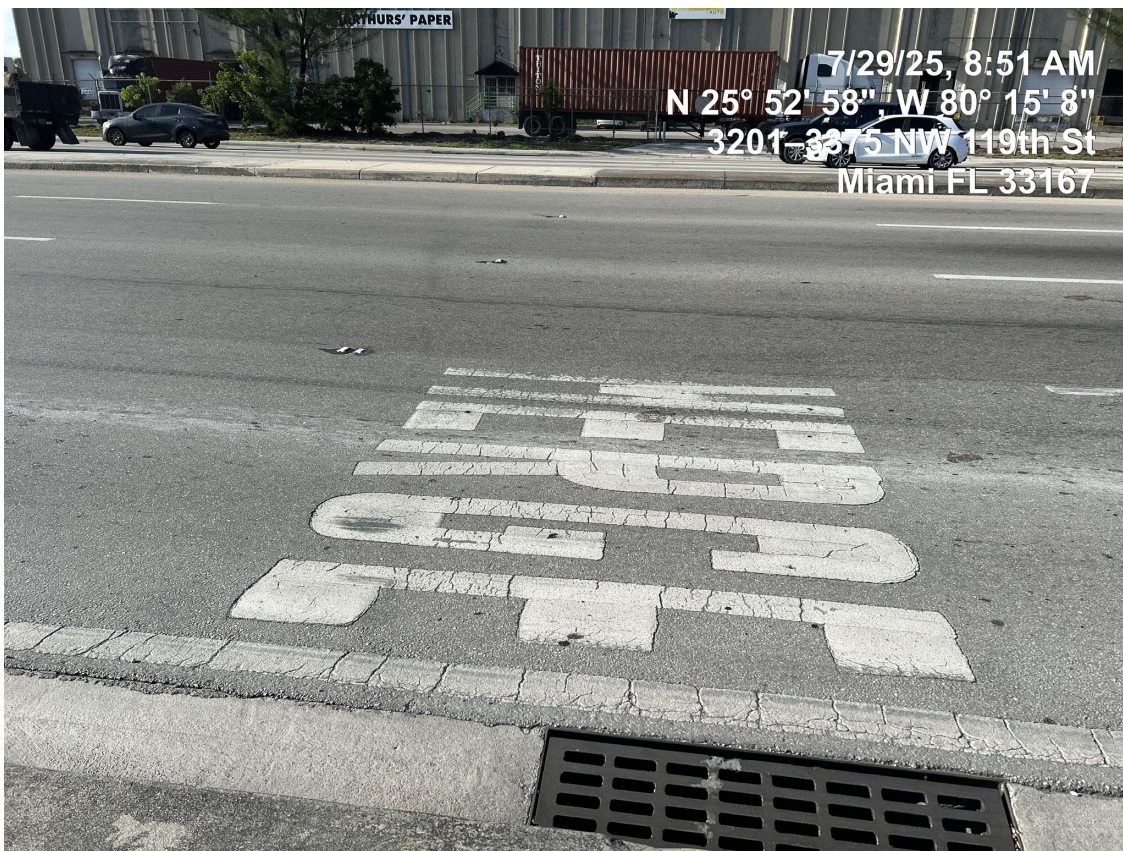
**ROADWAY INSPECTION  
LOCATION: MILE MARKER 4.8 MILES  
WESTBOUND MAINLINE**

**PAVEMENT SETTLEMENT AT LATERAL PIPE CROSSING**

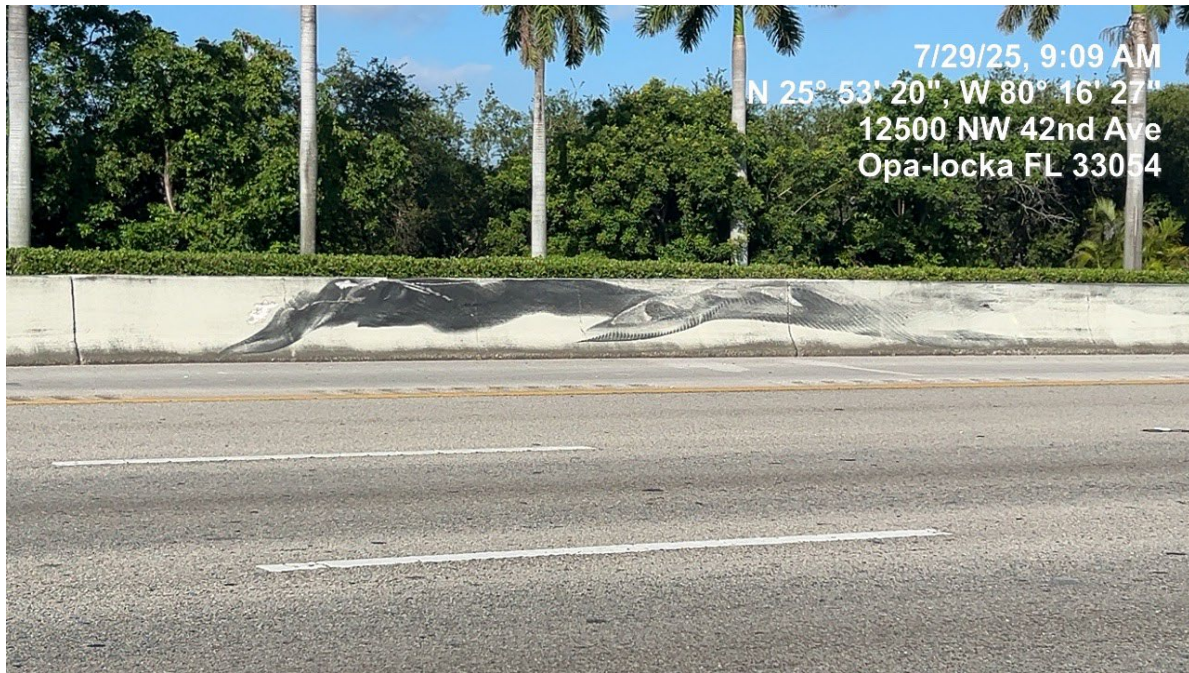
**ROADWAY INSPECTION  
LOCATION: MILE MARKER 2.45 MILES  
WESTBOUND MAINLINE**

**SCUFF MARKS ON BARRIER WALL**

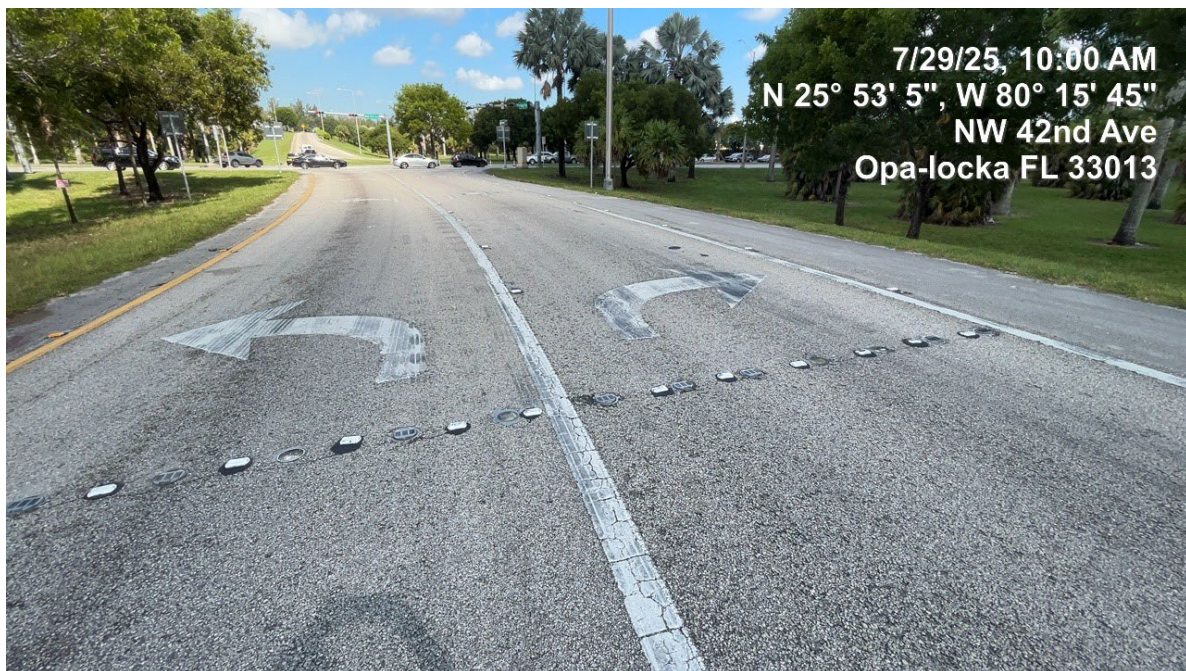
**ROADWAY INSPECTION  
LOCATION: MILE MARKER 4.1  
WESTBOUND OFF-RAMP TO NW 37<sup>th</sup> Ave.**

**DETERIORATED PAVEMENT MARKINGS AND TURN ARROWS**

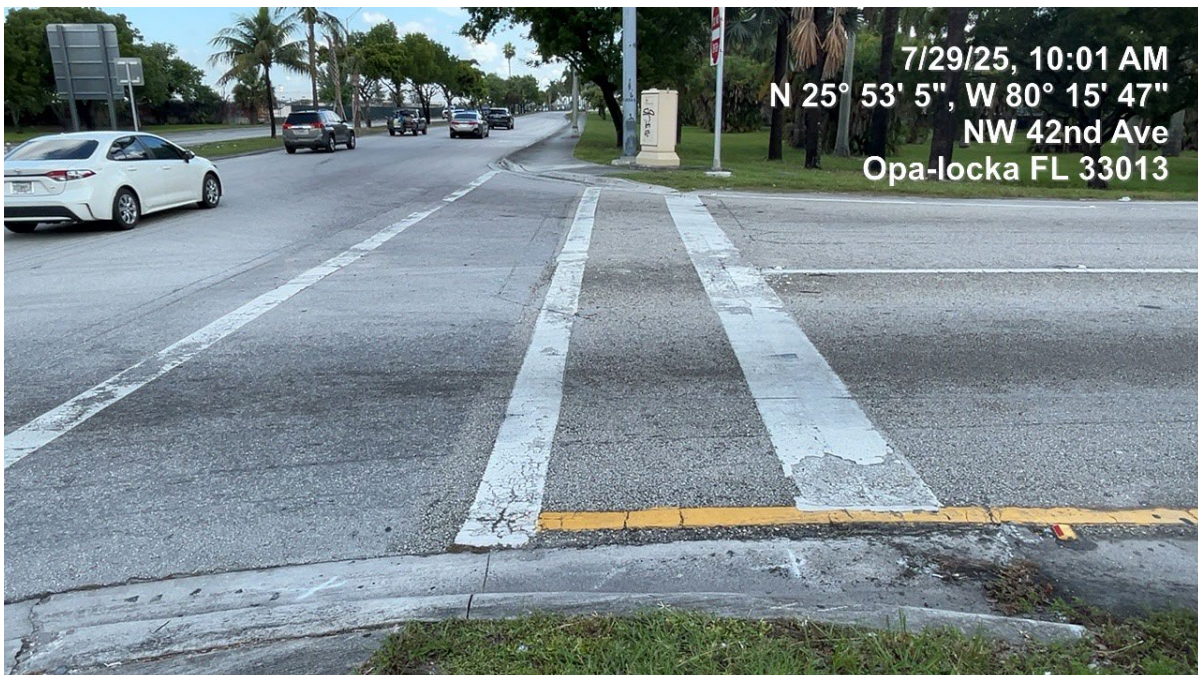
**ROADWAY INSPECTION  
LOCATION: MILE MARKER 2.0  
WESTBOUND OFF-RAMP TO NW 37<sup>th</sup> Ave.**

**DETERIORATED STOP BAR AND PEDESTRIAN CROSSWALK  
ITEM NOTED TO BE ADDRESSED BY GMX WORK PROGRAM 30033**

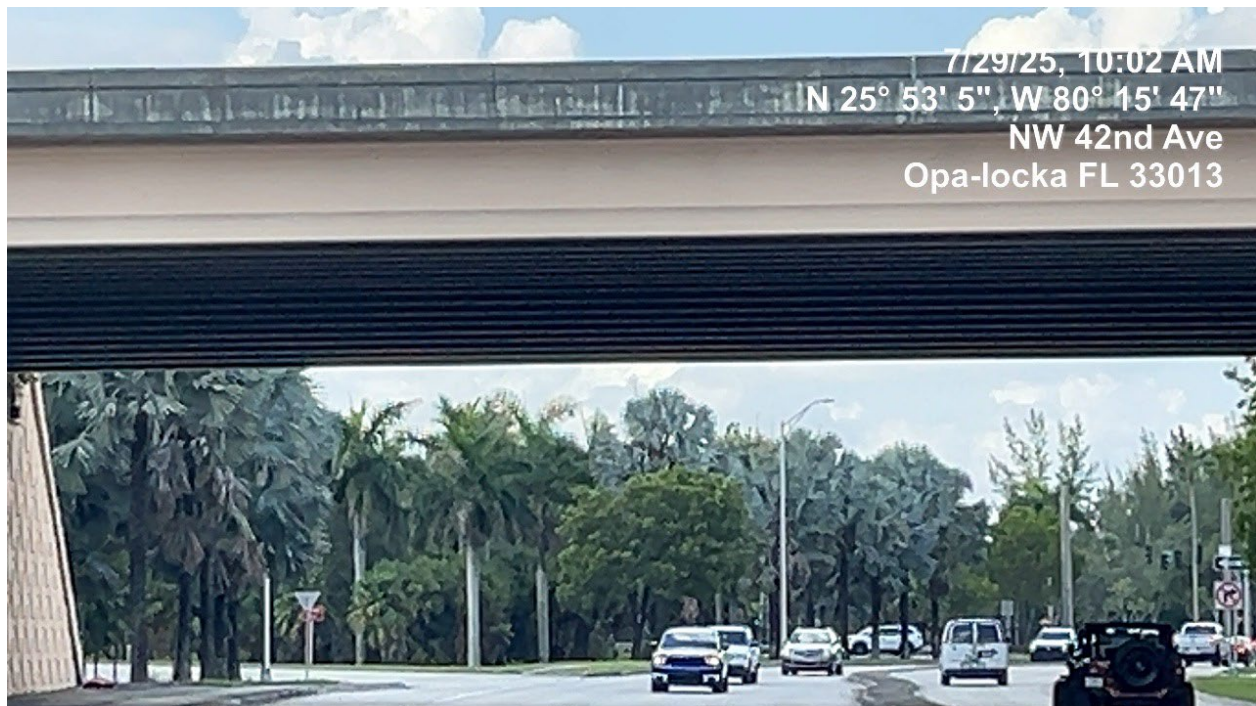
**ROADWAY INSPECTION  
LOCATION: MILE MARKER 4.1  
WESTBOUND MAINLINE OVER NW 37<sup>TH</sup> Ave.**

**DETERIORATED CLASS V COATING ON BRIDGE  
(BRIDGE #870739) TYPICALLY THROUGHOUT**

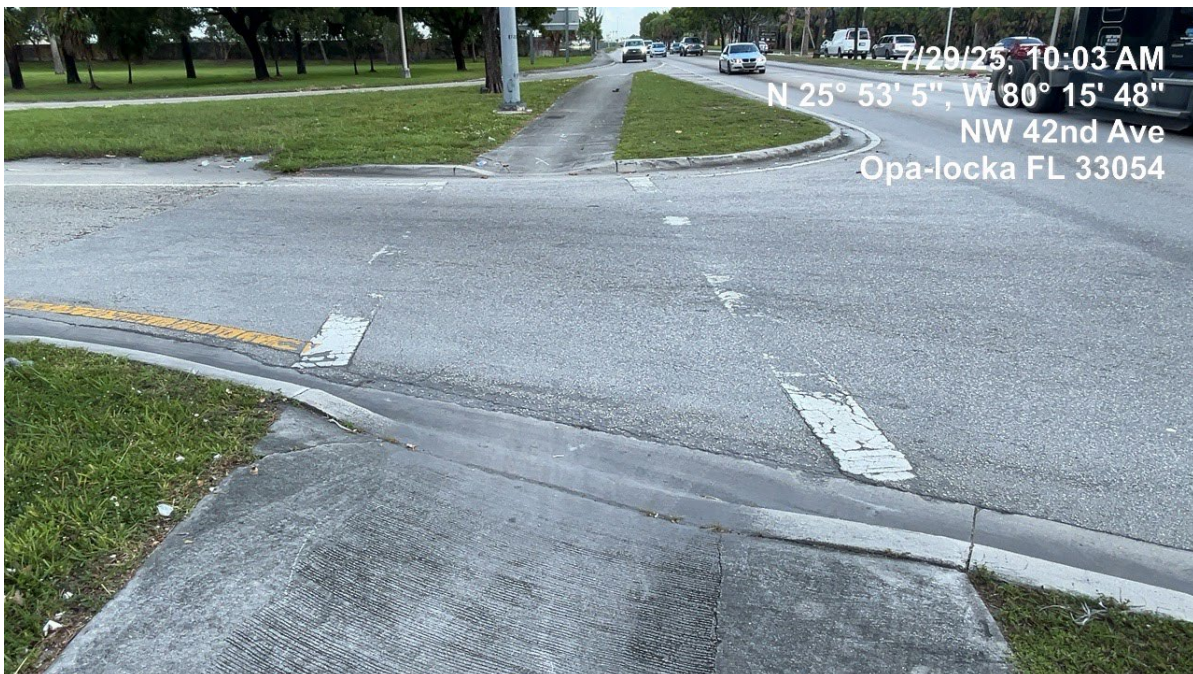
**ROADWAY INSPECTION  
LOCATION: MILE MARKER 4.08  
WESTBOUND ON-RAMP FROM NW 37<sup>TH</sup> AVE**

**DETERIORATED PEDESTRIAN CROSSWALK PAVEMENT MARKINGS**

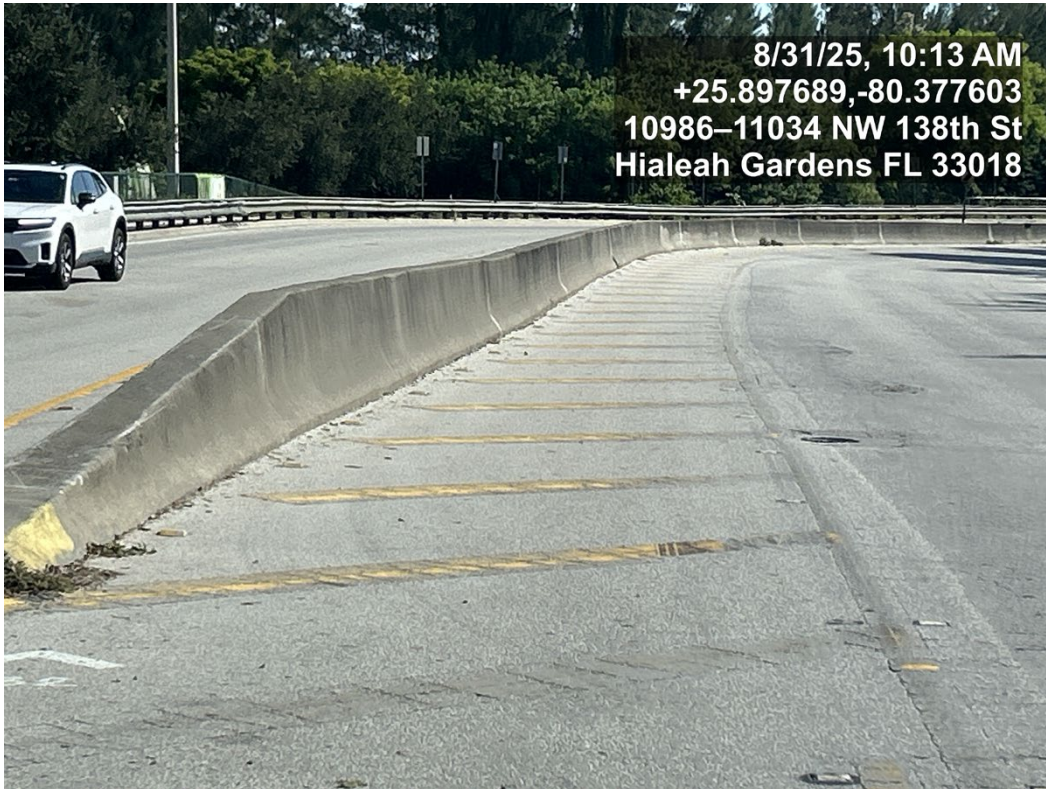
**ROADWAY INSPECTION  
LOCATION: EASTBOUND NW 138<sup>th</sup> STREET  
1120 FEET WEST OF NW 107 AVE.**

**DETERIORATED PAVEMENT MARKINGS**

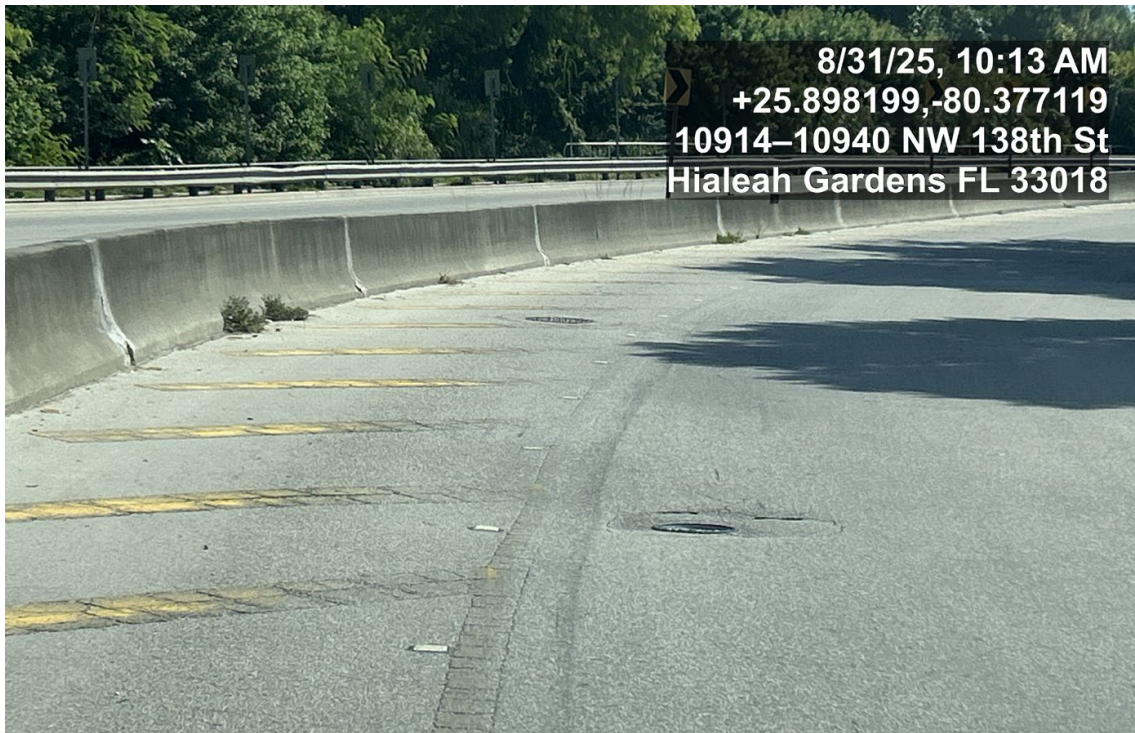
**ROADWAY INSPECTION  
LOCATION: EASTBOUND NW 138<sup>th</sup> STREET  
823 FEET NORTH OF FRONTAGE ROAD**

**PAVEMENT SETTLEMENT AT WATER VALVE**

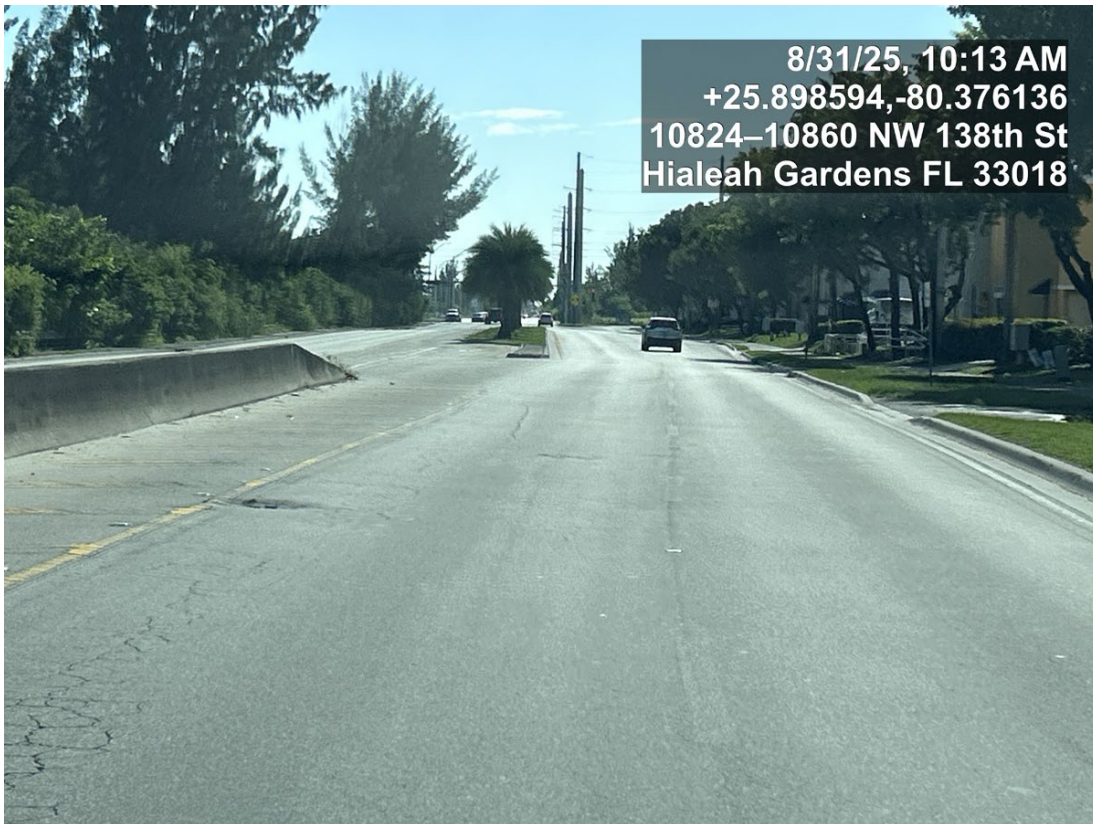
**ROADWAY INSPECTION  
LOCATION: EASTBOUND NW 138<sup>th</sup> STREET  
1120 FEET WEST OF NW 107 AVE.**

**DETERIORATED STRIPING**

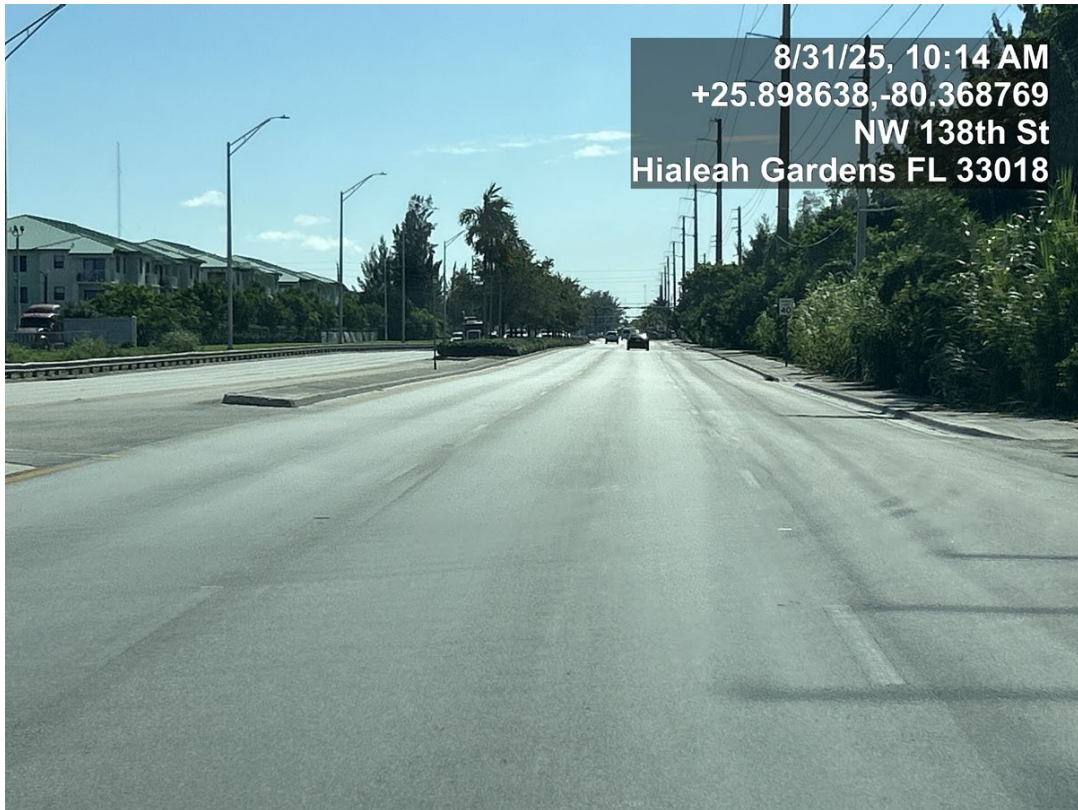
**ROADWAY INSPECTION  
LOCATION: EASTBOUND NW 138<sup>th</sup> STREET  
EAST OF NW 107 AVE.**

**DETERIORATED STRIPING**

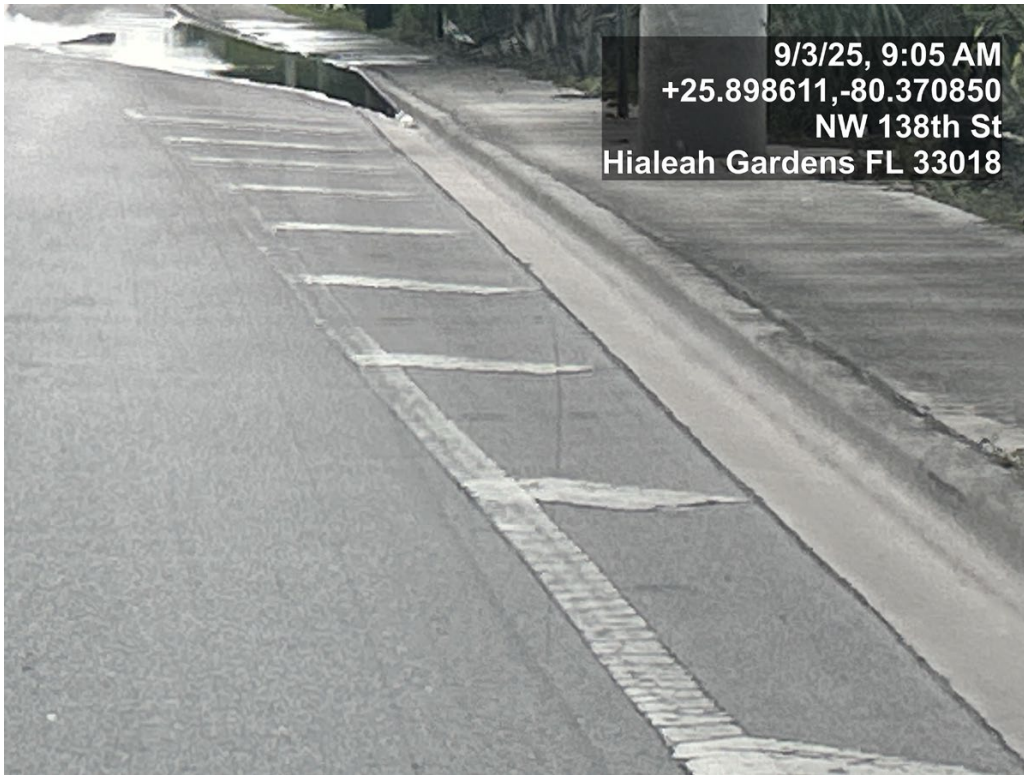
**ROADWAY INSPECTION  
LOCATION: EASTBOUND NW 138<sup>th</sup> STREET  
EAST OF NW 107 AVE.**

**DETERIORATED PAVEMENT MARKINGS IN GORE AREA**
