# Annual Inspection Report **2025**

# ANNUAL INSPECTION REPORT 2025

## ANNUAL INSPECTION REPORT

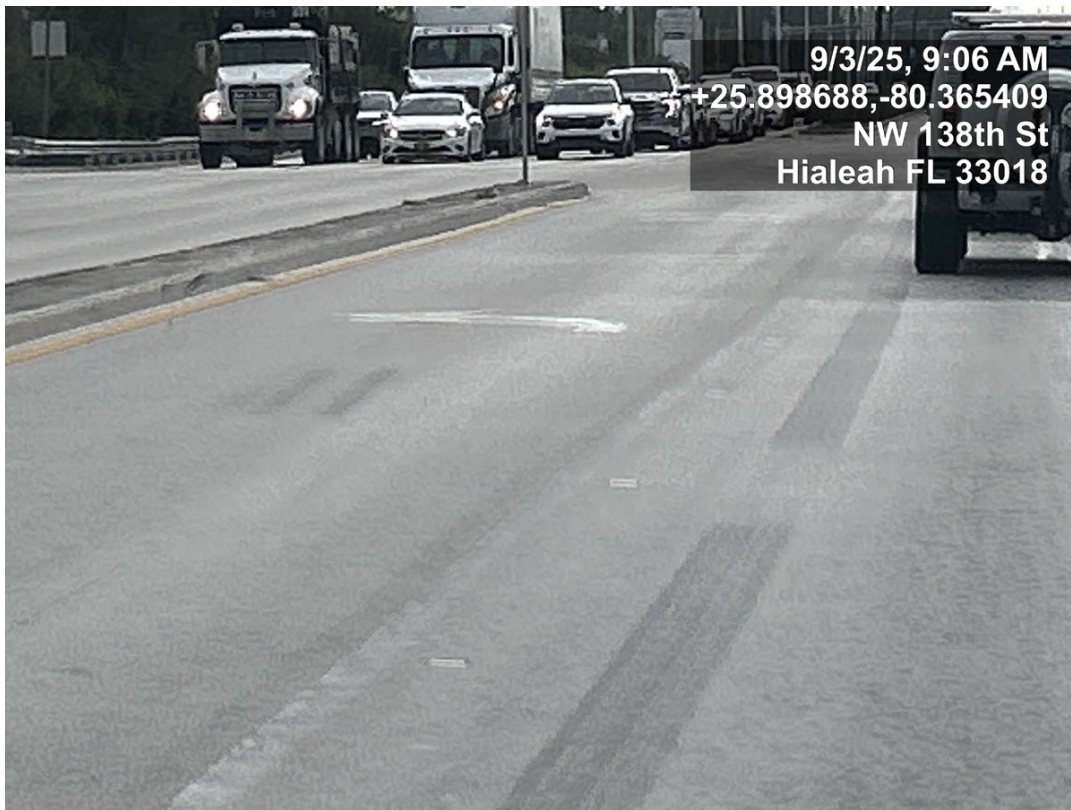
**ROADWAY INSPECTION  
LOCATION: EASTBOUND NW 138<sup>th</sup> STREET  
AT NW 107 AVE.**

**DETERIORATED PAVEMENT MARKINGS AND TURN ARROWS**

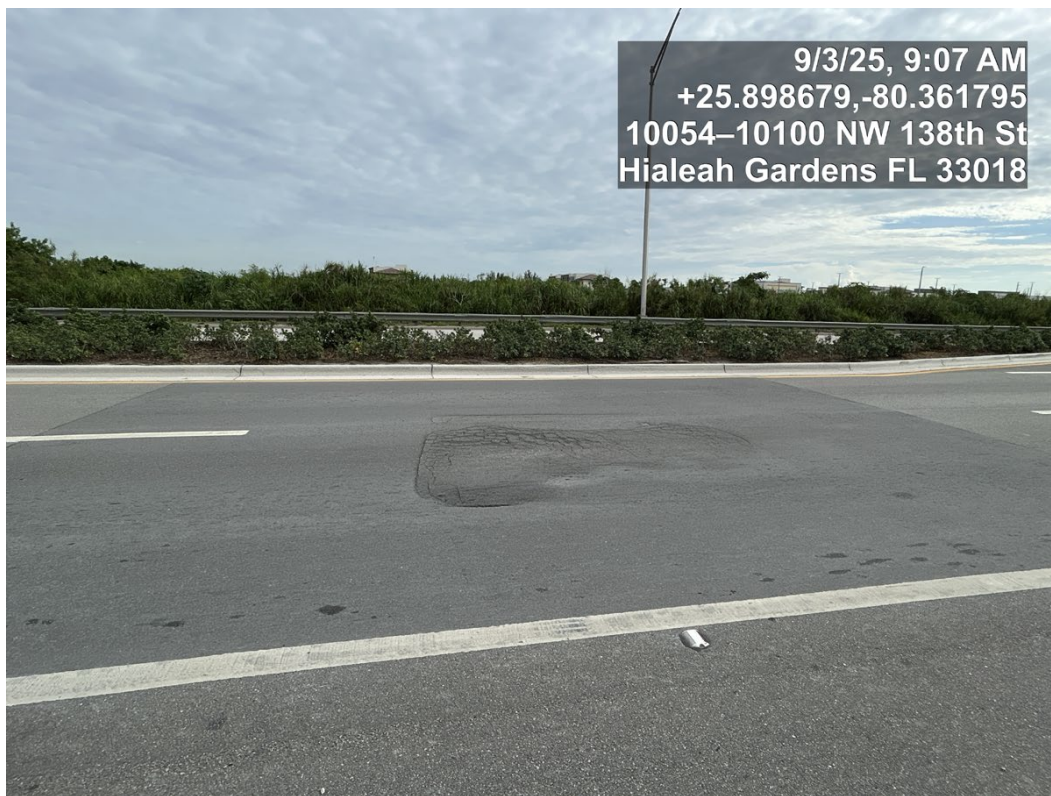
**ROADWAY INSPECTION  
LOCATION: EASTBOUND NW 138<sup>th</sup> STREET  
EAST OF NW 102 AVE.**

**SETTLEMENT ON PAVEMENT (OUTSIDE LANE)**

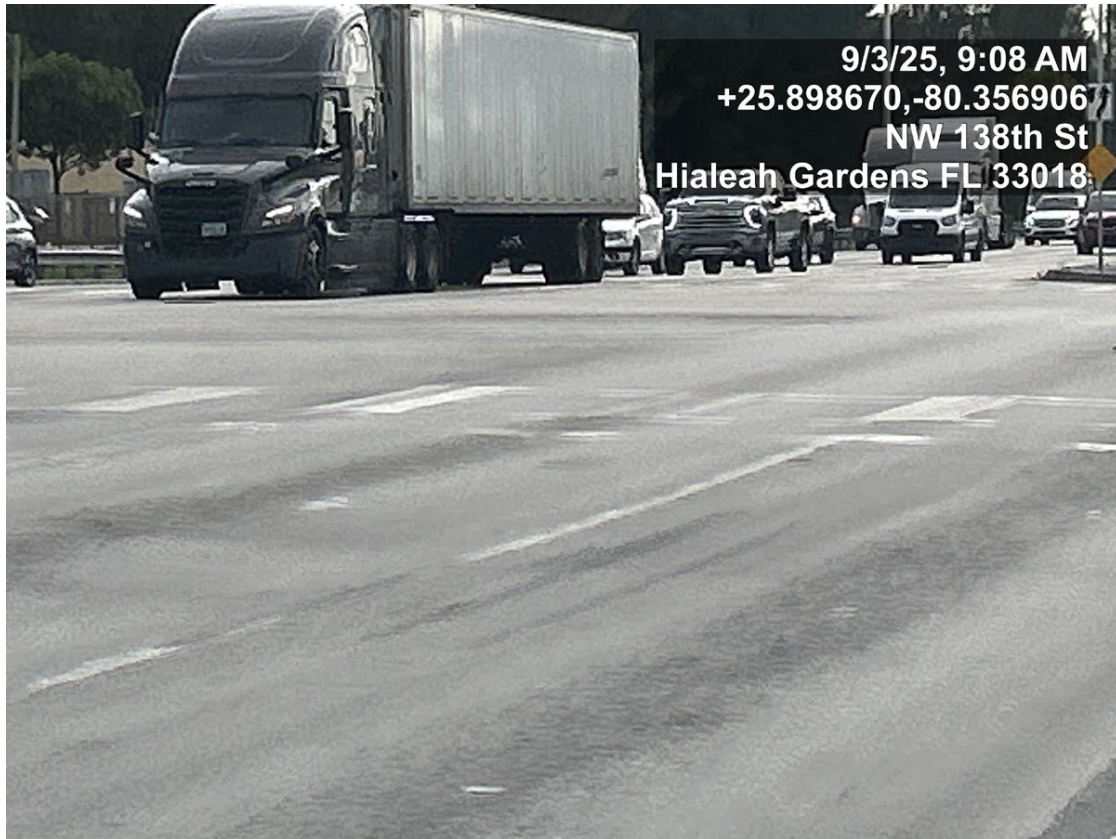
**ROADWAY INSPECTION  
LOCATION: EASTBOUND NW 138<sup>th</sup> STREET  
AT NW 97<sup>TH</sup> AVENUE.**

**DETERIORATED PAVEMENT MARKINGS, STOP BAR AND PEDESTRIAN  
CROSSWALK**

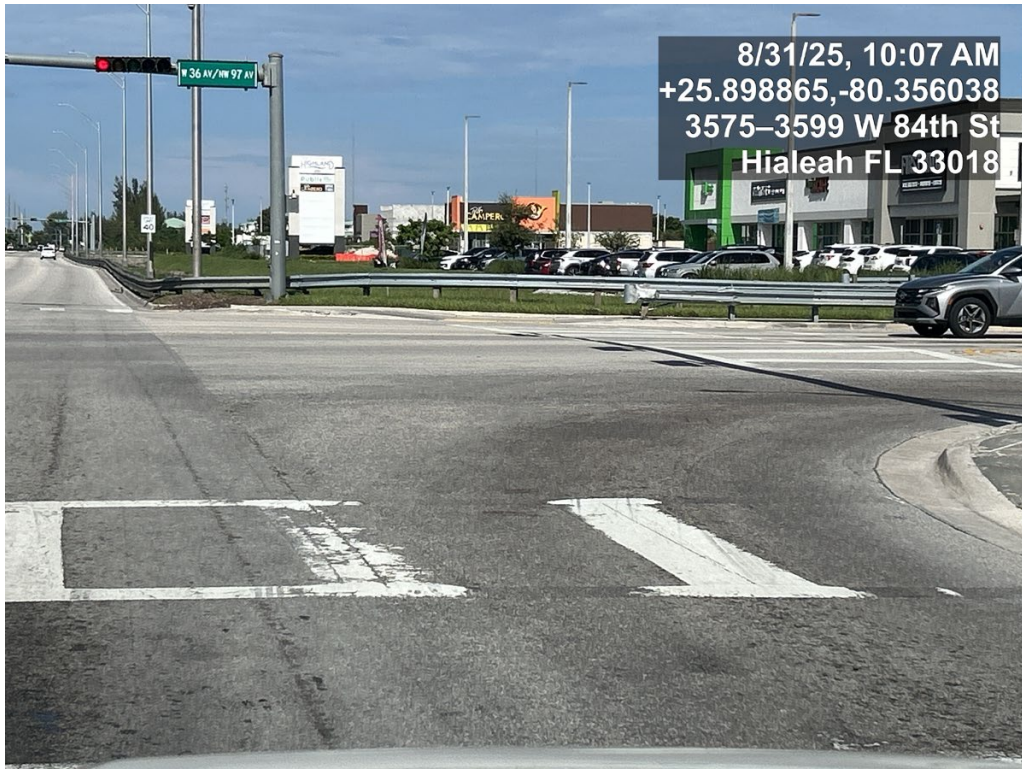
**ROADWAY INSPECTION  
LOCATION: WESTBOUND NW 138<sup>th</sup> STREET  
AT NW 97<sup>th</sup> AVENUE**

**DETERIORATED PAVEMENT MARKINGS ON PEDESTRIAN CROSSWALK**

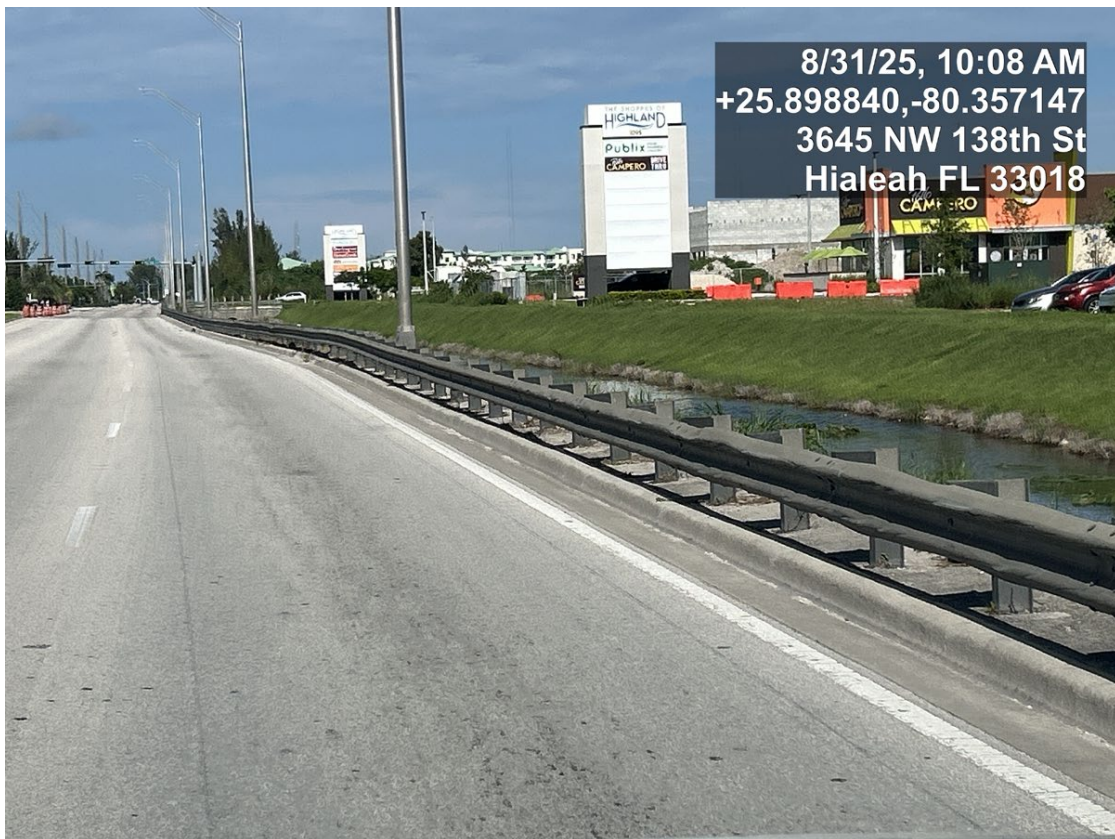
**ROADWAY INSPECTION  
LOCATION: WESTBOUND NW 138<sup>th</sup> STREET  
FROM 500 FT EAST OF NW 97<sup>th</sup> AVENUE  
TO FRONTAGE ROAD**

**GUARDRAIL HEIGHT NOT TO THE LATEST FDOT STANDARDS**

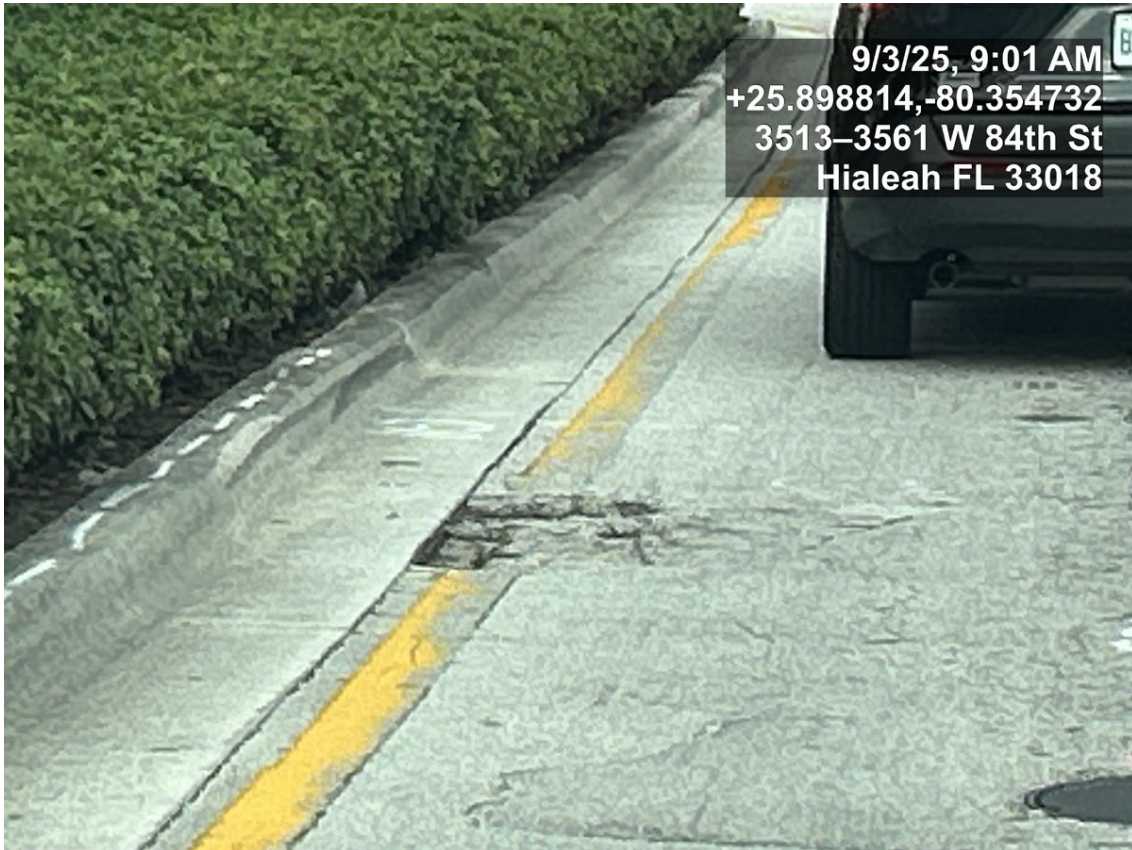
**ROADWAY INSPECTION  
LOCATION: WESTBOUND NW 138<sup>th</sup> STREET  
300 FT EAST OF NW 97<sup>TH</sup> AVENUE.**

**POTHOLE ON INSIDE LANE/ DETERIORATED STRIPING**

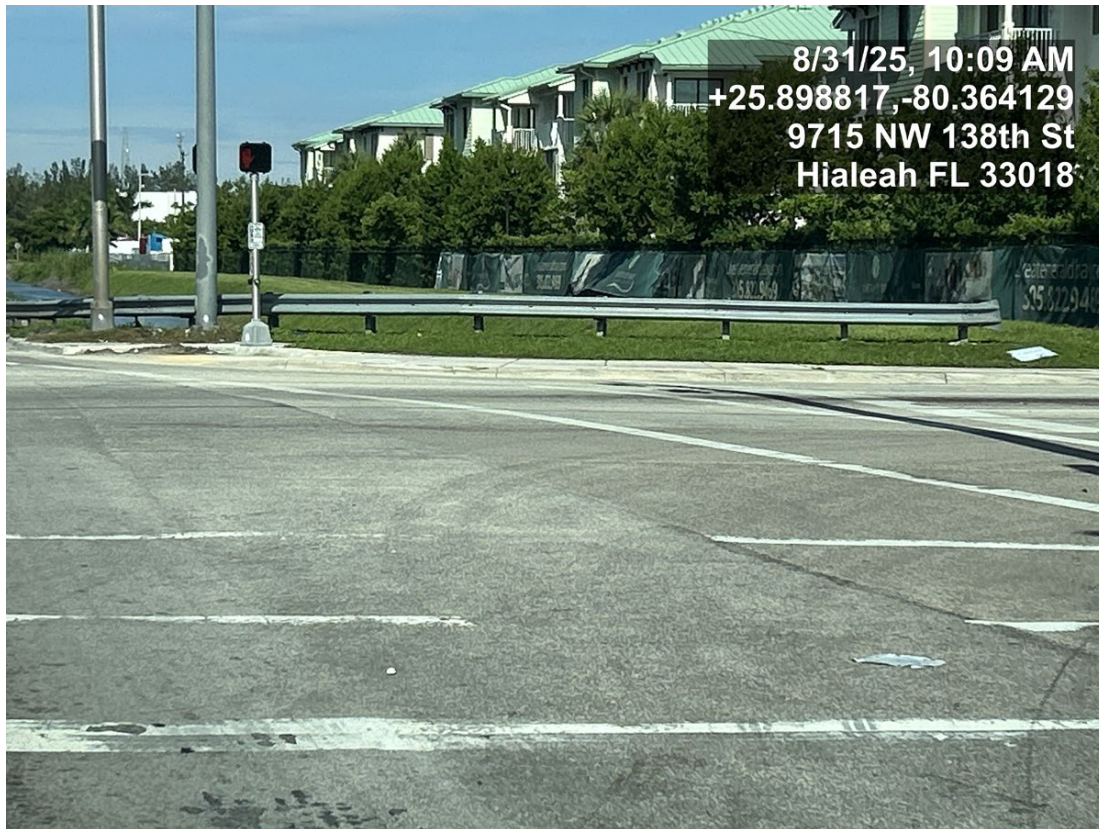
**ROADWAY INSPECTION  
LOCATION: WESTBOUND AT NW 138<sup>th</sup> STREET  
AT NW 102<sup>ND</sup> AVENUE.**

**DETERIORATED PEDESTRIAN CROSSWALK AND STOP BAR**

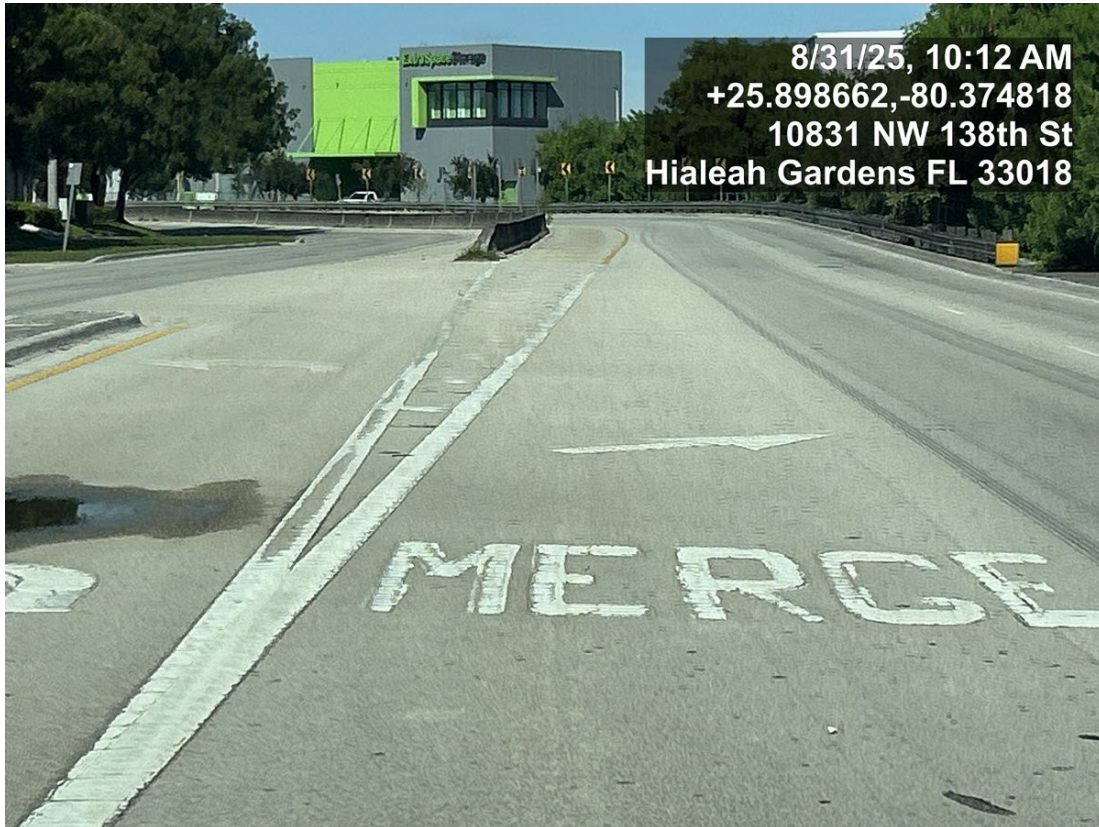
**ROADWAY INSPECTION  
LOCATION: WESTBOUND NW 138<sup>th</sup> STREET  
300 FT WEST OF NW 107<sup>th</sup> AVENUE.**

**DETERIORATED PAVEMENT MARKINGS AND PAVEMENT MESSAGE**

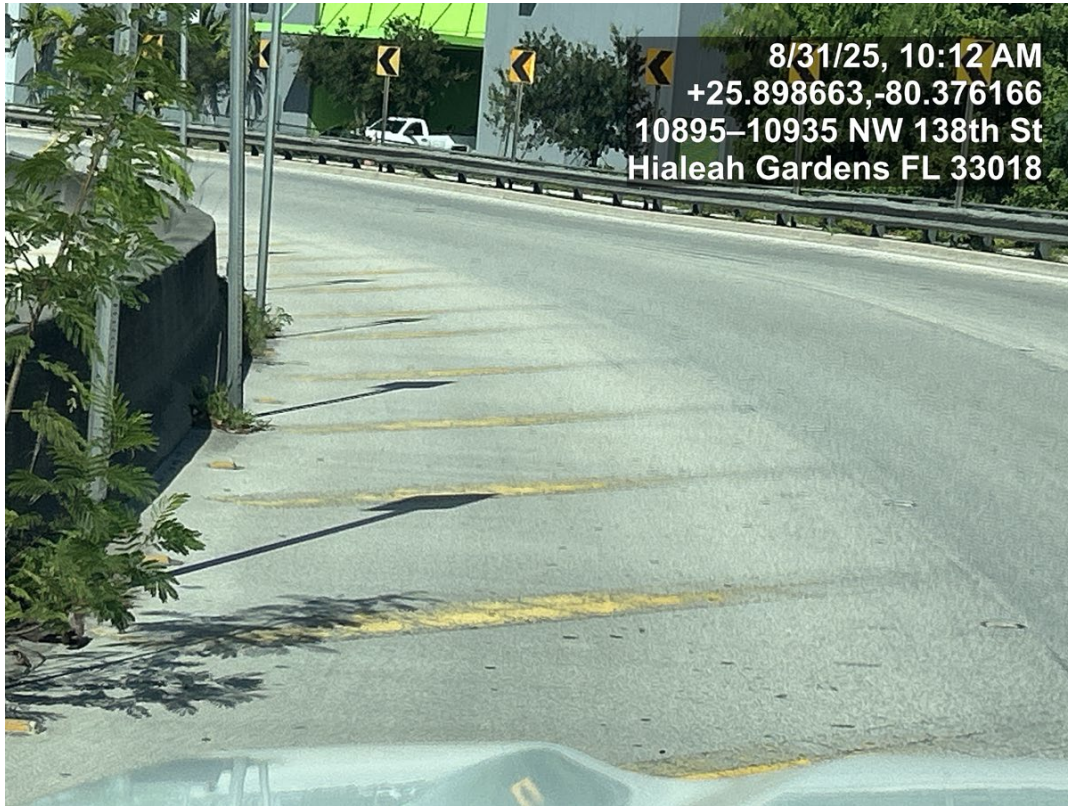
**ROADWAY INSPECTION  
LOCATION: WESTBOUND WEST OF NW 107<sup>th</sup> AVENUE**

**DETERIORATED CHEVRONS/OVERGROWN VEGETATION ADJACENT TO  
CHEVRONS SIGNS**

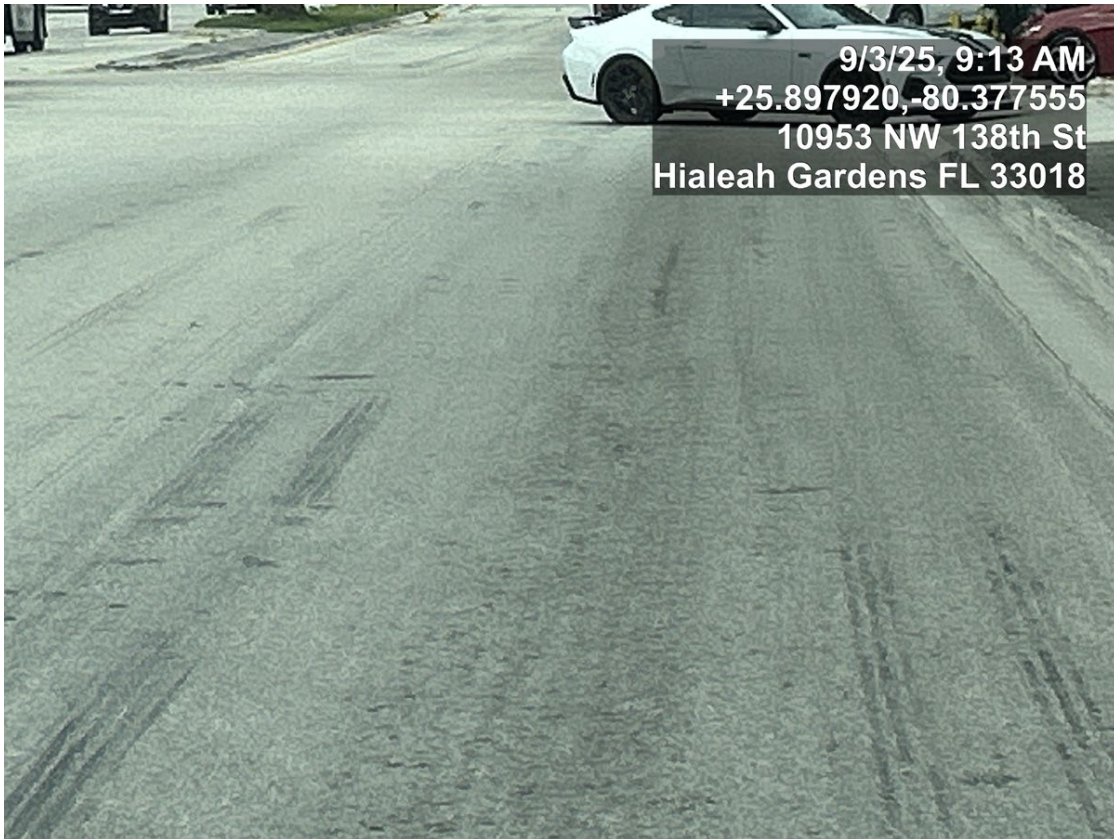
**ROADWAY INSPECTION  
LOCATION: WESTBOUND NORTH OF FRONTAGE ROAD**

**DETERIORATED PAVEMENT MARKINGS**

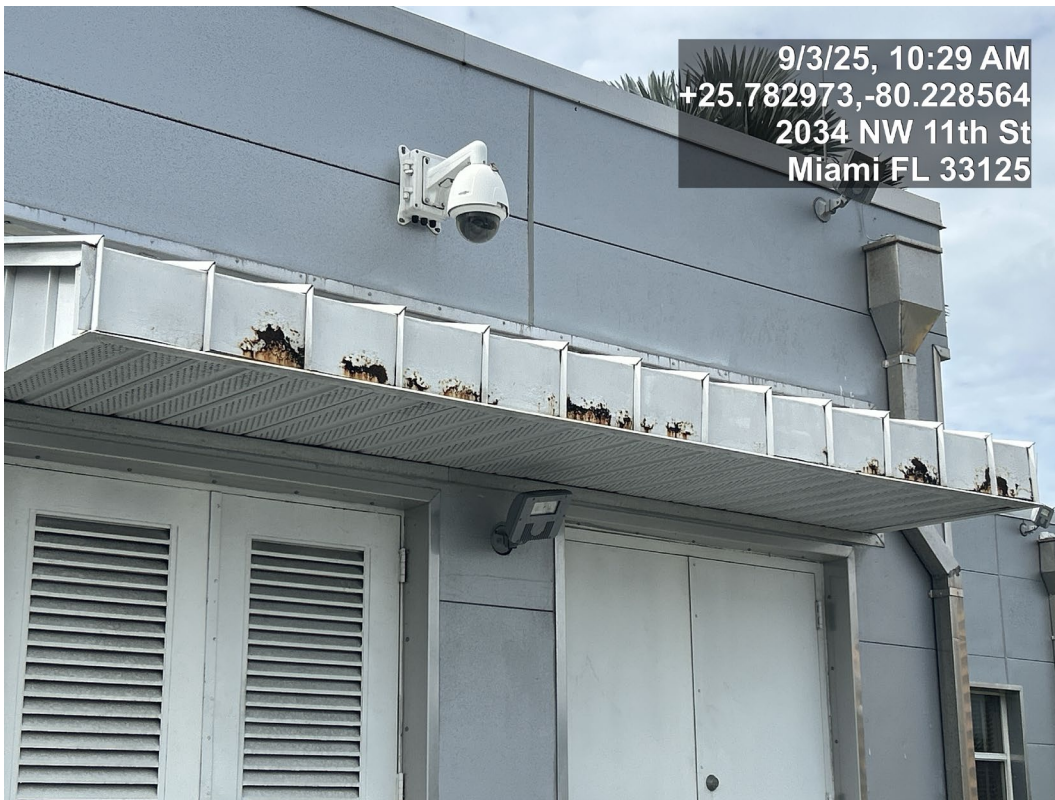
**ARCHITECTURAL INSPECTION  
LOCATION: SR-836 MAIN ADMINISTRATION BUILDING  
(MECHANICAL ROOM)**

**SURFACE CORROSION ON METAL CANOPY**

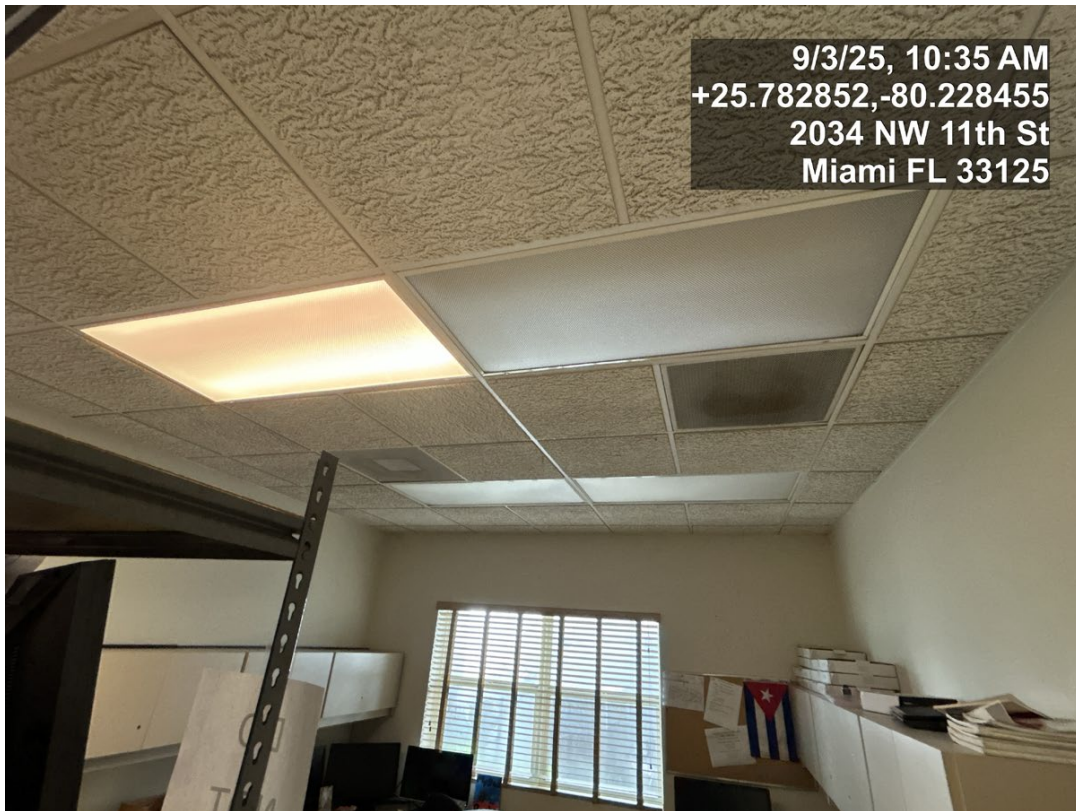
**ARCHITECTURAL INSPECTION  
LOCATION: SR-836 MAIN ADMINISTRATION BUILDING  
SUPPLY STORAGE**

**BURNED OUT LIGHTS**

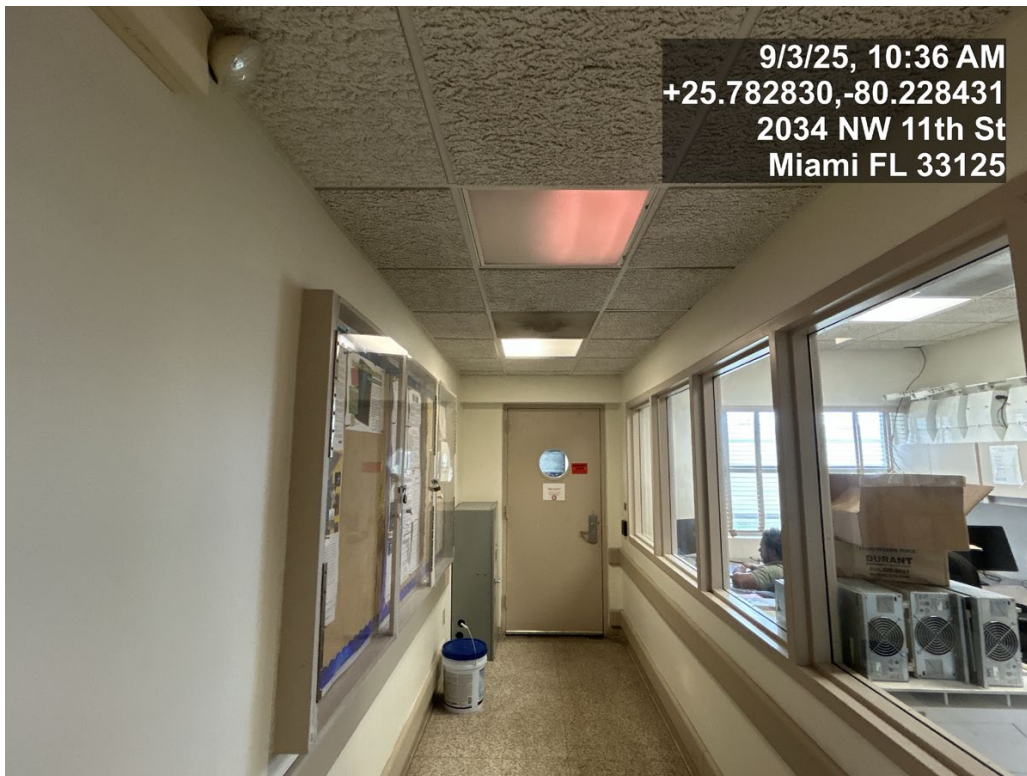
**ARCHITECTURAL INSPECTION  
LOCATION: SR-836 MAIN ADMINISTRATION BUILDING  
MANAGER'S OFFICE**

**BURNED OUT LIGHTS**

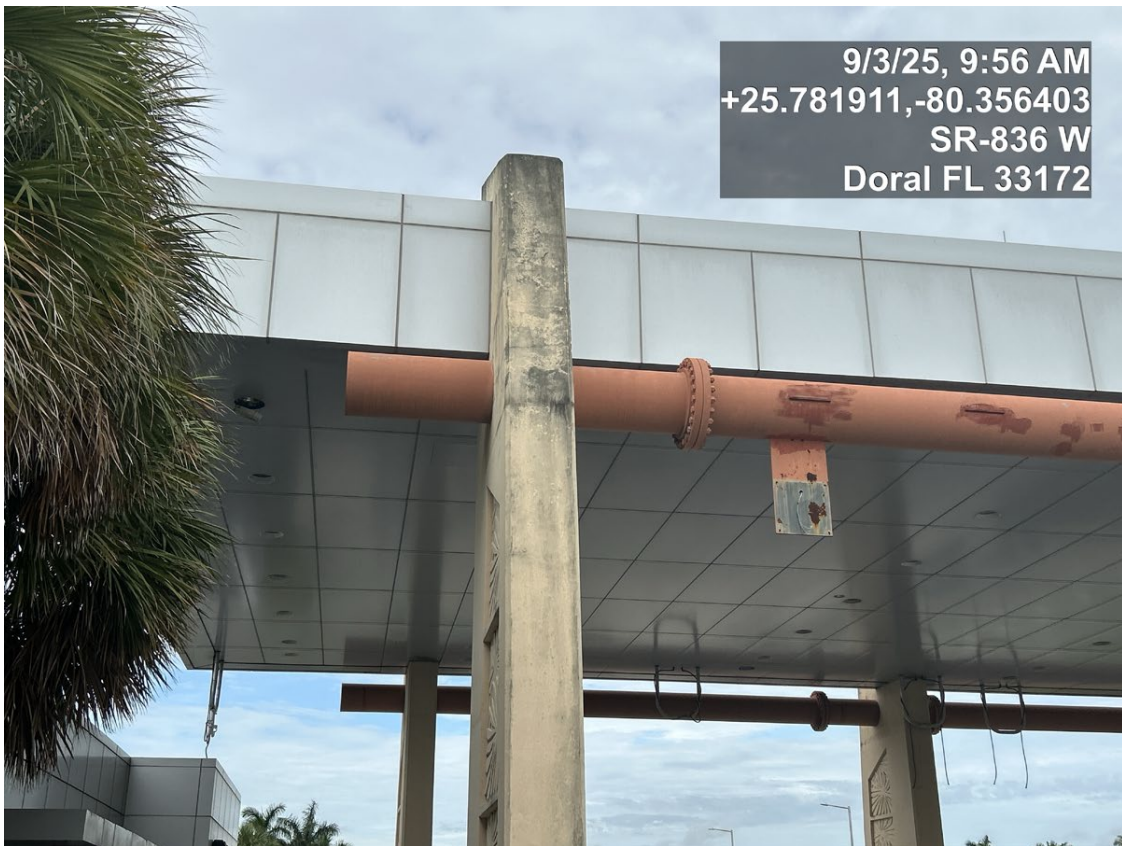
**ARCHITECTURAL INSPECTION  
LOCATION: SR-836 / NW 97<sup>th</sup> AVENUE WESTBOUND**

**DETERIORATED PAINT ON MONOTUBE/CLASS V COATING ON**

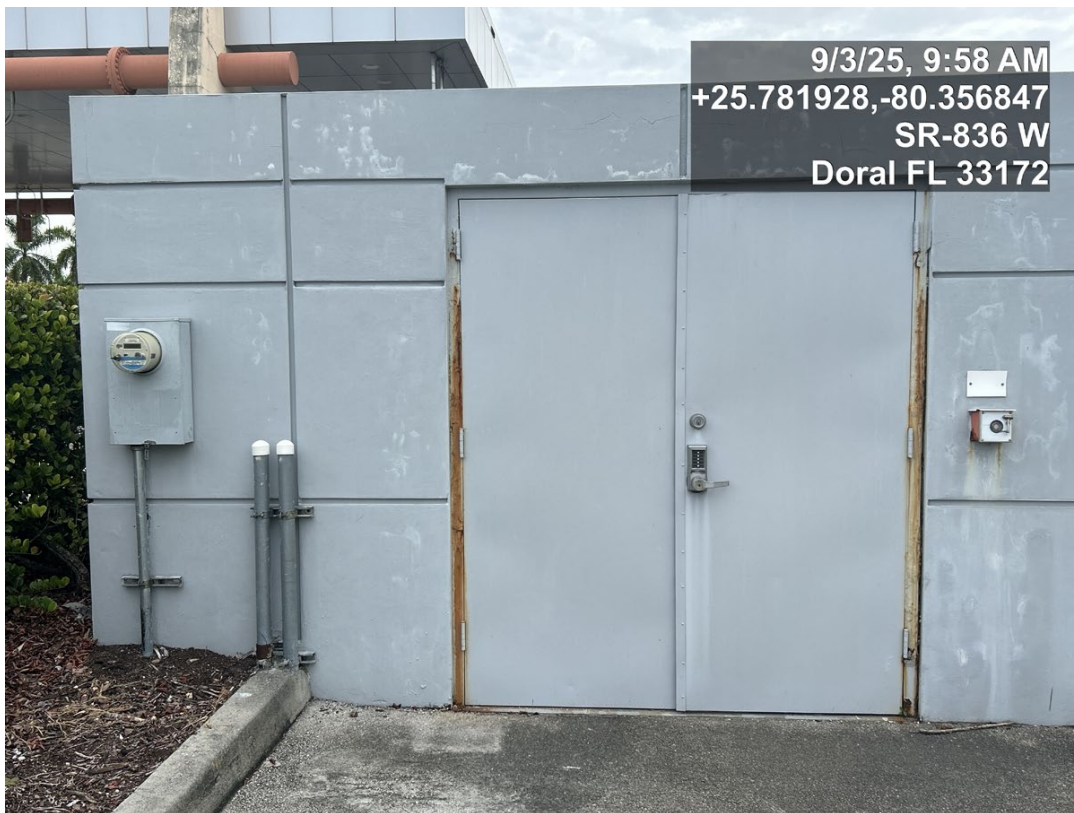
**ARCHITECTURAL INSPECTION  
LOCATION: SR-836 / NW 97<sup>th</sup> AVENUE WESTBOUND  
TOLL PLAZA**

**DETERIORATED PAINT ON WALLS AND DOORS ON GENERATOR ENCLOSURE**

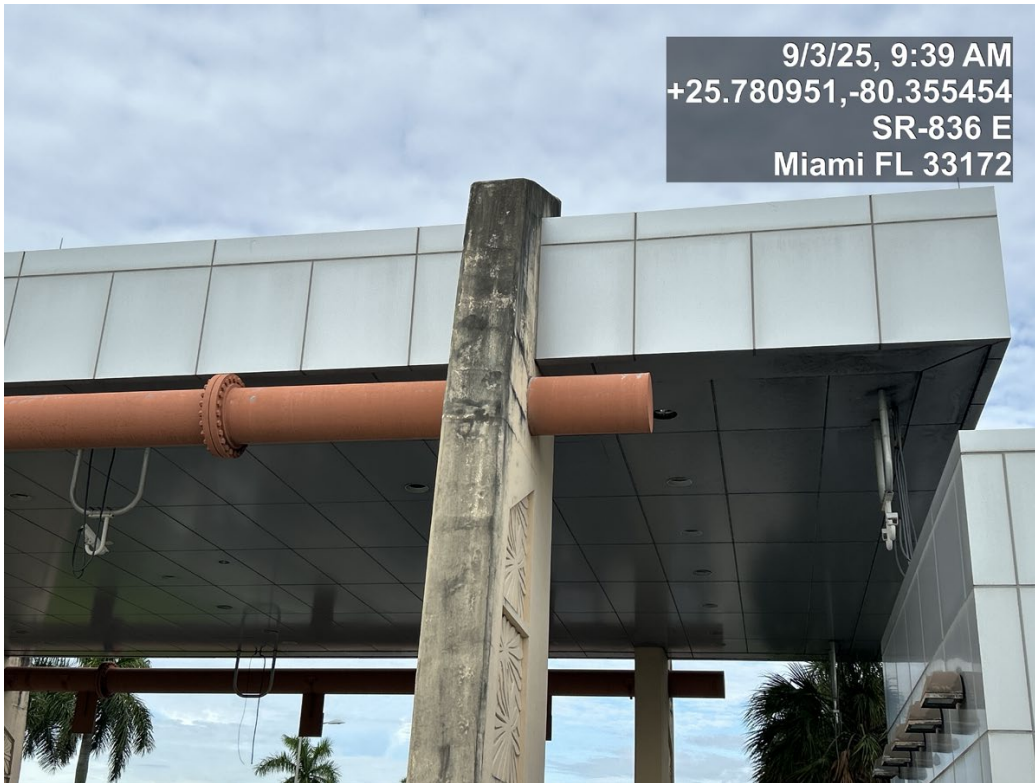
**ARCHITECTURAL INSPECTION  
LOCATION: SR-836 / NW 97<sup>th</sup> AVENUE EASTBOUND  
TOLL PLAZA CANOPY**

**DETERIORATED PAINT ON CANOPY COLUMNS**

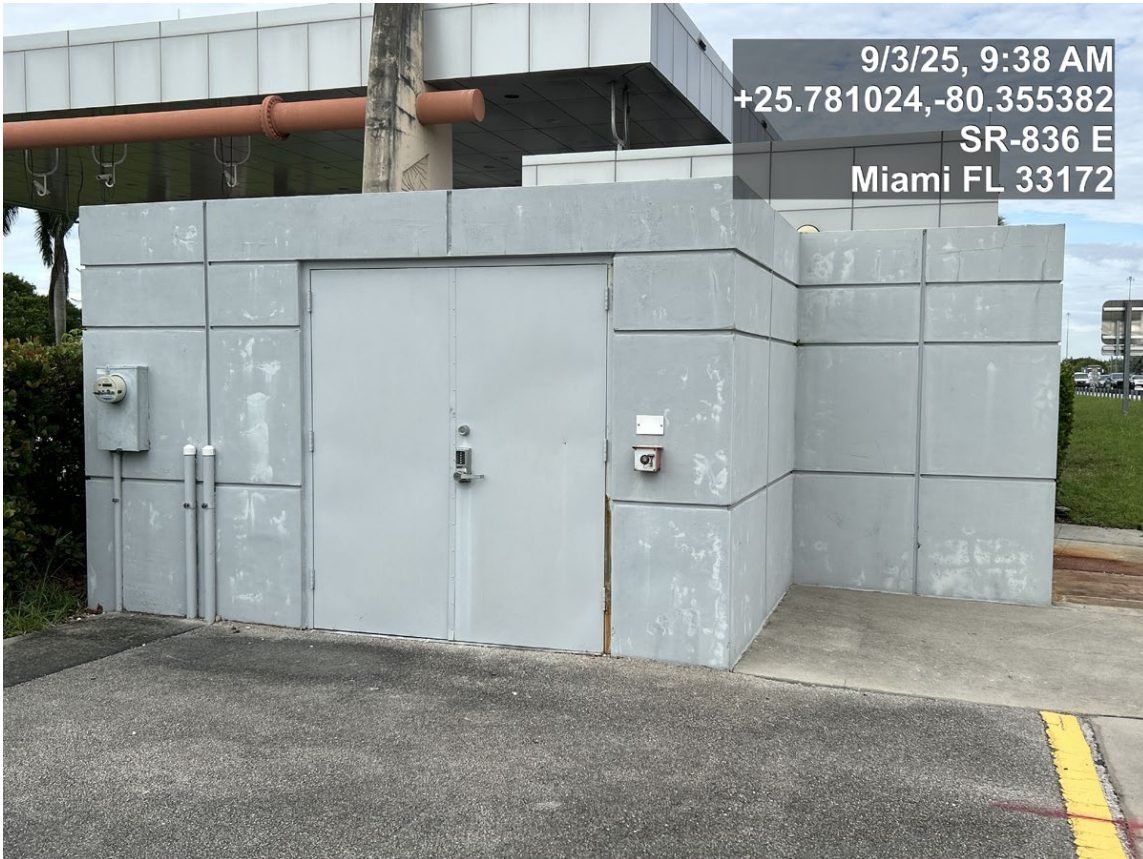
**ARCHITECTURAL INSPECTION  
LOCATION: SR-836 / NW 97<sup>th</sup> AVENUE EASTBOUND**

**DETERIORATED PAINT AT GENERATOR ENCLOSURE WALLS AND DOORS**
