# Annual Inspection Report **2025**

# ANNUAL INSPECTION REPORT 2025

## ANNUAL INSPECTION REPORT

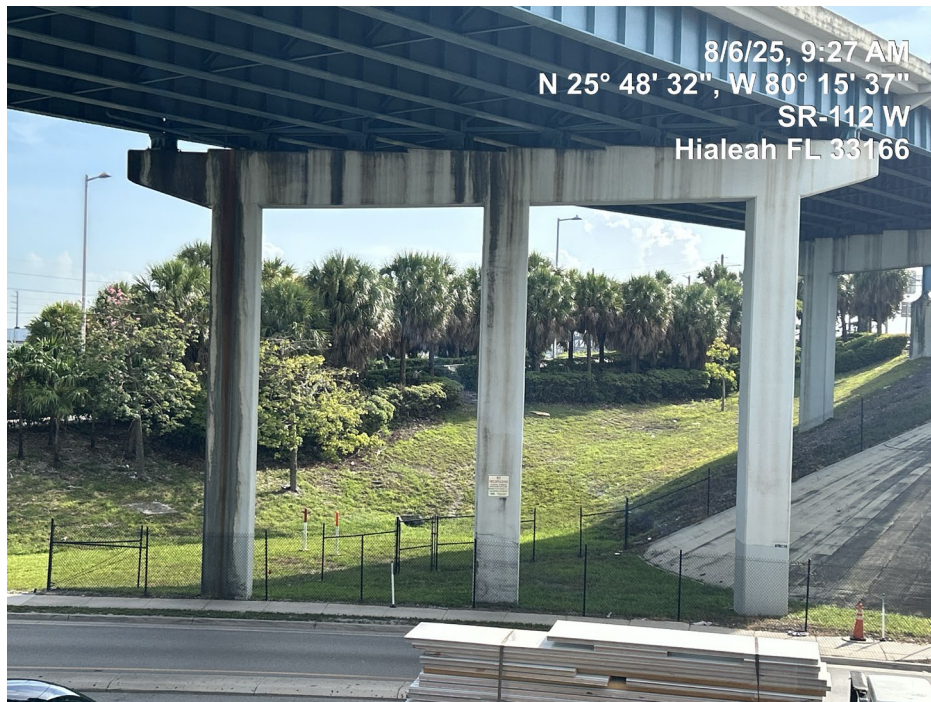
**PHOTO NO.: EB-002  
DATE: 8-6-2025**

**DETERIORATED PAINT ON STEEL BRIDGE/ CLASS V COATING ON CONCRETE  
SURFACES  
(BRIDGE 870238)**

**ITEMS NOTED TO BE ADDRESSED BY GMX WORK PROGRAM TBD**

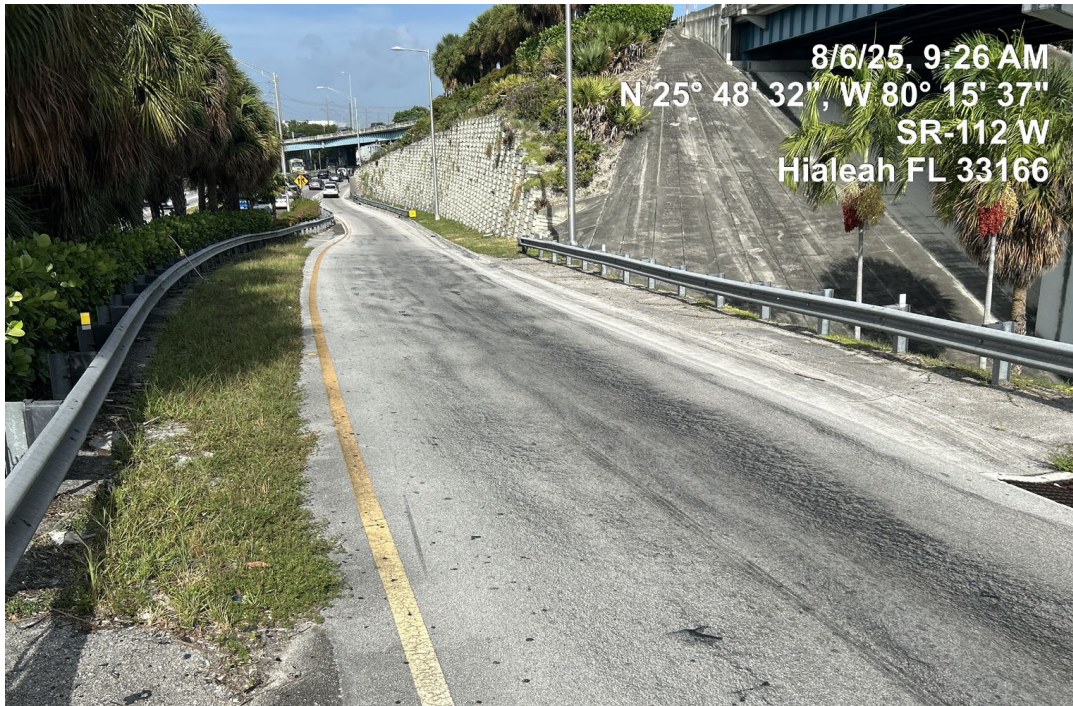
**PHOTO NO.: WB-002  
DATE: 8-6-2025**

**DETERIORATED ASPHALT PAVEMENT**

**ITEM NOTED TO BE ADDRESSED BY GMX WORK PROGRAM 30044**

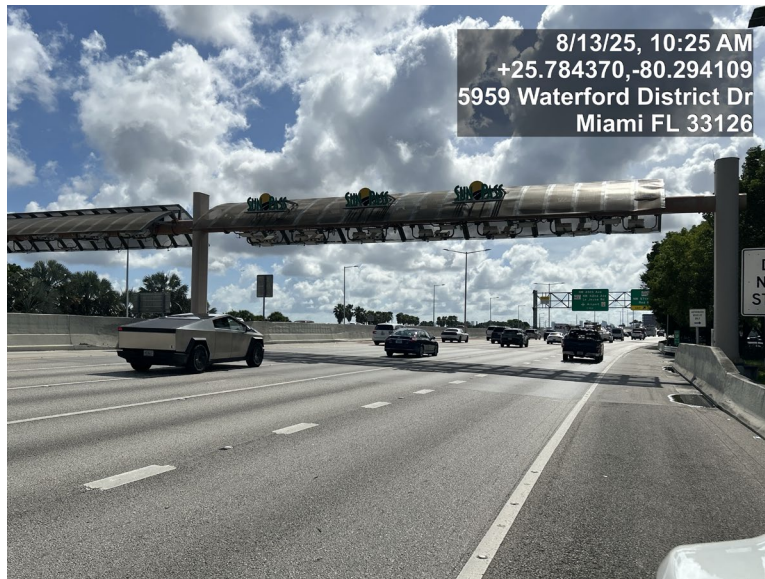
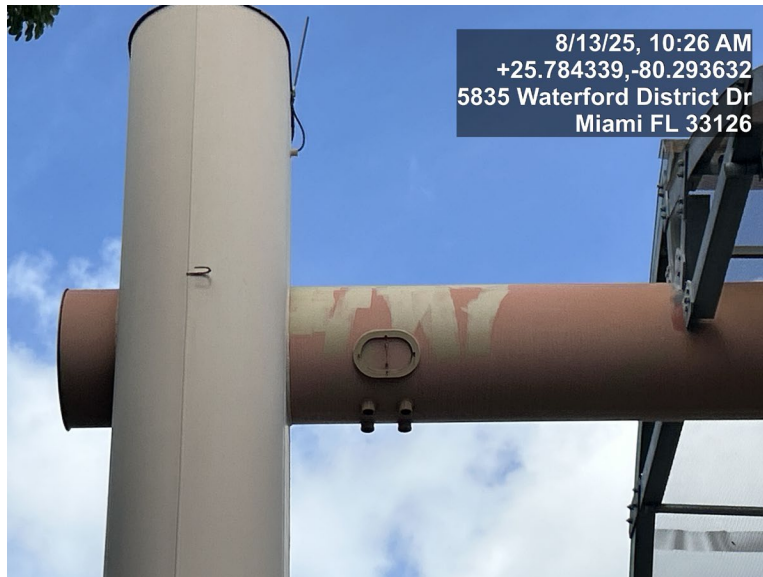
**PHOTO NO.: EB-007  
DATE: 8-13-2025**

**DETERIORATED PAINT ON MONOTUB AND STRUCTURE UPRIGHT  
(STRUCTURE #87A258)**

**ITEM NOTED TO BE ADDRESSED BY GMX WORK PROGRAM 30043**

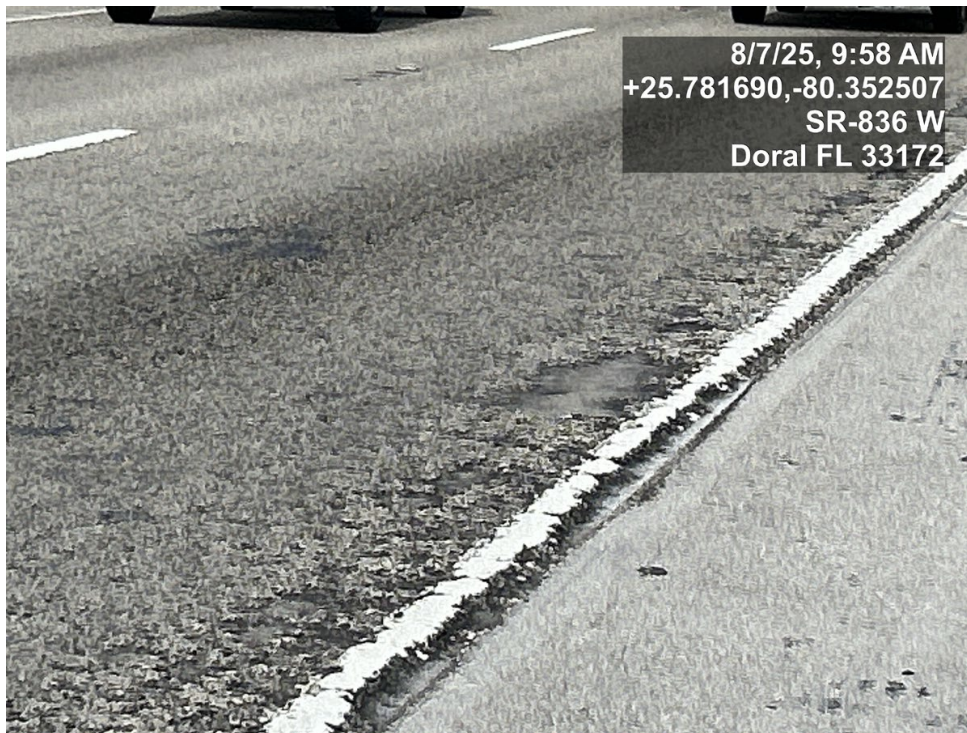
**PHOTO NO.: WB-005  
DATE: 8-7-2025**

**DETERIORATED ASPHALT PAVEMENT**

**ITEM NOTED TO BE ADDRESSED BY GMX WORK PROGRAM 30044**

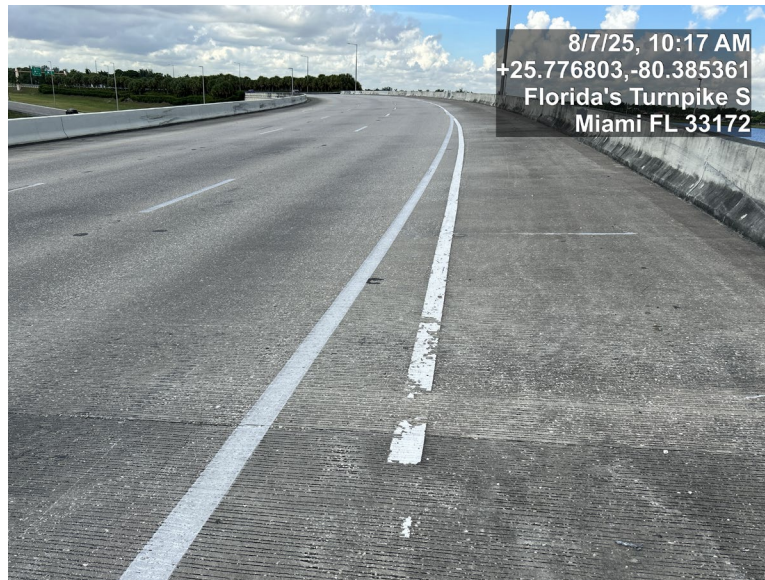
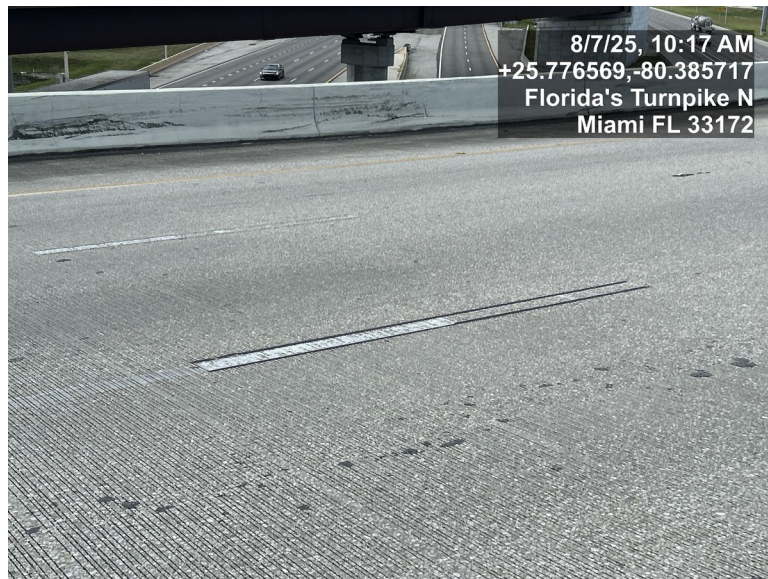
**PHOTO NO.: WB-008  
DATE: 8-7-2025**

**CONFLICTING PAVEMENT MARKINGS/ DETERIORATED SKIP LINES  
(BRIDGE # 870998)**

**ITEM NOTED TO BE ADDRESSED BY GMX WORK PROGRAM 30033**

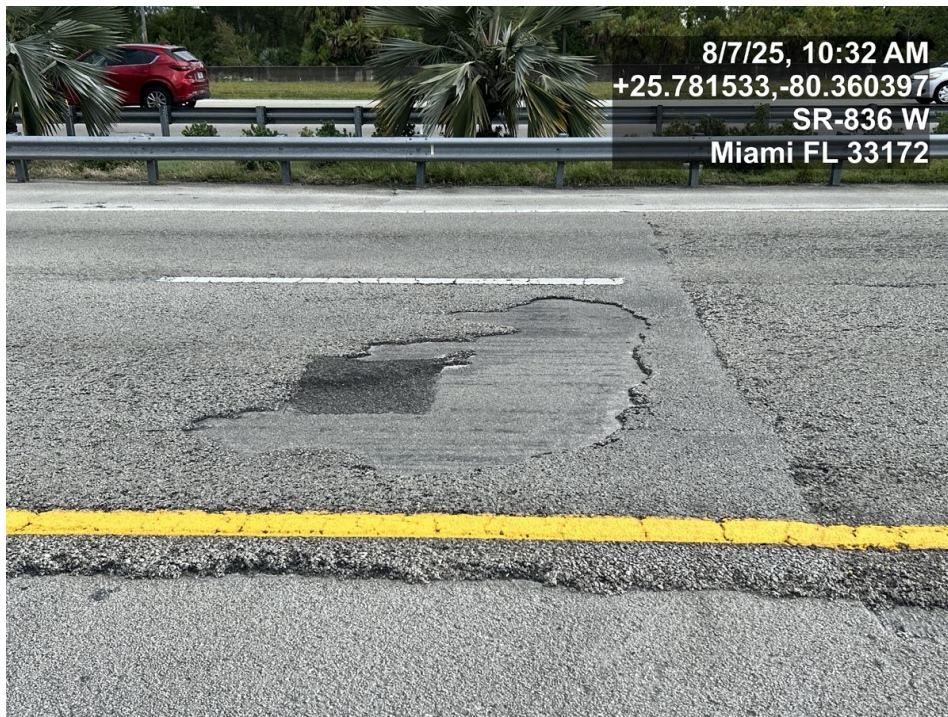
**PHOTO NO.: WB-010  
DATE: 8-7-2025**

**DETERIORATED PAVEMENT**

**ITEM NOTED TO BE ADDRESSED BY GMX WORK PROGRAM 30044**

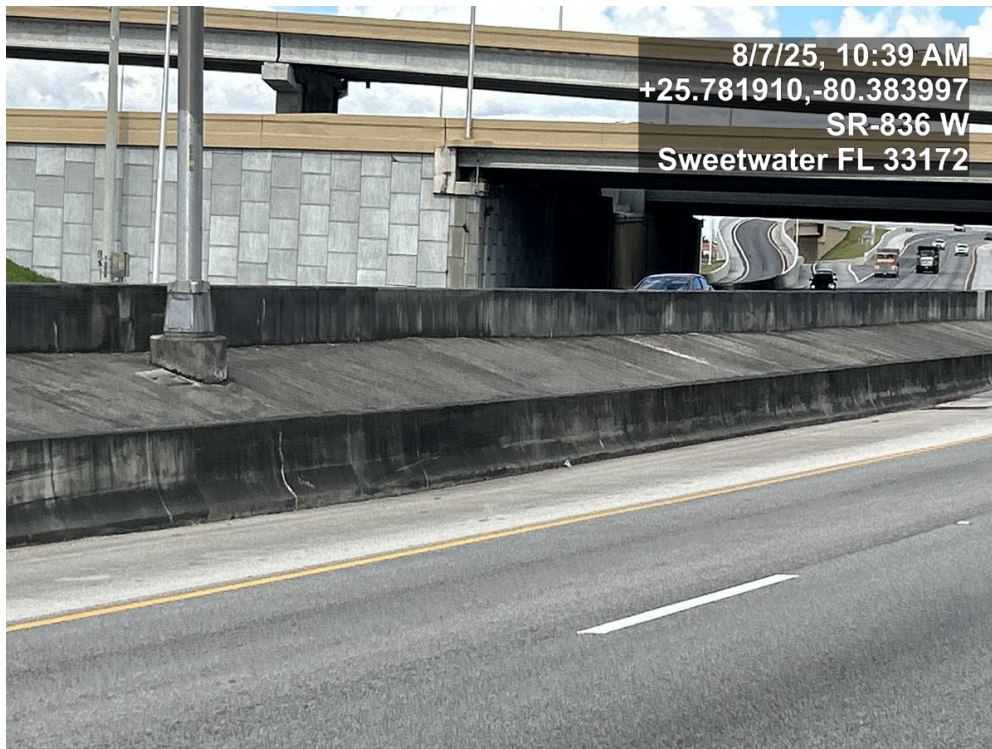
**PHOTO NO.: WB-011  
DATE: 8-7-2025**

**DETERIORATED CLASS V COATING ON BARRIER WALL AND TRAFFIC  
SEPARATOR**

**ITEM NOTED TO BE ADDRESSED BY GMX WORK PROGRAM TBD**

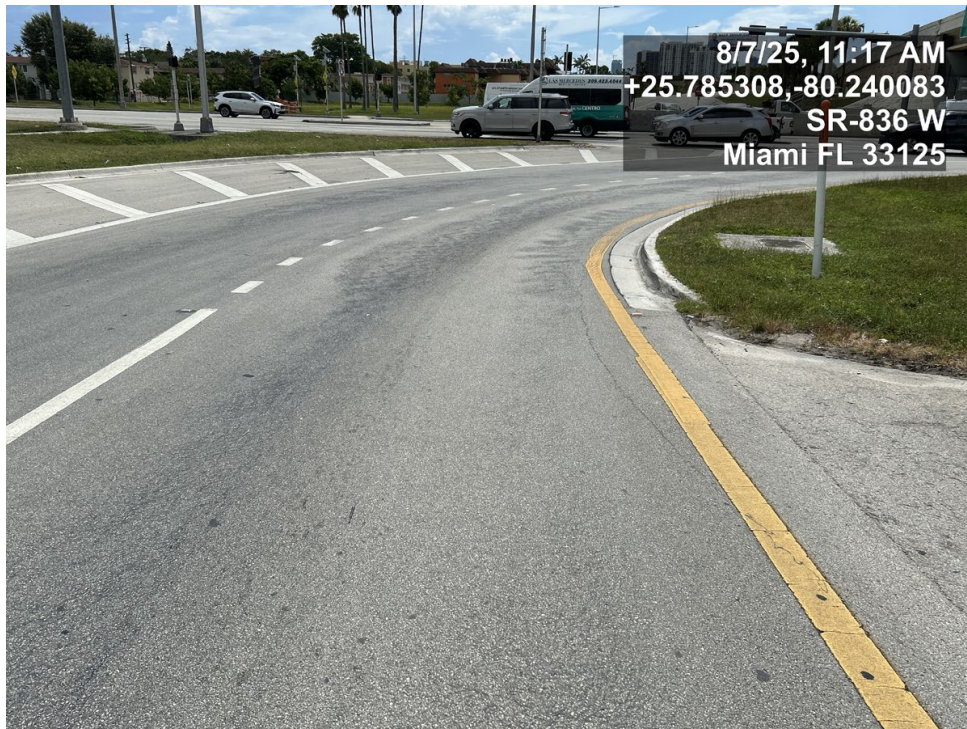
**PHOTO NO.: WB-013  
DATE: 8-7-2025**

**PAVEMENT SETTLEMENT ON CURVE INSIDE LANE**

**ITEM NOTED TO BE ADDRESSED BY GMX WORK PROGRAM 30044**

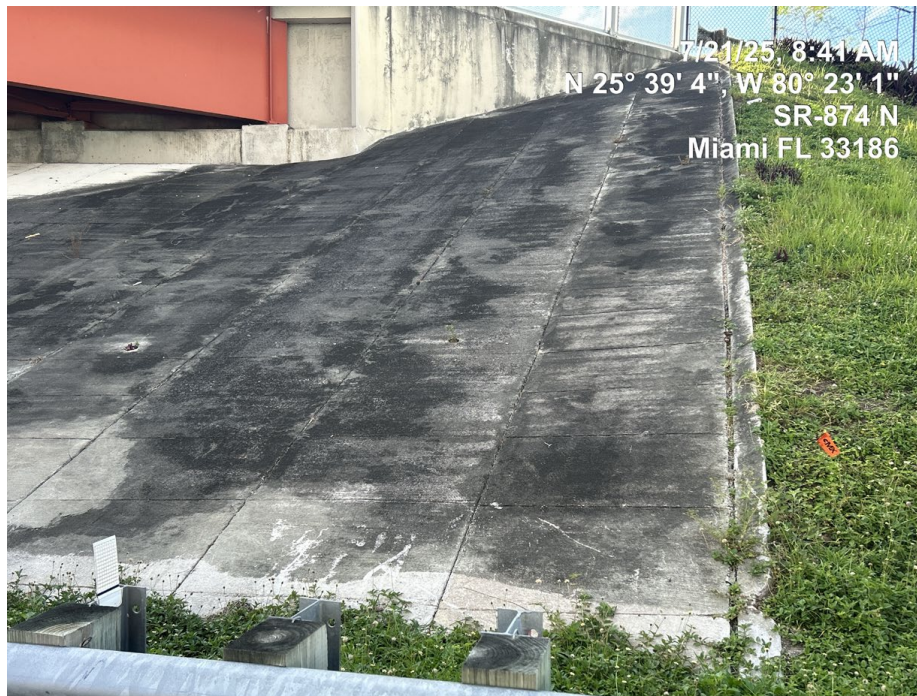
**PHOTO NO.: NB-001  
DATE: 7-21-2025**

**DETERIORATED CLASS V COATING ON SLOPE  
(BRIDGE #870460)**

**ITEM NOTED TO BE ADDRESSED BY GMX WORK PROGRAM TBD**

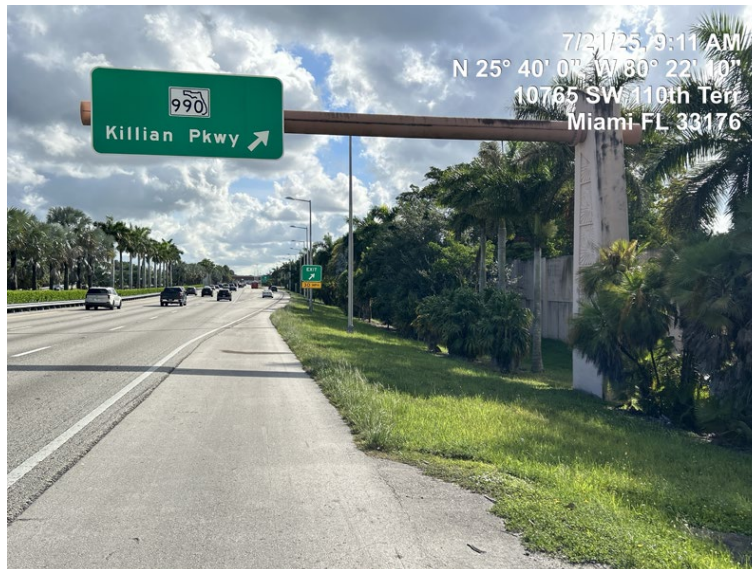
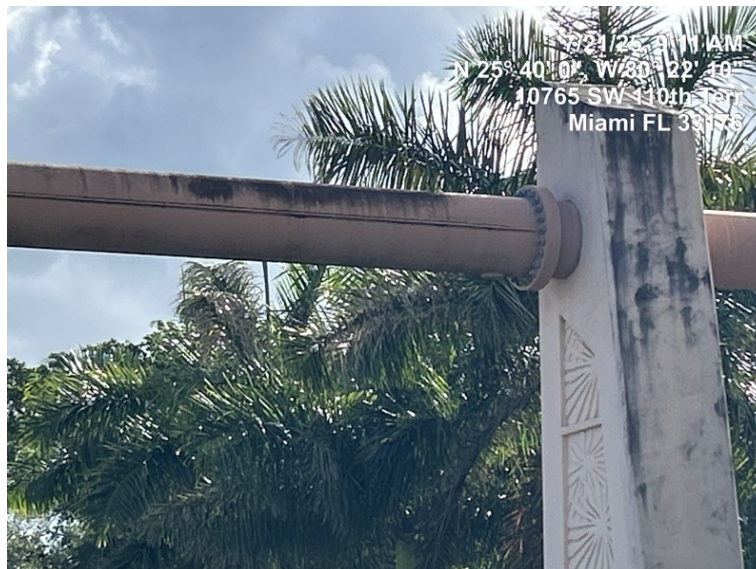
PHOTO NO.: NB-002  
DATE: 7-21-2025

**DETERIORATED PAINT ON MONOTUBE AND CLASS V COATING ON  
STRUCTURE UPRIGHT (STRUCTURE #87A048)**

**ITEM NOTED TO BE ADDRESSED BY GMX WORK PROGRAM 30047**

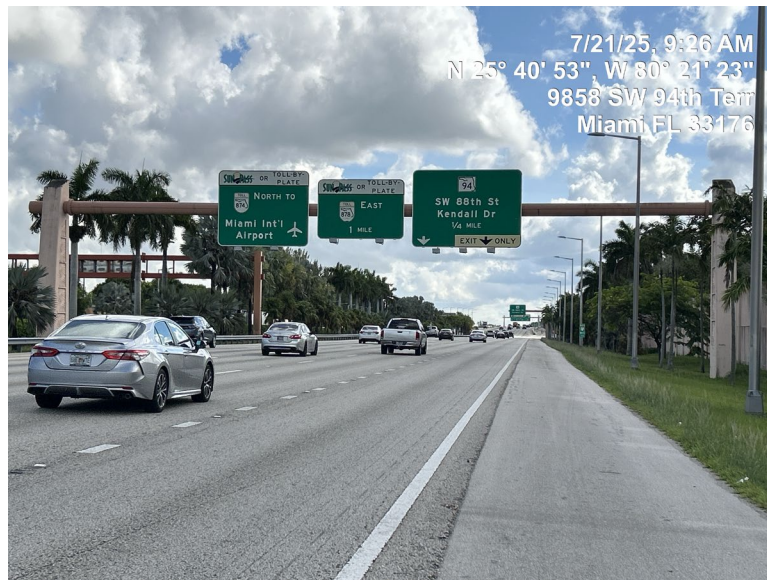
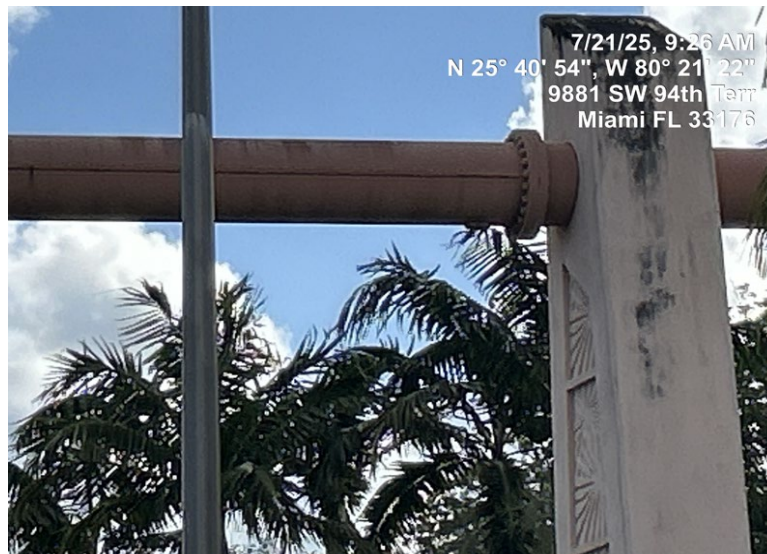
PHOTO NO.: NB-003  
DATE: 7-21-2025

**DETERIORATED PAINT ON MONOTUBE AND CLASS V COATING ON  
STRUCTURE UPRIGHT (STRUCTURE #87A052)**

**ITEM NOTED TO BE ADDRESSED BY GMX WORK PROGRAM 30047**

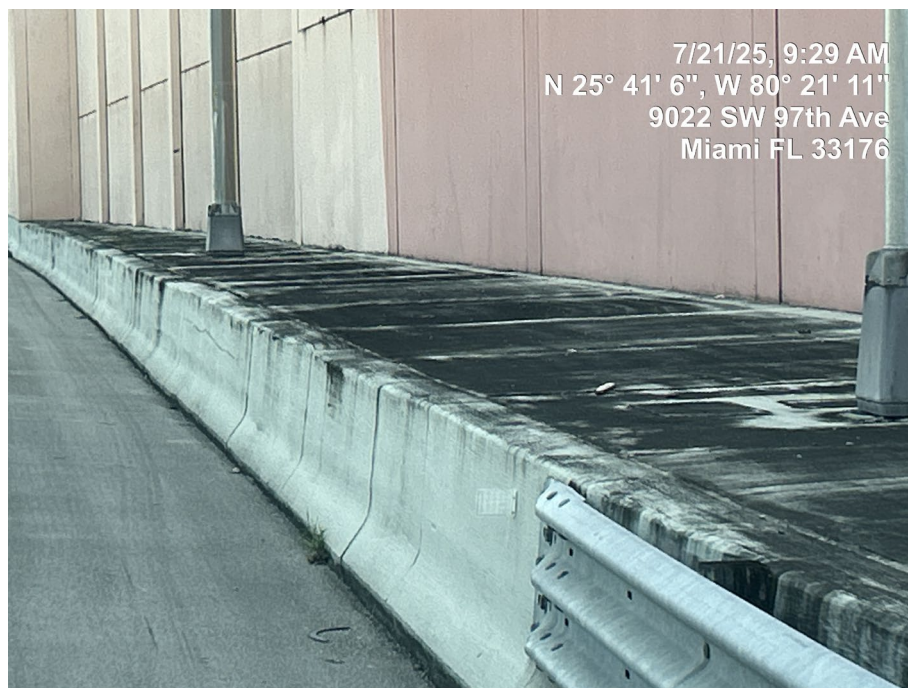
**PHOTO NO.: NB-004  
DATE: 7-21-2025**

**DETERIORATED CLASS V COATING ON BARRIER WALL TOP SLAB**

**ITEM NOTED TO BE ADDRESSED BY GMX WORK PROGRAM TBD**

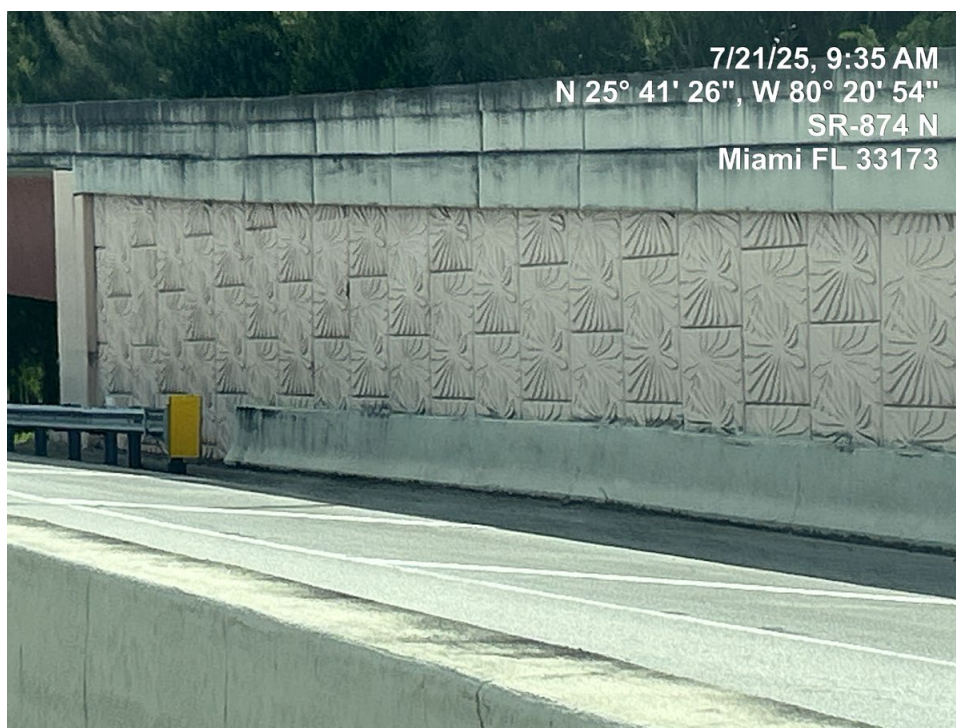
**PHOTO NO.: NB-005  
DATE: 7-21-2025**

**DETERIORATED CLASS V COATING ON MSE WALL**

**ITEM NOTED TO BE ADDRESSED BY GMX WORK PROGRAM TBD**

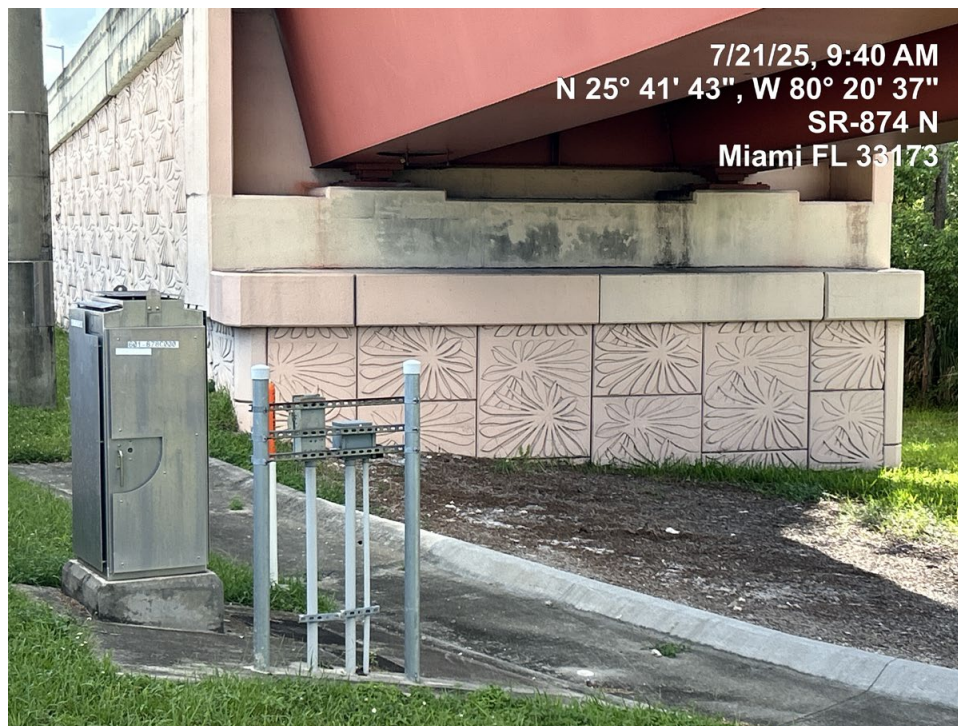
**PHOTO NO.: NB-006  
DATE: 7-21-2025**

**DETERIORATED CLASS V COATING ON END BENT AND MSE WALL**

**ITEM NOTED TO BE ADDRESSED BY GMX WORK PROGRAM TBD**

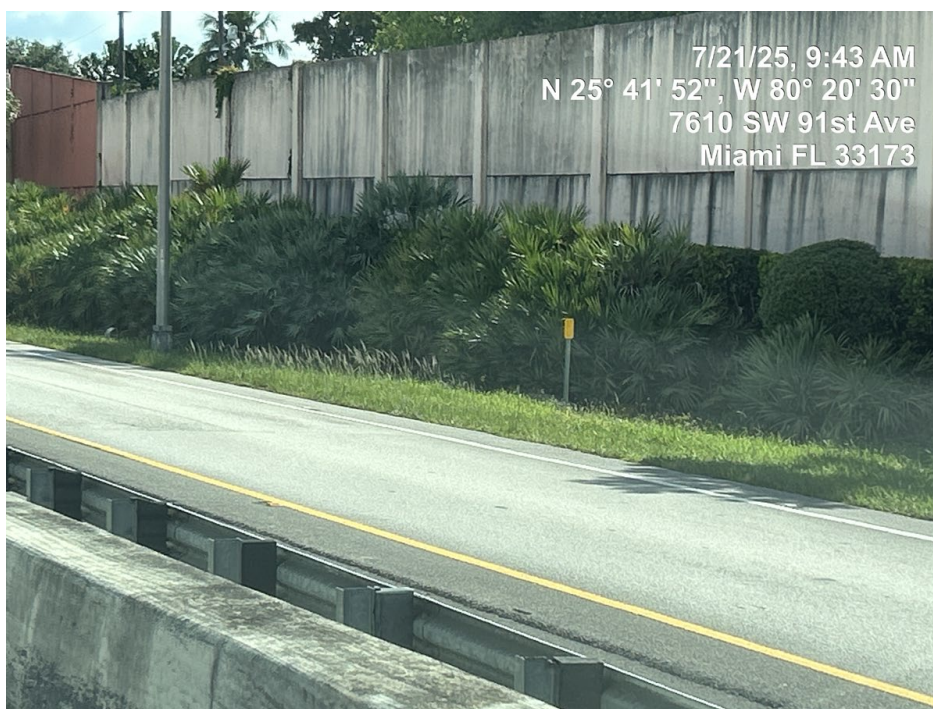
**PHOTO NO.: NB-007  
DATE: 7-21-2025**

**DETERIORATED CLASS V COATING ON SOUND WALL**

**ITEM NOTED TO BE ADDRESSED BY GMX WORK PROGRAM TBD**

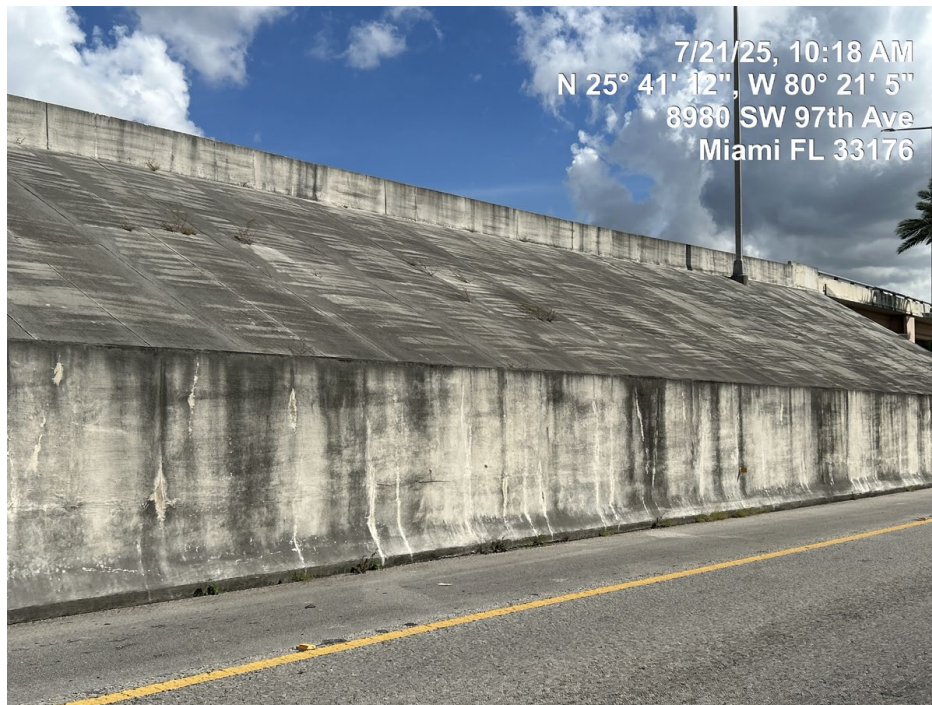
**PHOTO NO.: NB-008  
DATE: 7-21-2025**

**DETERIORATED CLASS V COATING ON RETAINING WALL**

**ITEM NOTED TO BE ADDRESSED BY GMX WORK PROGRAM TBD**

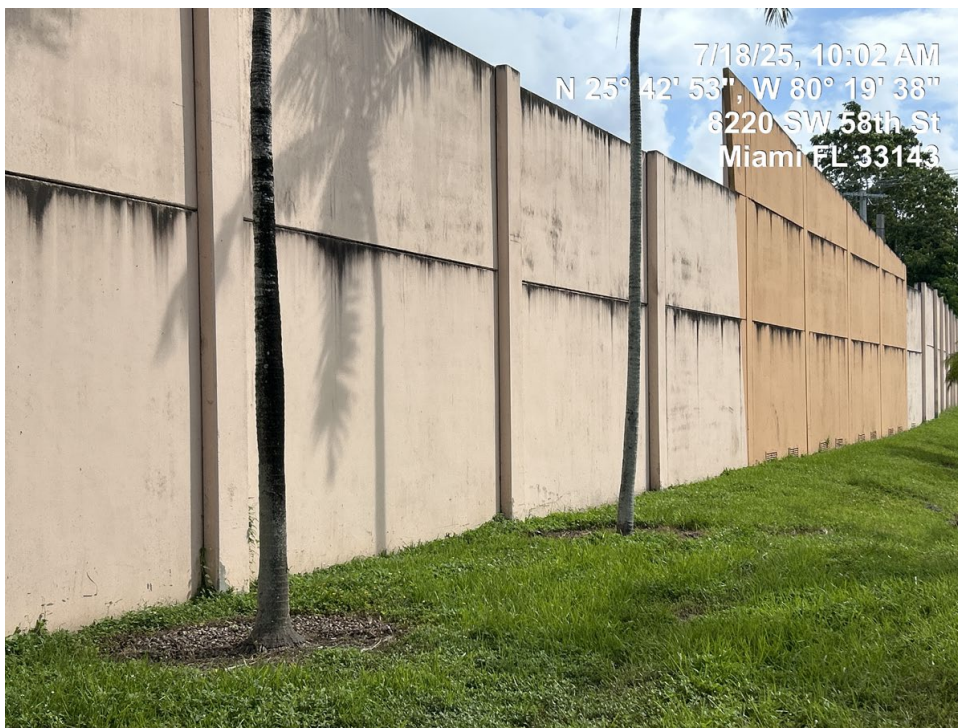
**PHOTO NO.: SB-002  
DATE: 7-18-2025**

**DETERIORATED CLASS V COATING ON SOUND WALL**

**ITEM NOTED TO BE ADDRESSED BY GMX WORK PROGRAM TBD**

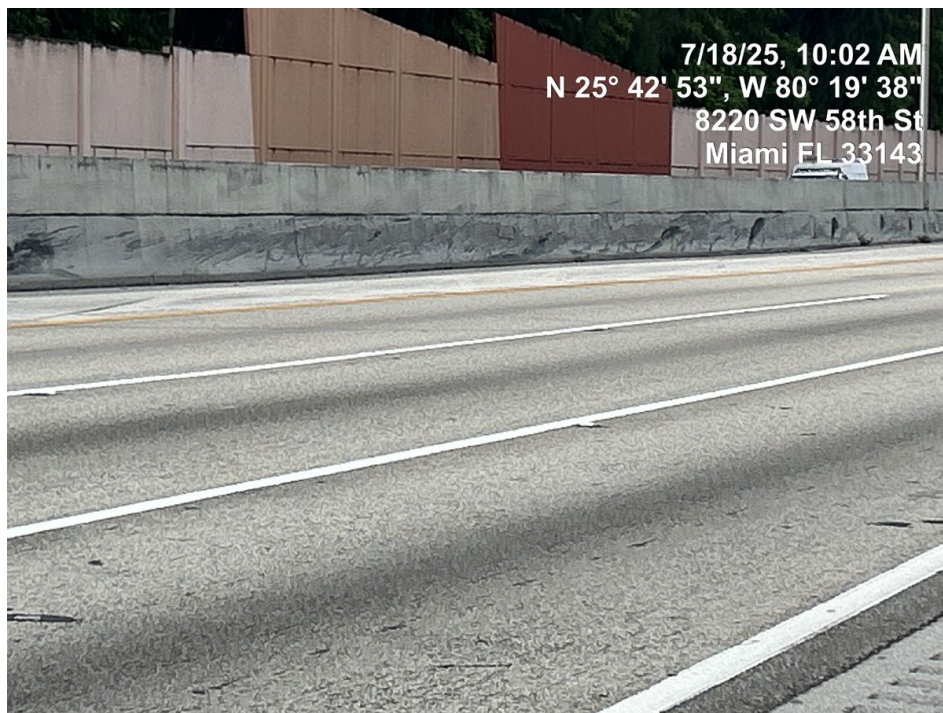
**PHOTO NO.: SB-003  
DATE: 7-18-2025**

**SKUFF MARKS ON BARRIER WALL AND DETERIORATED CLASS V COATING ON  
ITEM NOTED TO BE ADDRESSED BY GMX WORK PROGRAM TBD**

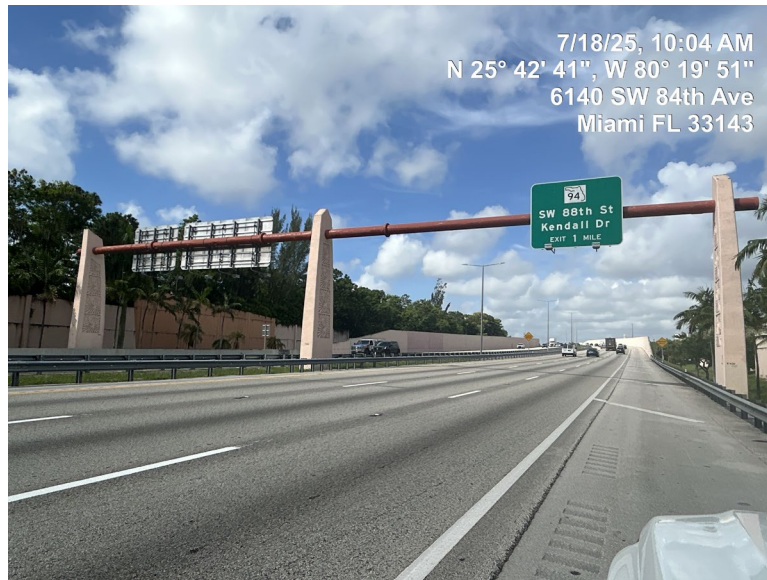
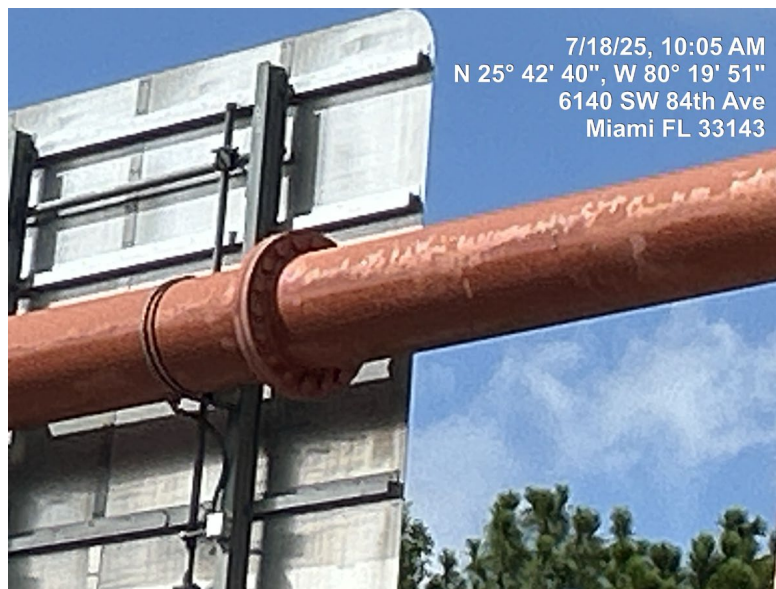
**PHOTO NO.: SB-004  
DATE: 7-18-2025**

**DETERIORATED PAINT ON MONOTUBE AND CLASS V COATING ON  
STRUCTURE UPRIGHT (STRUCTURE # 87A134)**

**ITEM NOTED TO BE ADDRESSED BY GMX WORK PROGRAM 30047**

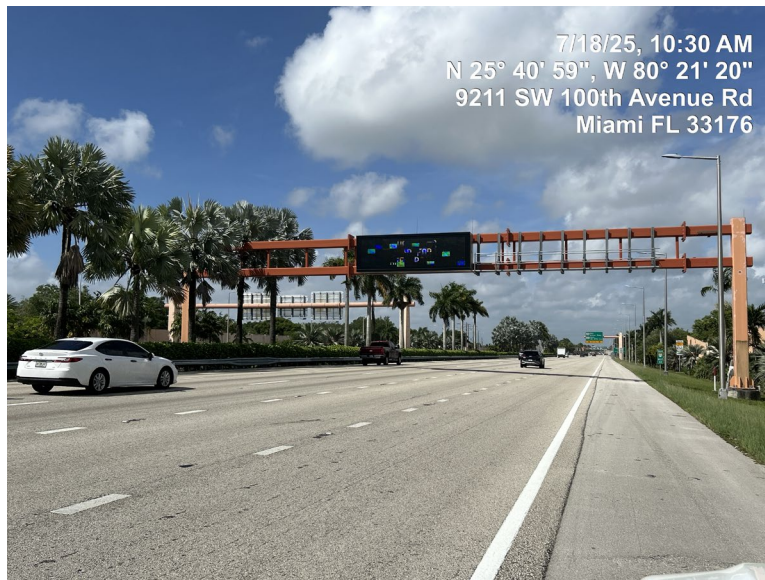
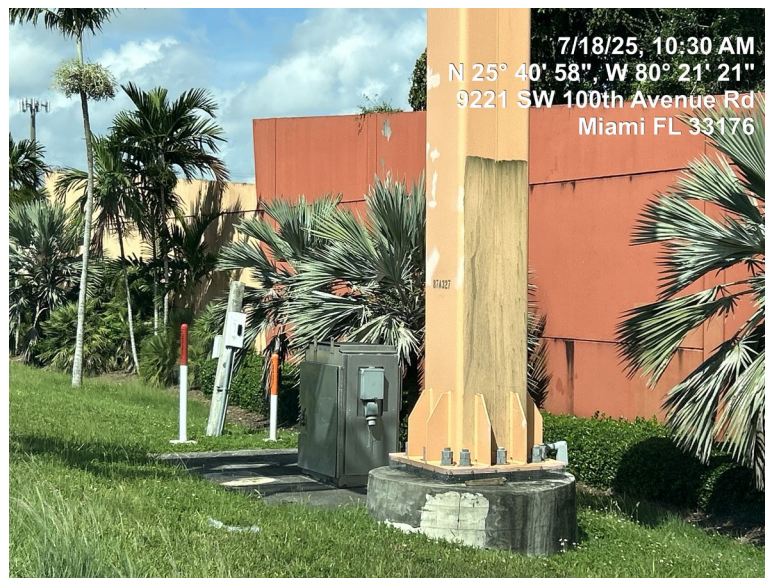
PHOTO NO.: SB-005  
DATE: 7-18-2025

**DETERIORATED PAINT ON UPRIGHT**

**ITEM NOTED TO BE ADDRESSED BY GMX WORK PROGRAM 30043**

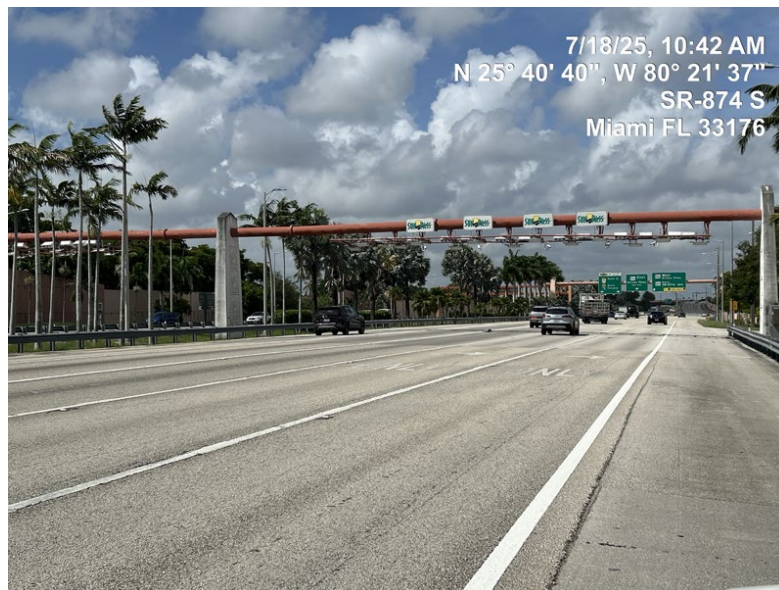
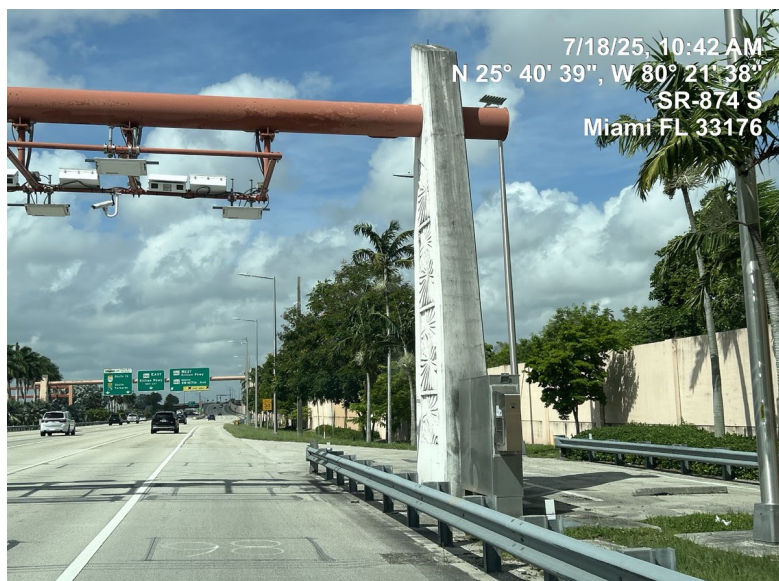
PHOTO NO.: SB-006  
DATE: 7-18-2025

**DETERIORATED PAINT ON SIGN STRUCTURE MONOTUBE AND CLASS V ON  
STRUCTURE UPRIGHT (STRUCTURE #87S938)**

**ITEM NOTED TO BE ADDRESSED BY GMX WORK PROGRAM NO 30043**

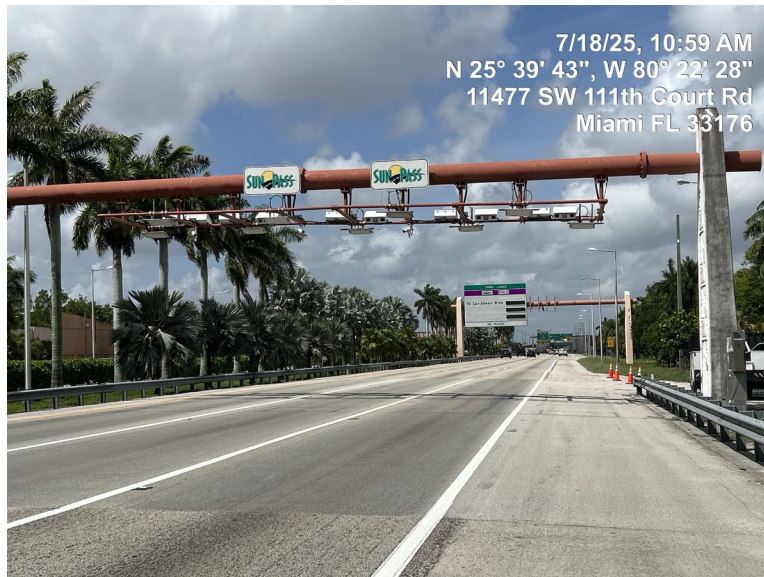
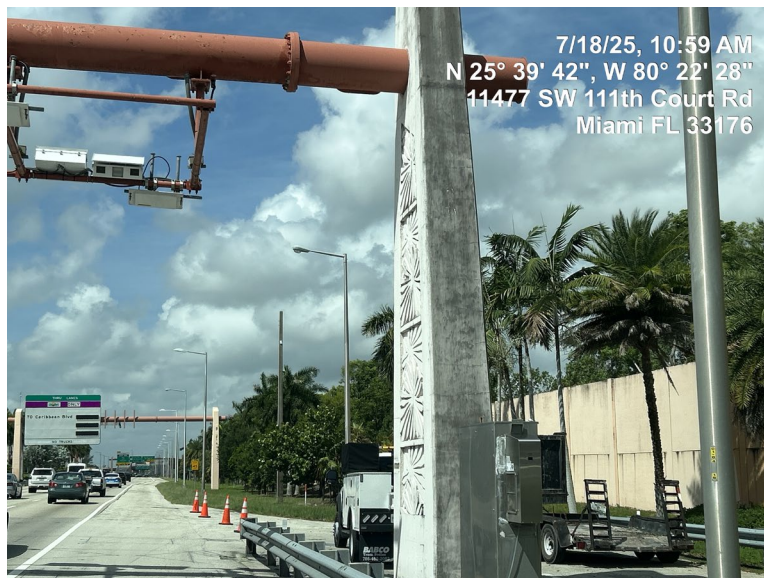
PHOTO NO.: SB-008  
DATE: 7-18-2025

**DETERIORATED PAINT ON MONOTUBE AND CLASS V COATING ON UPRIGHT  
(STRUCTURE #87S937)**

**ITEM NOTED TO BE ADDRESSED BY GMX WORK PROGRAM 30043**

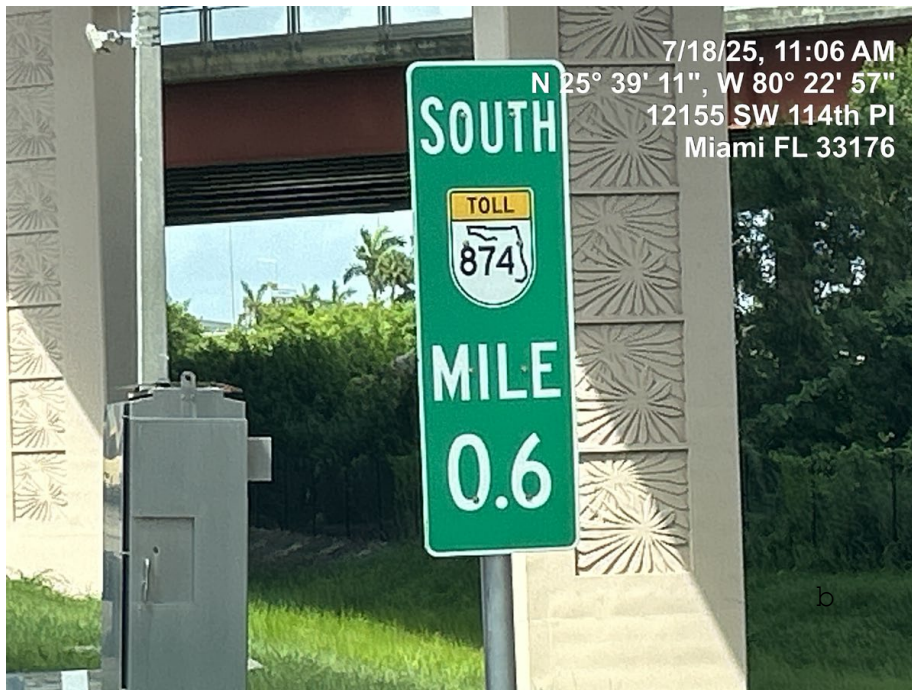
**PHOTO NO.: SB-009  
DATE: 7-18-2025**

**IMPROPER MILE MARKER NUMBERING/LOCATION**

**ITEM NOTED TO BE ADDRESSED BY GMX MAINTENANCE ITB-23-17**

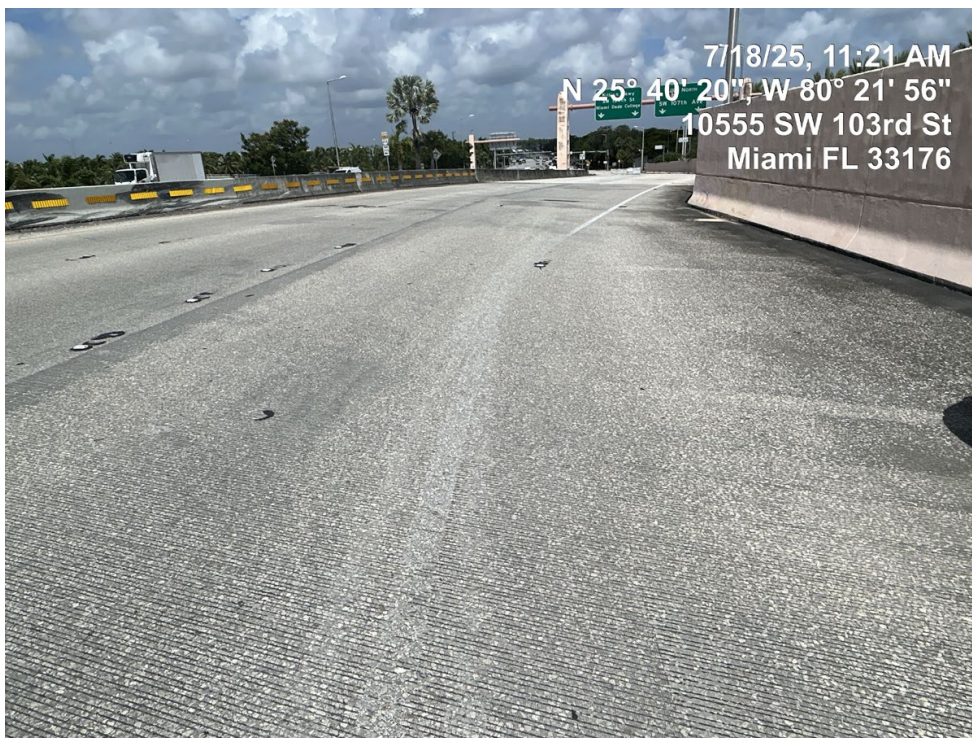
**PHOTO NO.: SB-010  
DATE: 7-18-2025**

**DETERIORATED STRIPPING MISSING RPM's**

**ITEM NOTED TO BE ADDRESSED BY GMX WORK PROGRAM 30033**

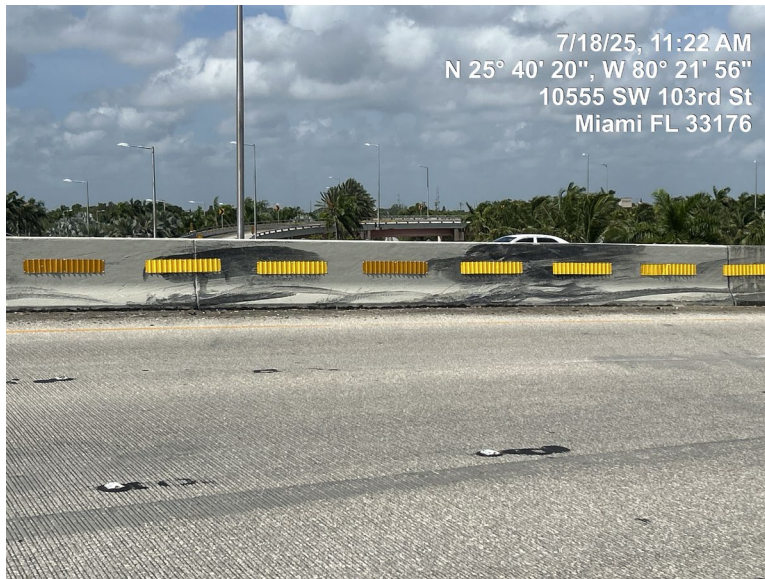
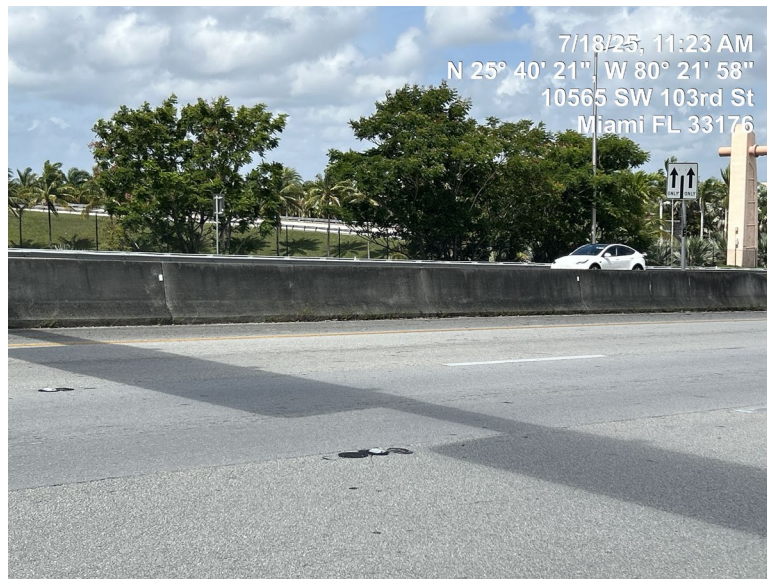
PHOTO NO.: SB-011  
DATE: 7-18-2025

**DETERIORATED CLASS V COATING ON BARRIER WALL**

**ITEM NOTED TO BE ADDRESSED BY GMX WORK PROGRAM TBD**

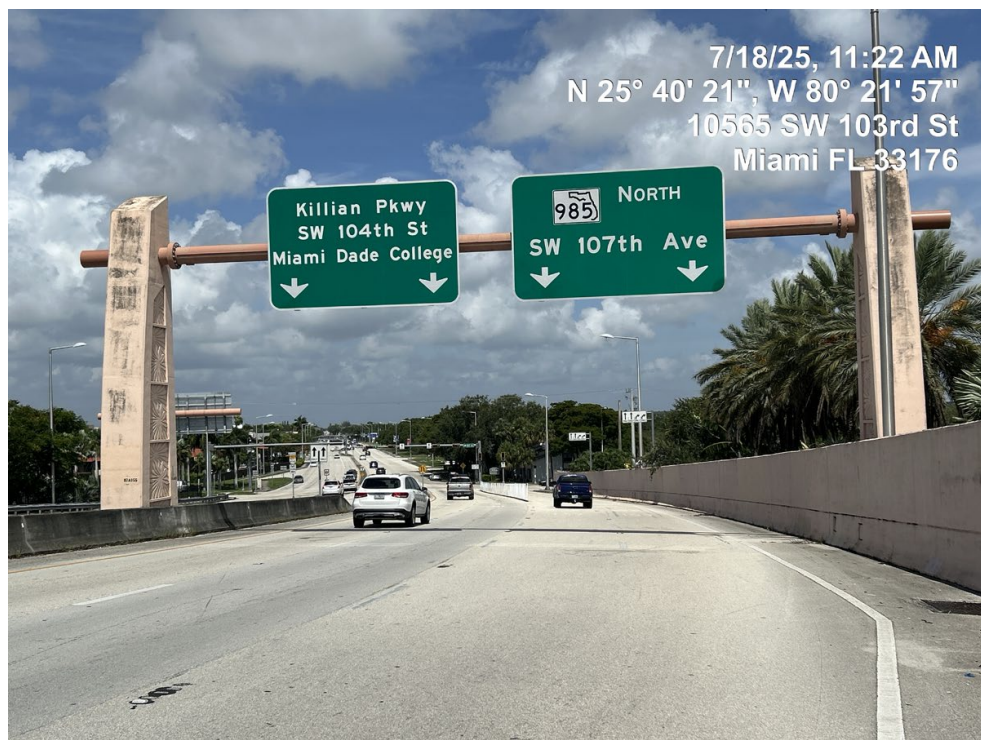
**PHOTO NO.: SB-012  
DATE: 7-18-2025**

**DETERIORATED PAINT ON MONOTUBE AND CLASS V COATING ON UPRIGHT**

**ITEM NOTED TO BE ADDRESSED BY GMX WORK PROGRAM 30047**

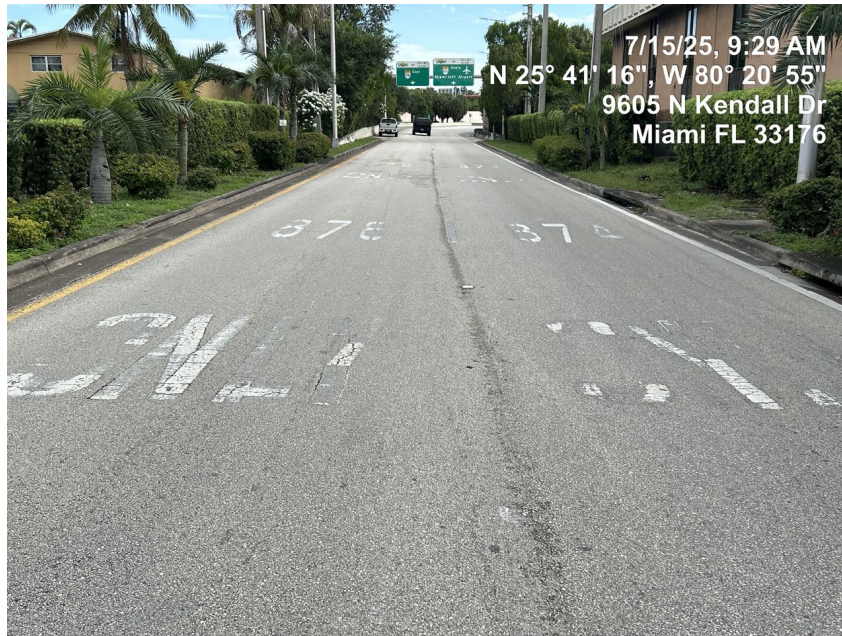
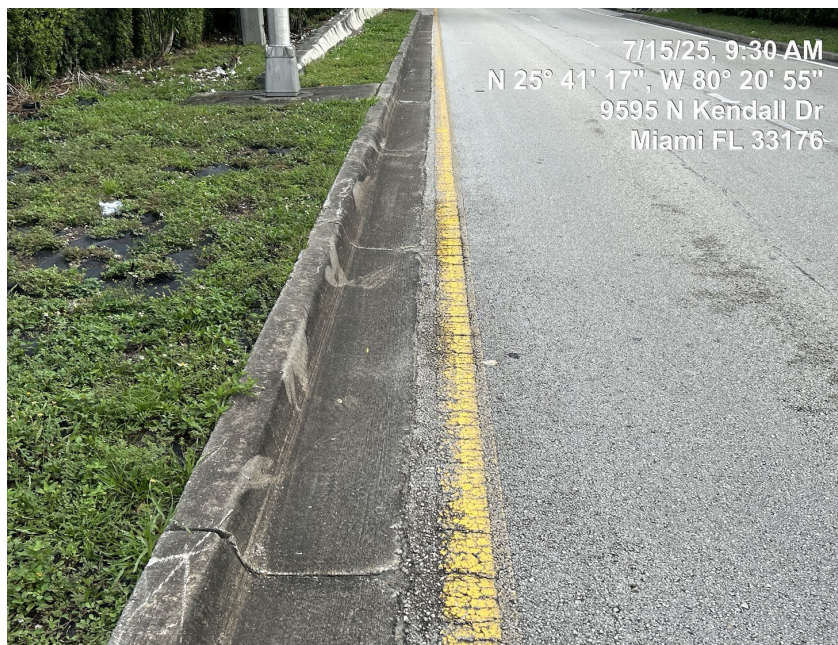
**PHOTO NO.: EB-001**  
**DATE: 7-15-2025**

**DETERIOTATED PAVEMENT MARKINGS AND PAVEMENT MESSAGE**

**ITEM NOTED TO BE ADDRESSED BY GMX WORK PROGRAM 30033**

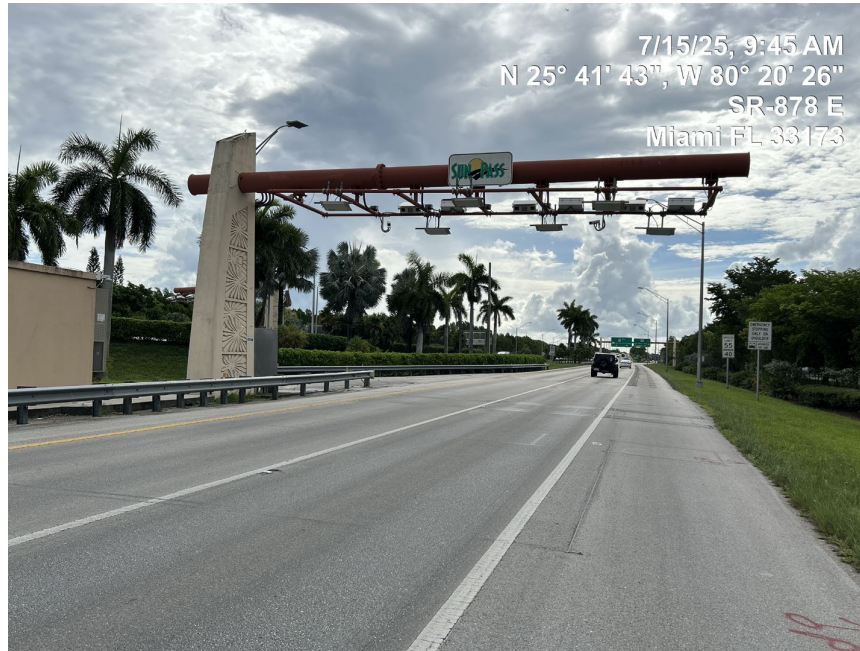
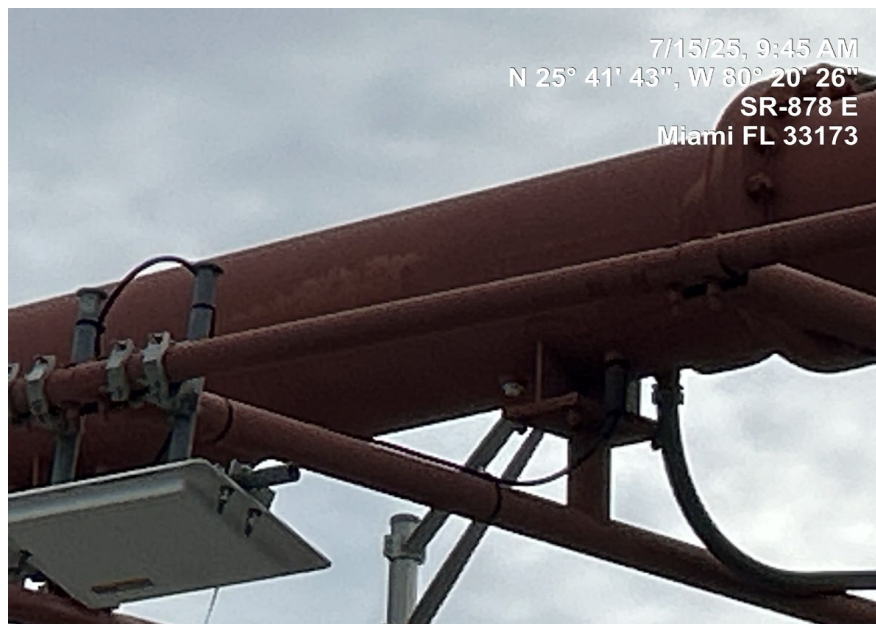
**PHOTO NO.: EB-005**  
**DATE: 7-15-2025**

**DETERIORATED PAINT ON GANTRY MONOTUBE AND CLASS V ON UPRIGHT**

**ITEM NOTED TO BE ADDRESSED BY GMX WORK PROGRAM 30043**
