# Annual Inspection Report **2025**

# ANNUAL INSPECTION REPORT 2025

## ANNUAL INSPECTION REPORT

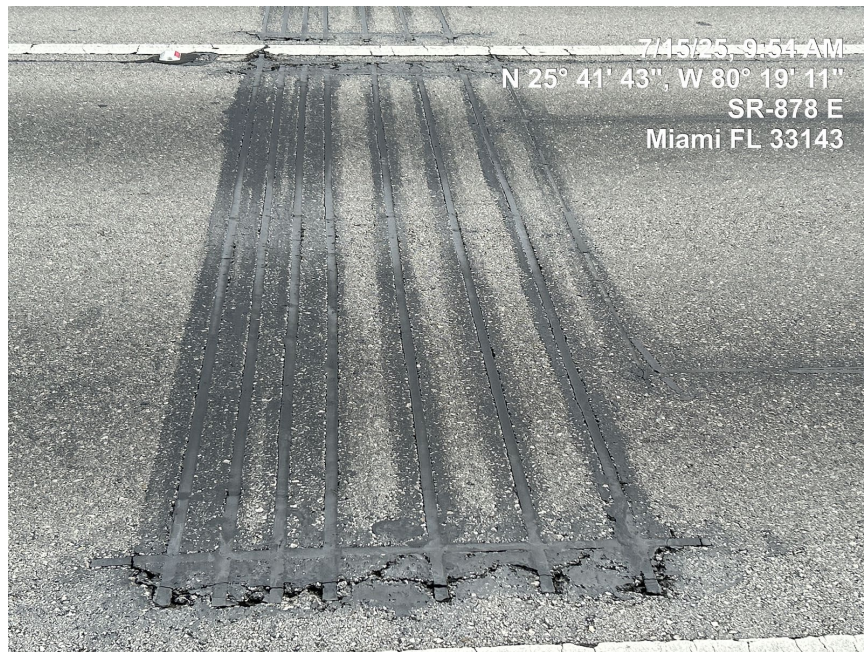
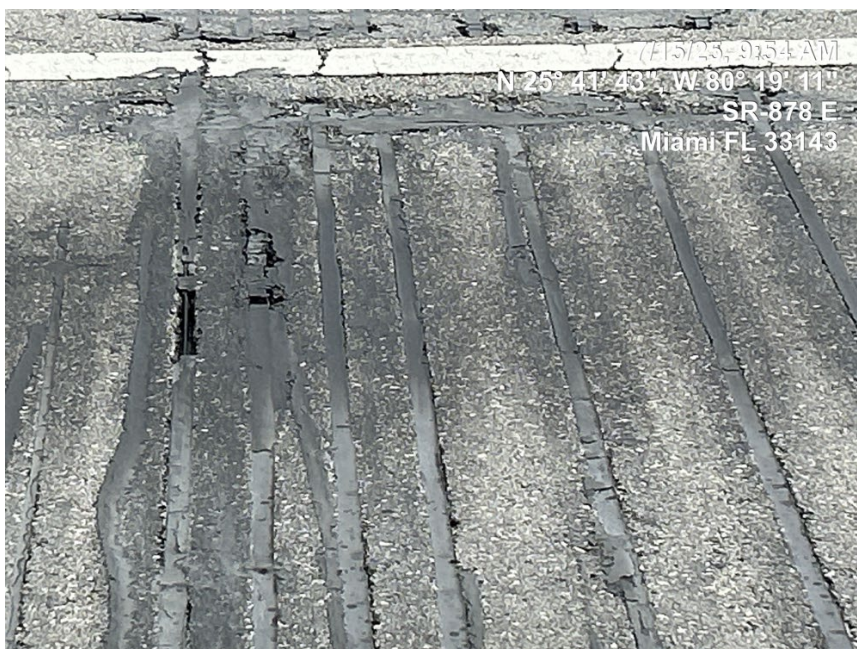
**PHOTO NO.: EB-007  
DATE: 7-15-2025**

**DETERIORATED SEALANT ON GANTRY LOOP DETECTORS**

**ITEM NOTED TO BE ADDRESSED BY GMX ITS**

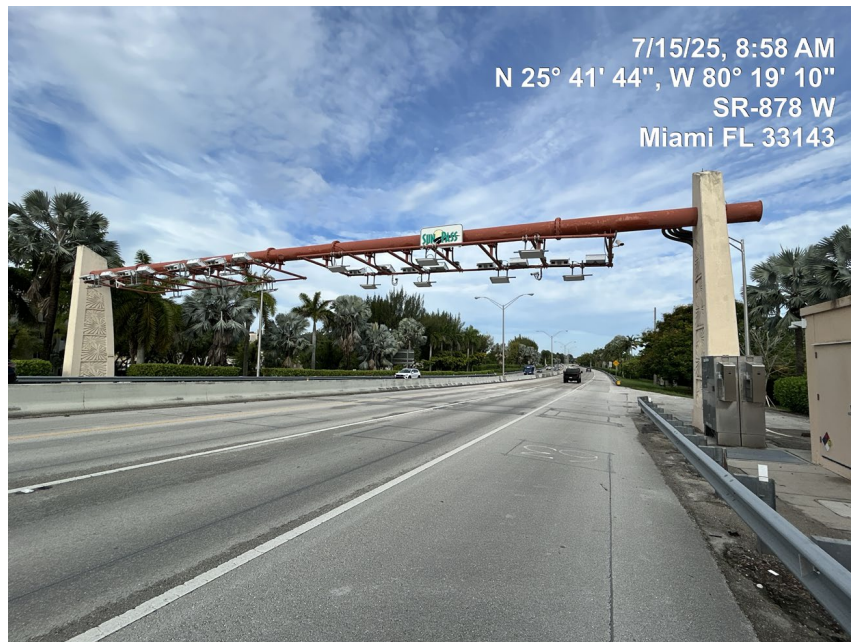
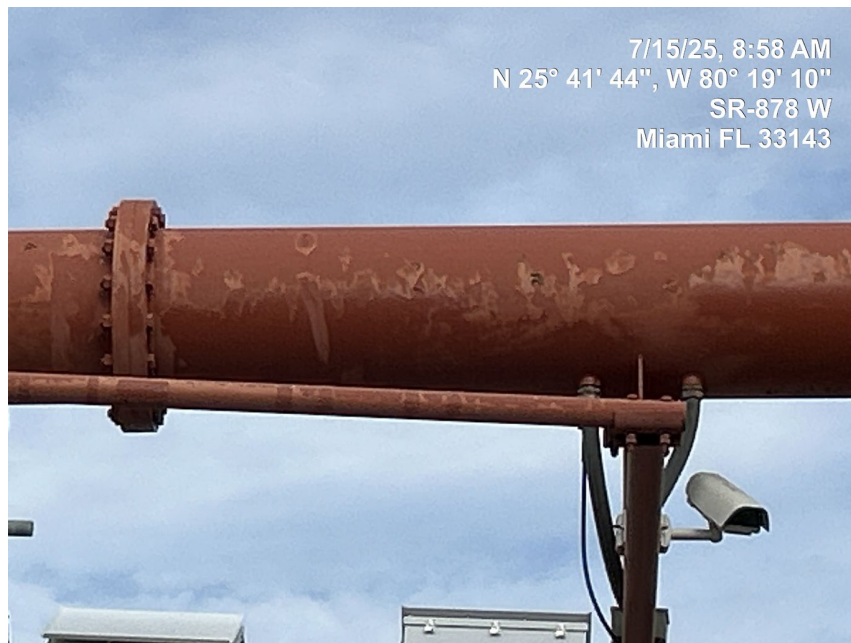
**PHOTO NO.: WB-002  
DATE: 7-15-2025**

**DETERIORATED PAINT ON GANTRY MONOTUBE AND CLASS V ON UPRIGHT**

**ITEM NOTED TO BE ADDRESSED BY GMX WORK PROGRAM 30043**

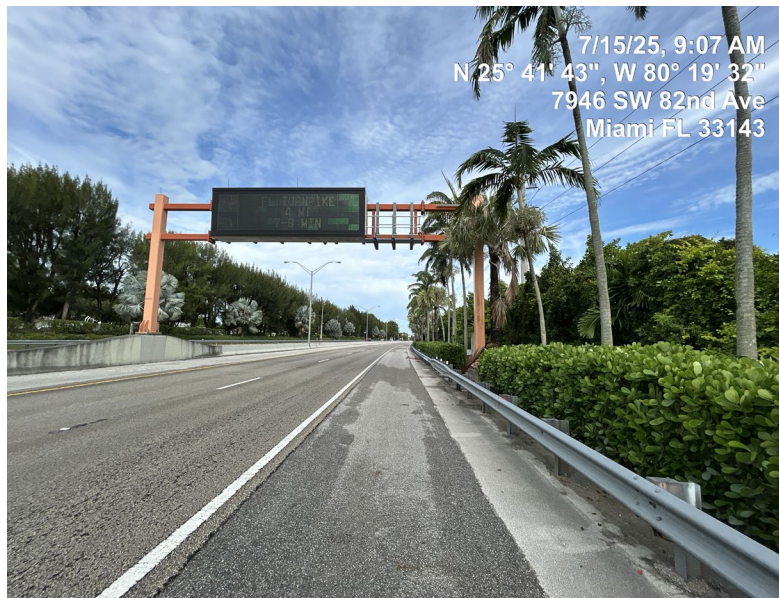
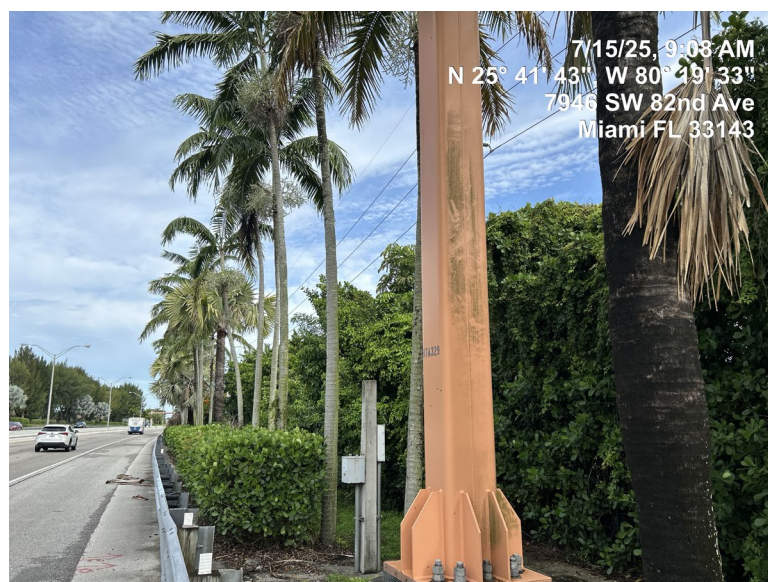
**PHOTO NO.: WB-005  
DATE: 7-15-2025**

**DETERIORATED PAINT ON DMS SIGN STRUCTURE  
(STRUCTURE #87A329)**

**ITEM NOTED TO BE ADDRESSED BY GMX WORK PROGRAM 30043**

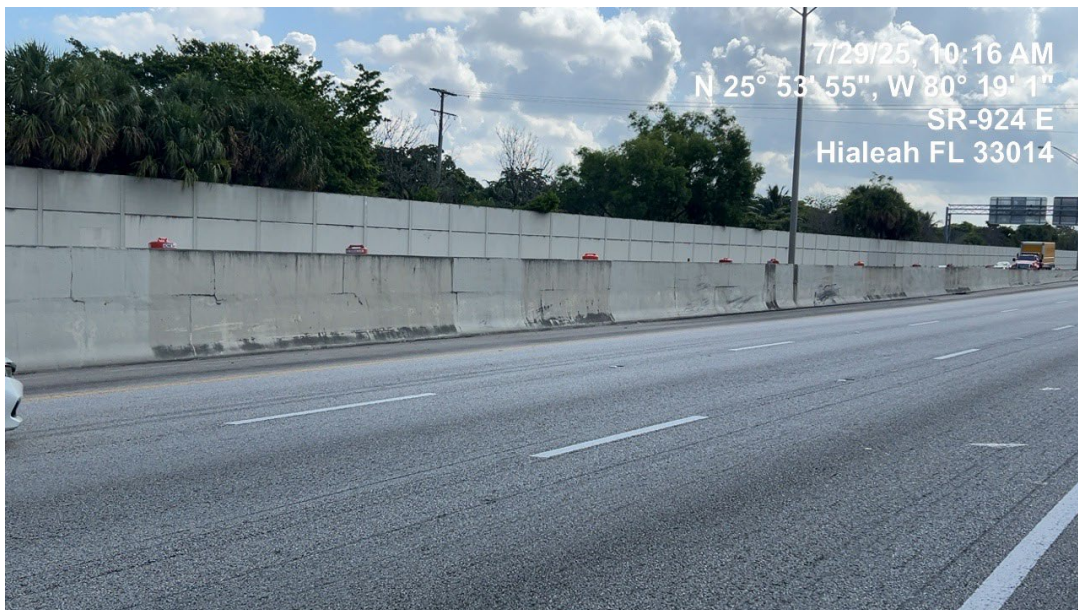
**PHOTO NO.: EB-001  
DATE: 7-29-2025**

**DETERIORATED CLASS V COATING ON MEDIAN BARRIER WALL  
ITEM NOTED TO BE ADDRESSED BY GMX WORK PROGRAM TBD**

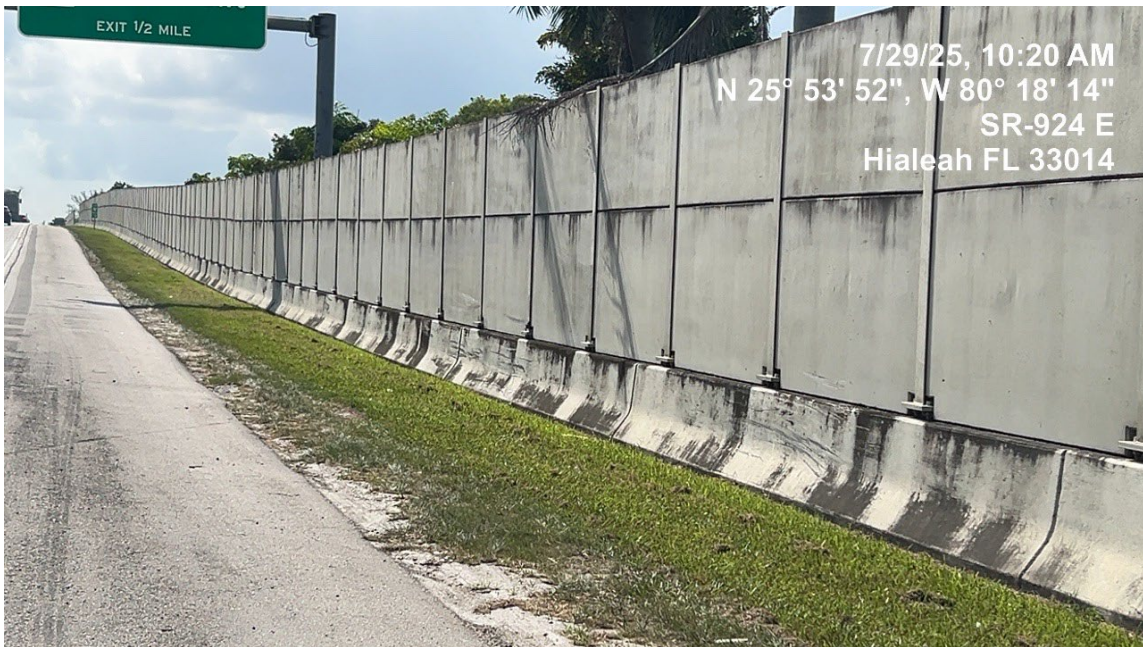
**PHOTO NO.: EB-002  
DATE: 7-29-2025**

**DETERIORATED CLASS V COATING ON BARRIER WALL AND SOUNDWALL**

**ITEM NOTED TO BE ADDRESSED BY GMX WORK PROGRAM TBD**

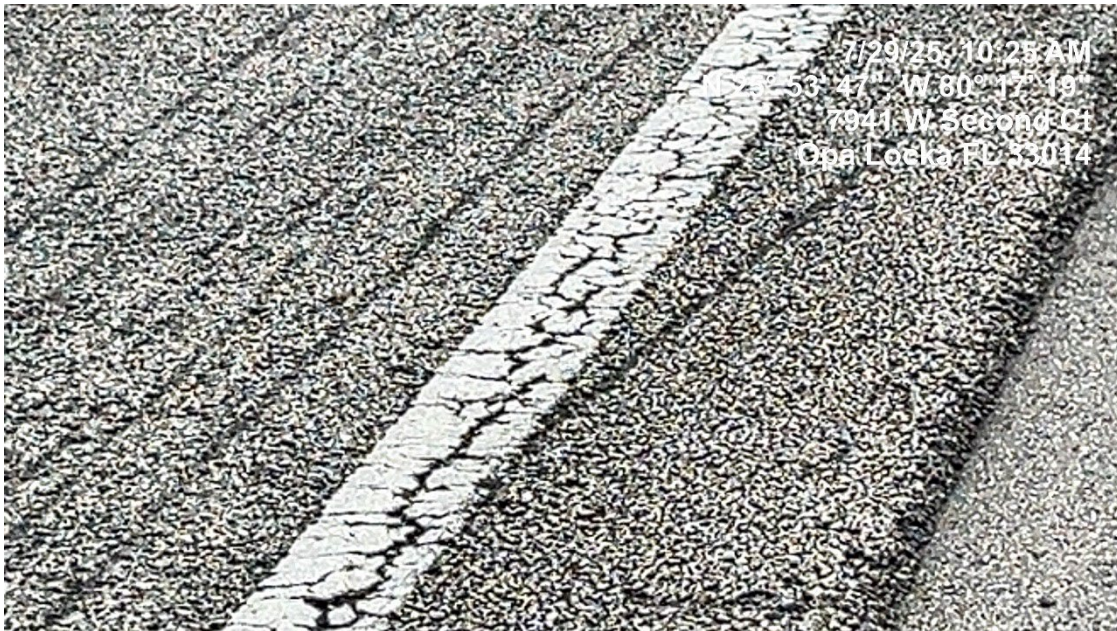
**PHOTO NO.: EB-003  
DATE: 7-29-2025**

**DETERIORATED PAVEMENT MARKINGS**

**ITEM NOTED TO BE ADDRESSED BY GMX WORK PROGRAM 30033**

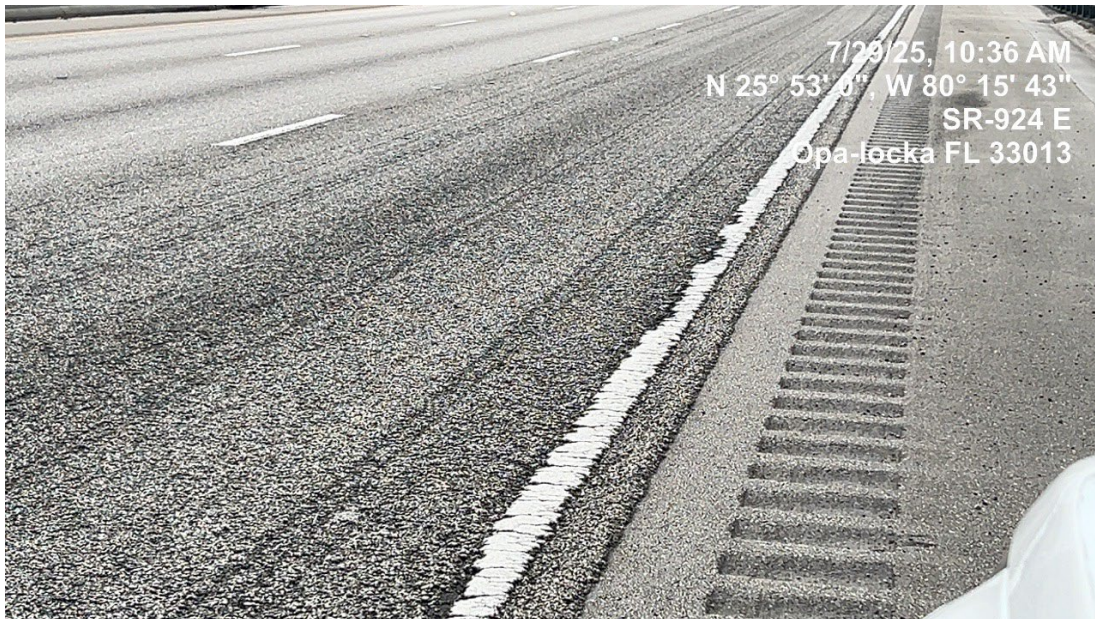
**PHOTO NO.: EB-004  
DATE: 7-29-2025**

**DETERIORATED PAVEMENT MARKINGS**

**ITEM NOTED TO BE ADDRESSED BY GMX WORK PROGRAM 30033**

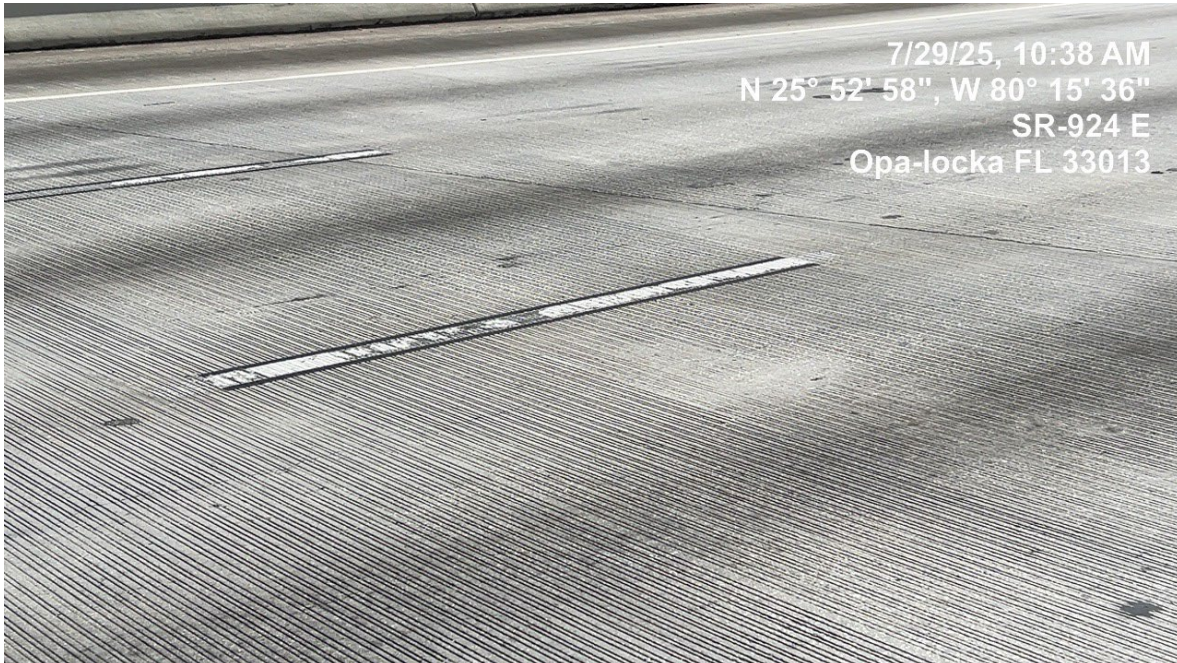
**PHOTO NO.: EB-005  
DATE: 7-29-2025**

**DETERIORATED SKIP LINES (BRIDGE #870740)**

**ITEM NOTED TO BE ADDRESSED BY GMX WORK PROGRAM 30033**

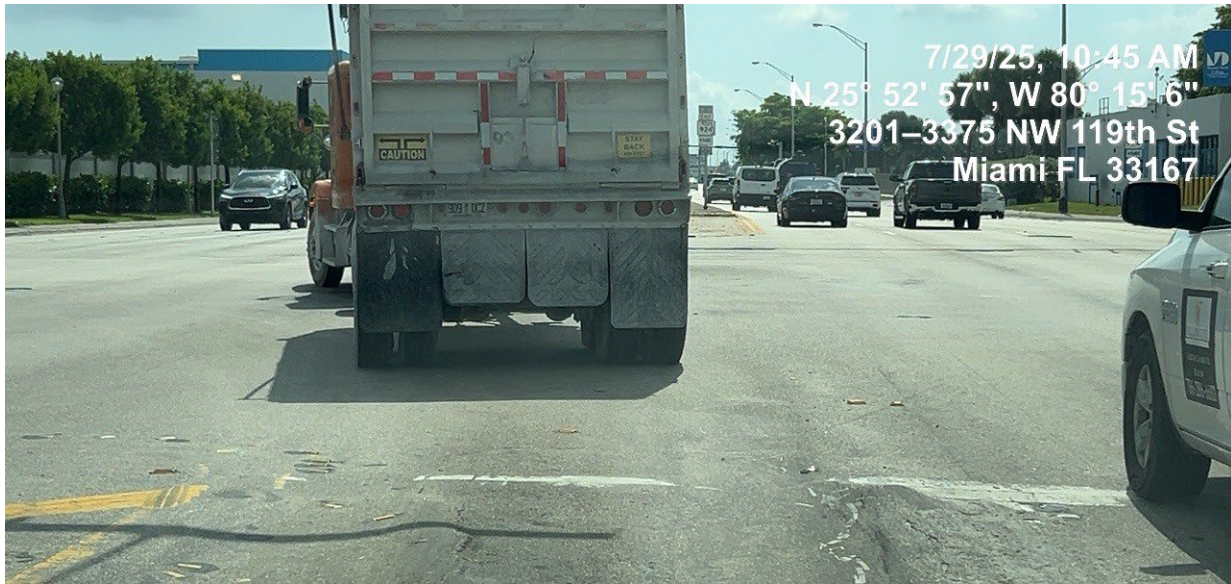
**PHOTO NO.: EB-006  
DATE: 7-29-2025**

**DAMAGED PAVEMENT**

**ITEM NOTED TO BE ADDRESSED BY GMX WORK PROGRAM 30044**

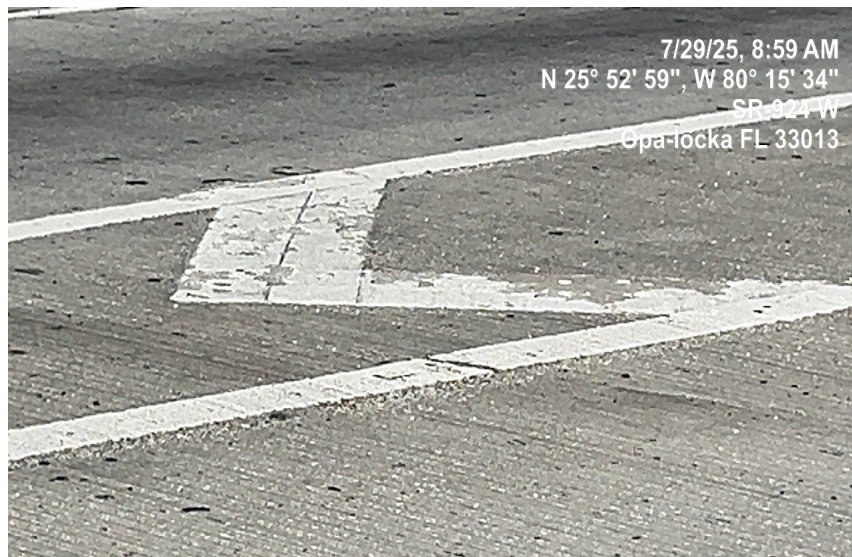
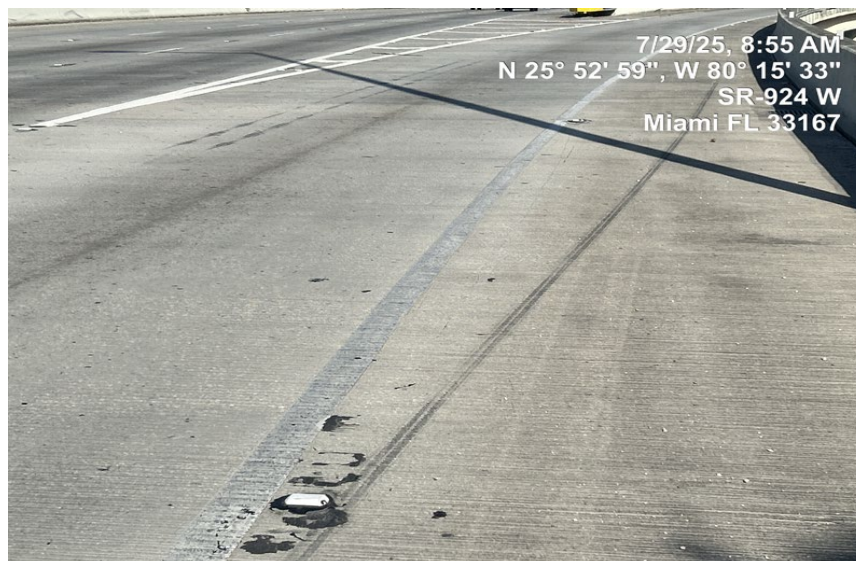
**PHOTO NO.: WB-002  
DATE: 7-29-2025**

**DETERIORATED PAVEMENT MARKINGS IN GORE AREA AND EDGE LINES  
(BRIDGE #870740)**

**ITEM NOTED TO BE ADDRESSED BY GMX WORK PROGRAM 30033**

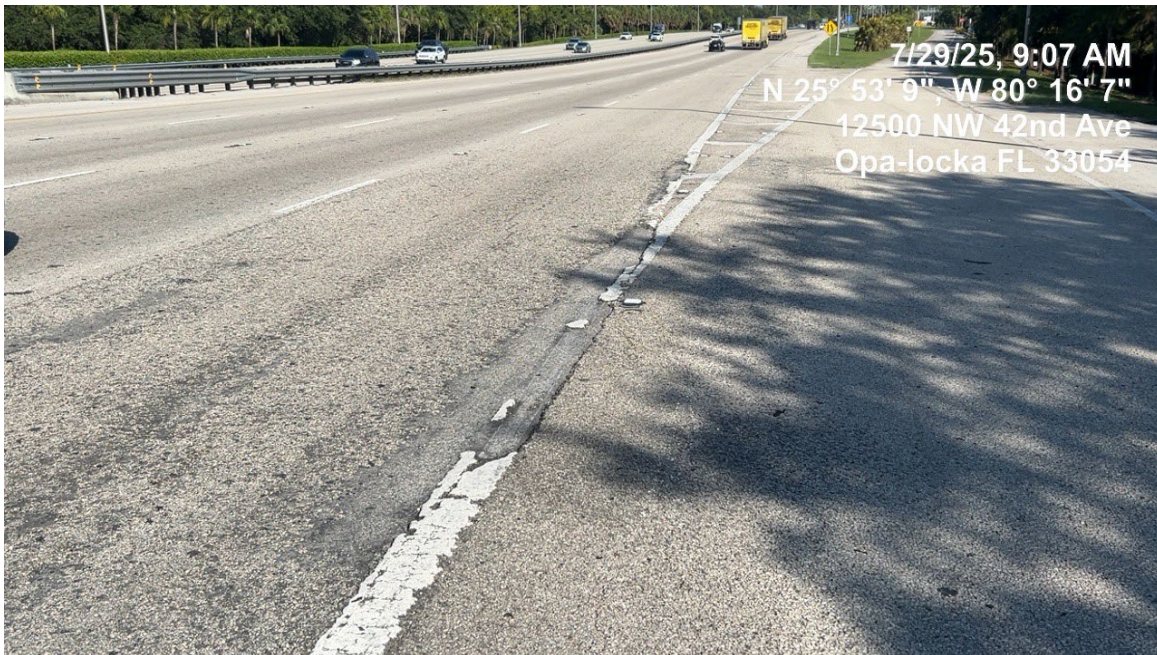
**PHOTO NO.: WB-003  
DATE: 7-29-2025**

**DETERIORATED ASPHALT PAVEMENT AND PAVEMENT MARKINGS**

**ITEM NOTED TO BE ADDRESSED BY GMX WORK PROGRAM 30044**

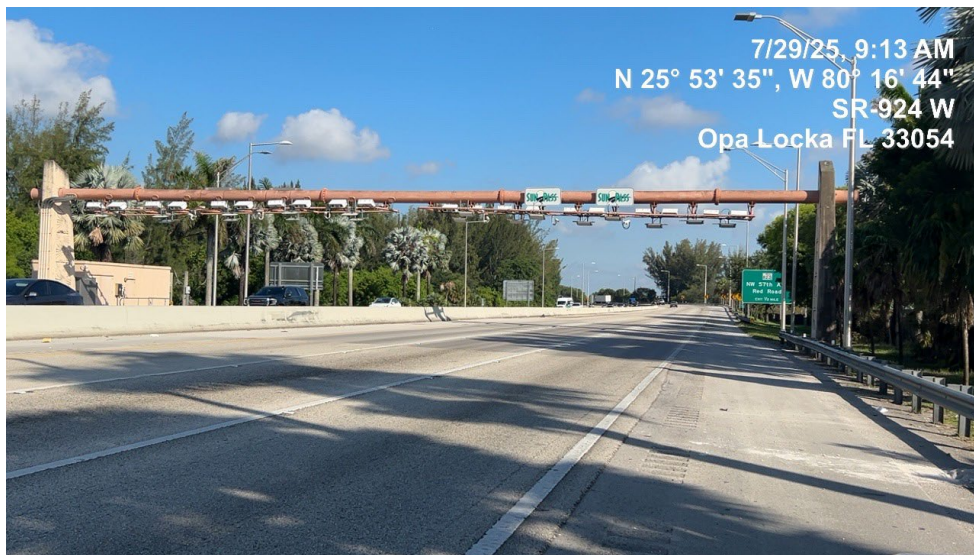
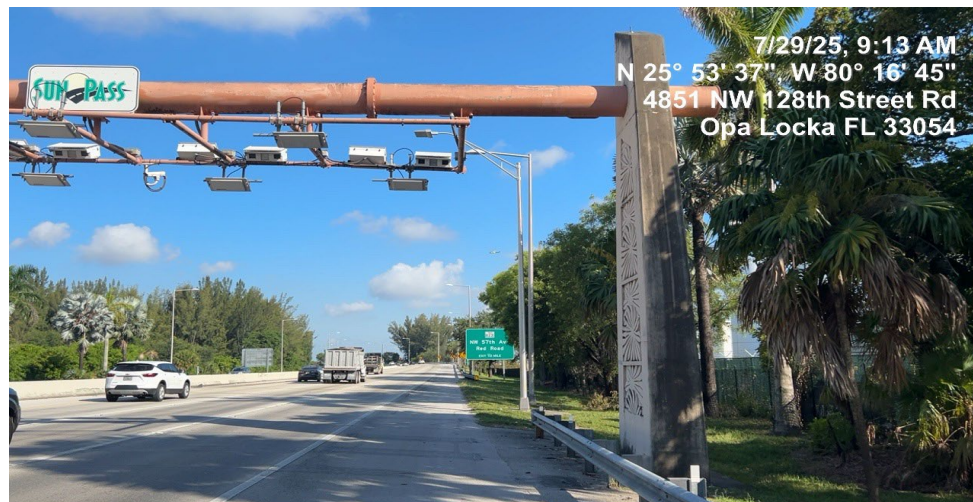
**PHOTO NO.: WB-005  
DATE: 7-29-2025**

**DETERIORATED PAINT ON MONO-TUBE AND CLASS V COATING ON UPRIGHT**

**ITEM NOTED TO BE ADDRESSED BY GMX WORK PROGRAM 30043**

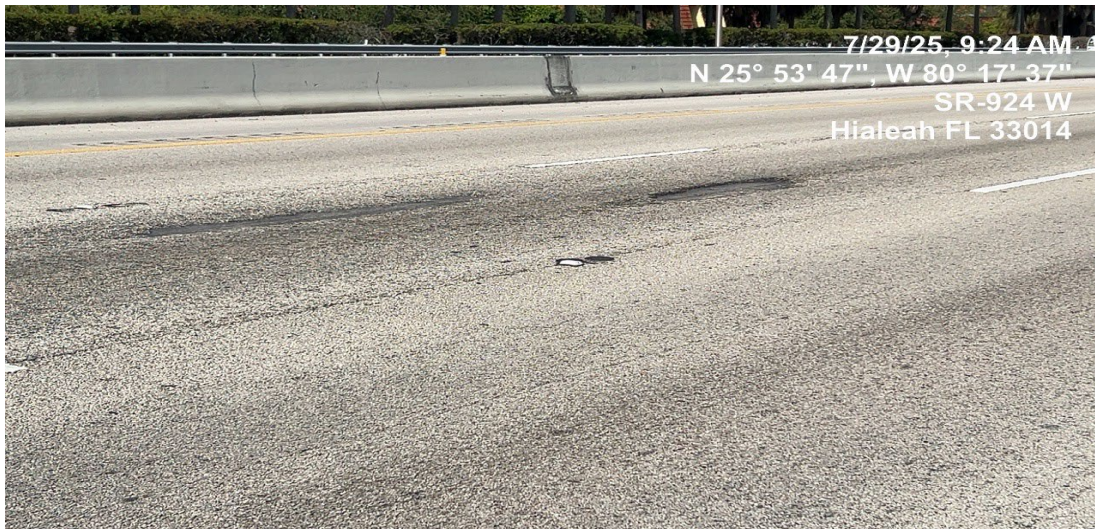
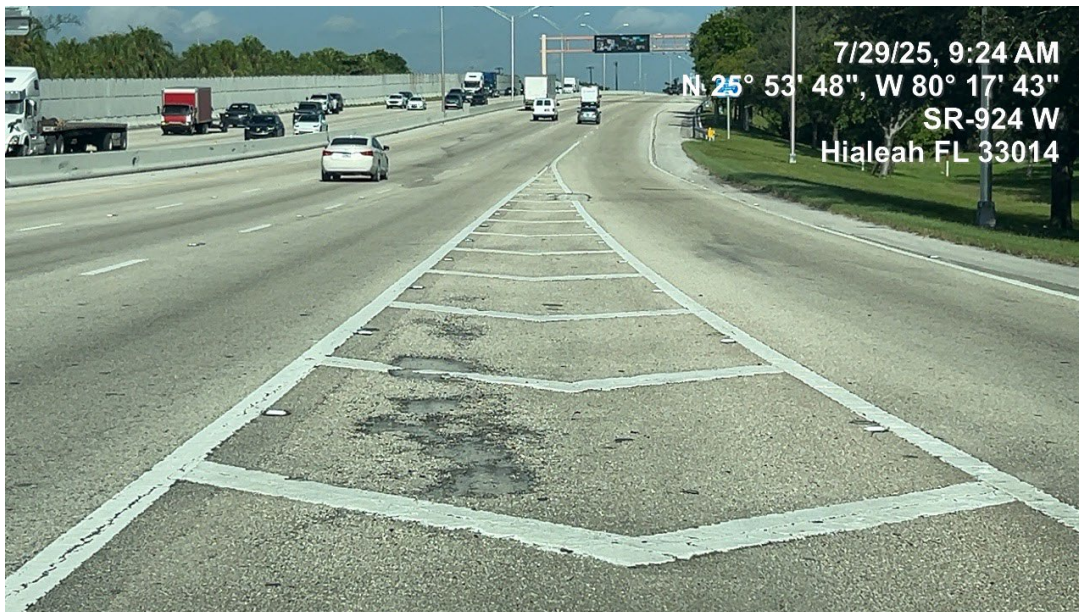
**PHOTO NO.: WB-006  
DATE: 7-29-2025**

**DETERIORATED ASPHALT PAVEMENT**

**ITEM NOTED TO BE ADDRESSED BY GMX WORK PROGRAM 30044**

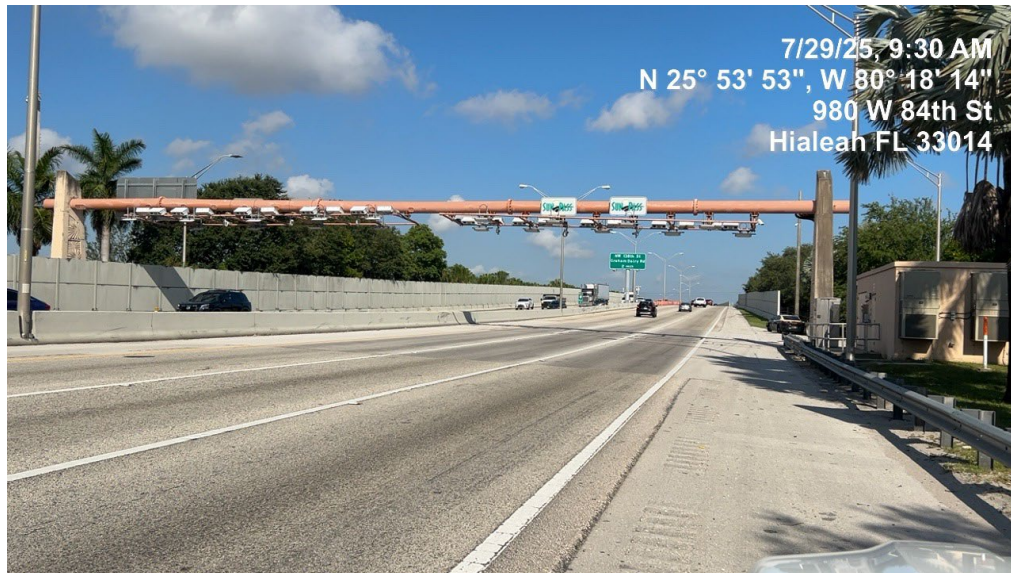
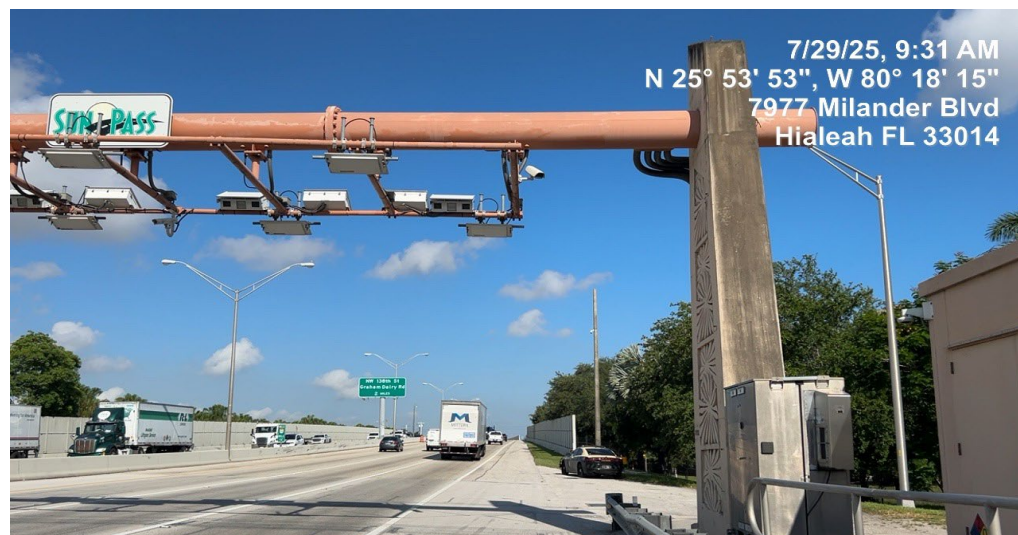
**PHOTO NO.: WB-007  
DATE: 7-29-2025**

**DETERIORATED PAINT ON MONO-TUBE AND CLASS V COATING ON UPRIGHT**

**ITEM NOTED TO BE ADDRESSED BY GMX WORK PROGRAM 30043**

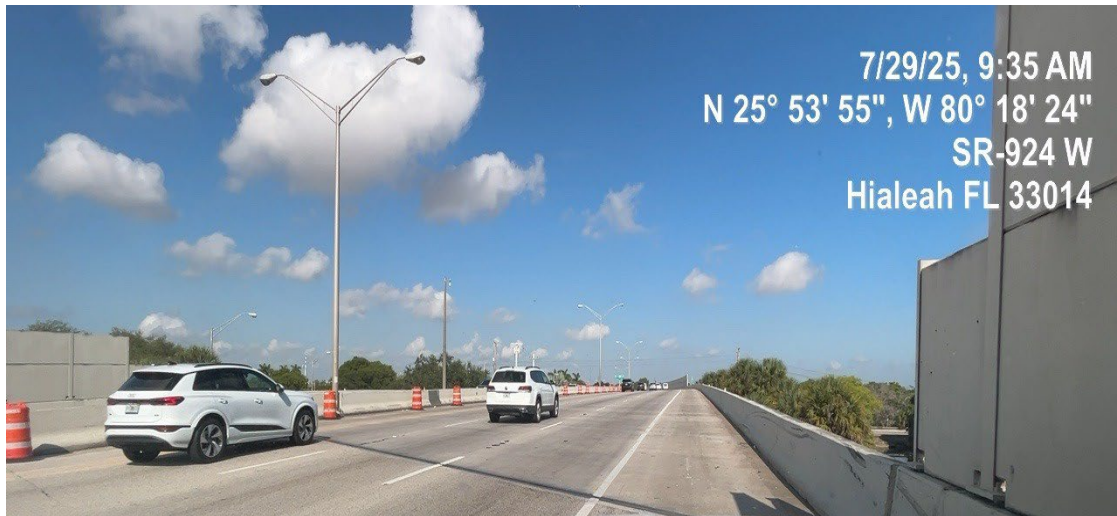
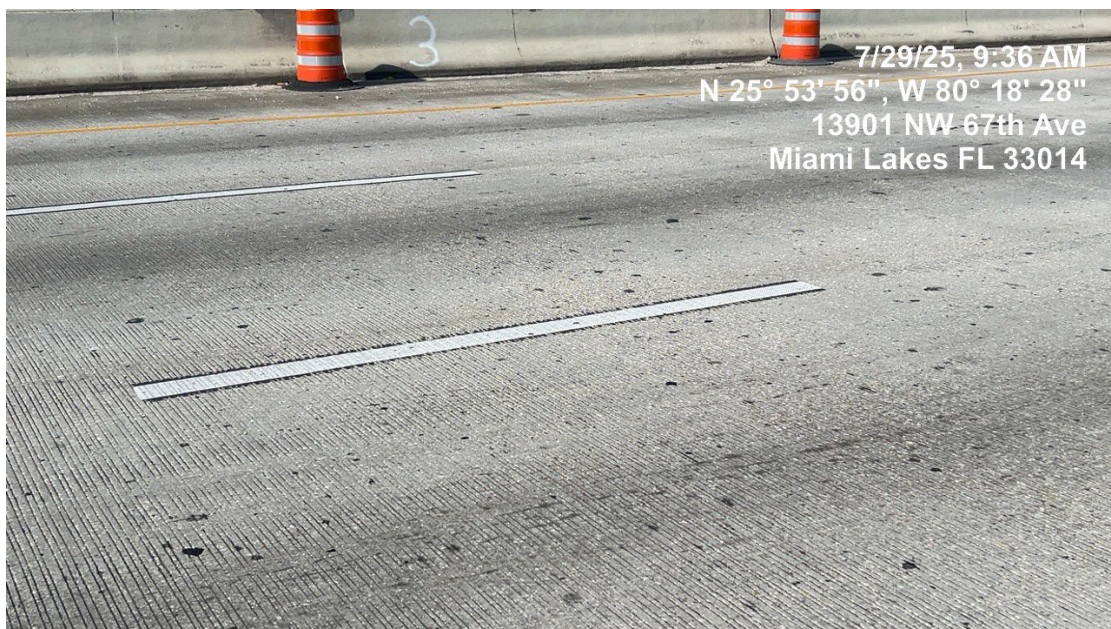
**PHOTO NO.: WB-008  
DATE: 7-29-2025**

**DETERIORATED PAVEMENT MARKINGS**

**ITEM NOTED TO BE ADDRESSED BY GMX WORK PROGRAM 30033**

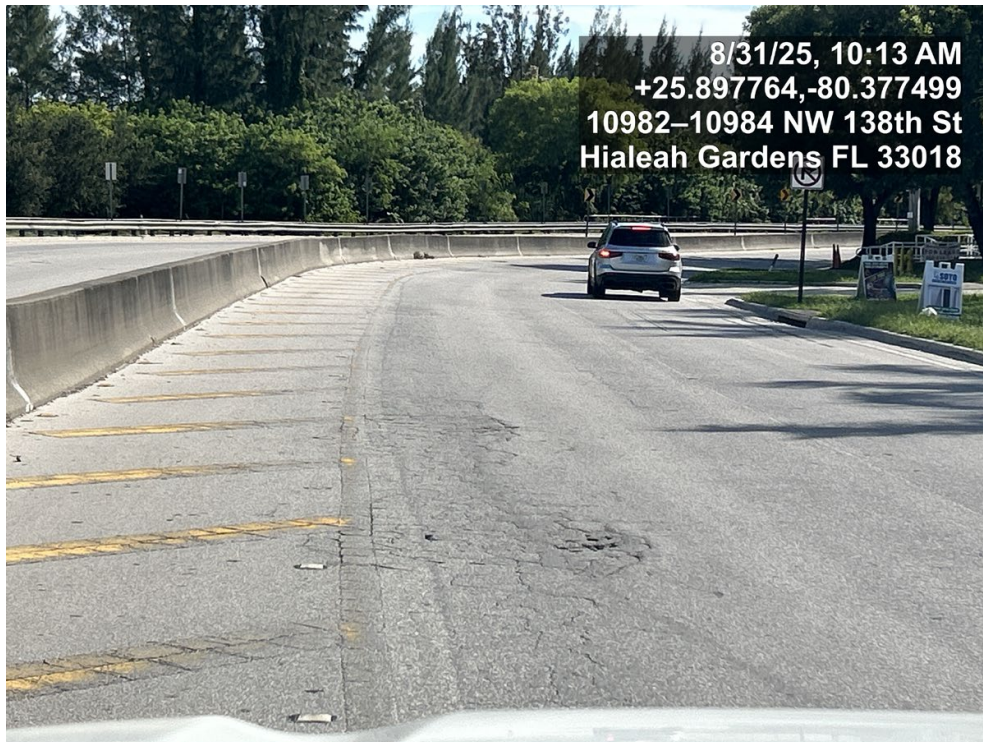
**PHOTO NO.: EB-002  
DATE: 8-31-2025**

**DETERIORATED ASPHALT PAVEMENT**

**ITEM NOTED TO BE ADDRESSED BY GMX WORK PROGRAM 30061**

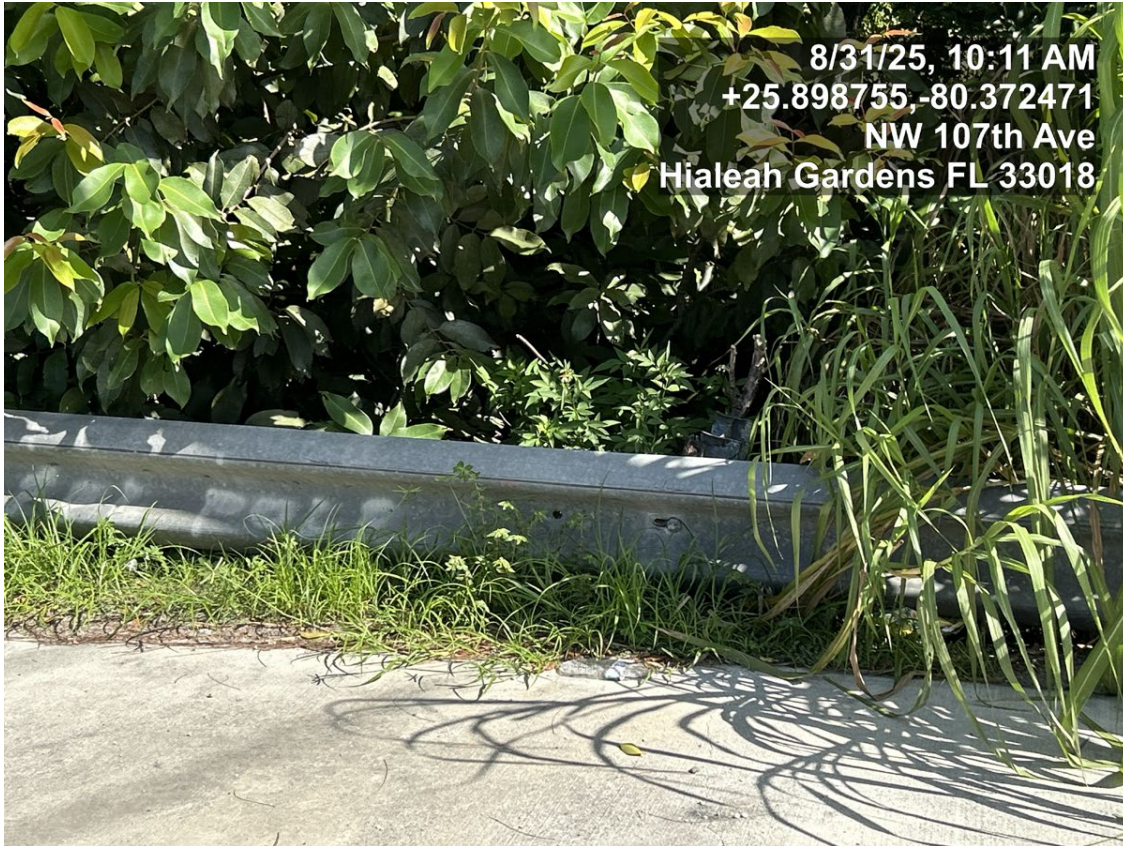
**PHOTO NO.: WB-005  
DATE: 8-31-2025**

**EXISTING GUARDRAIL NOT TO FDOT STANDARDS**

**ITEM NOTED TO BE ADDRESSED BY GMX WORK PROGRAM 30061**

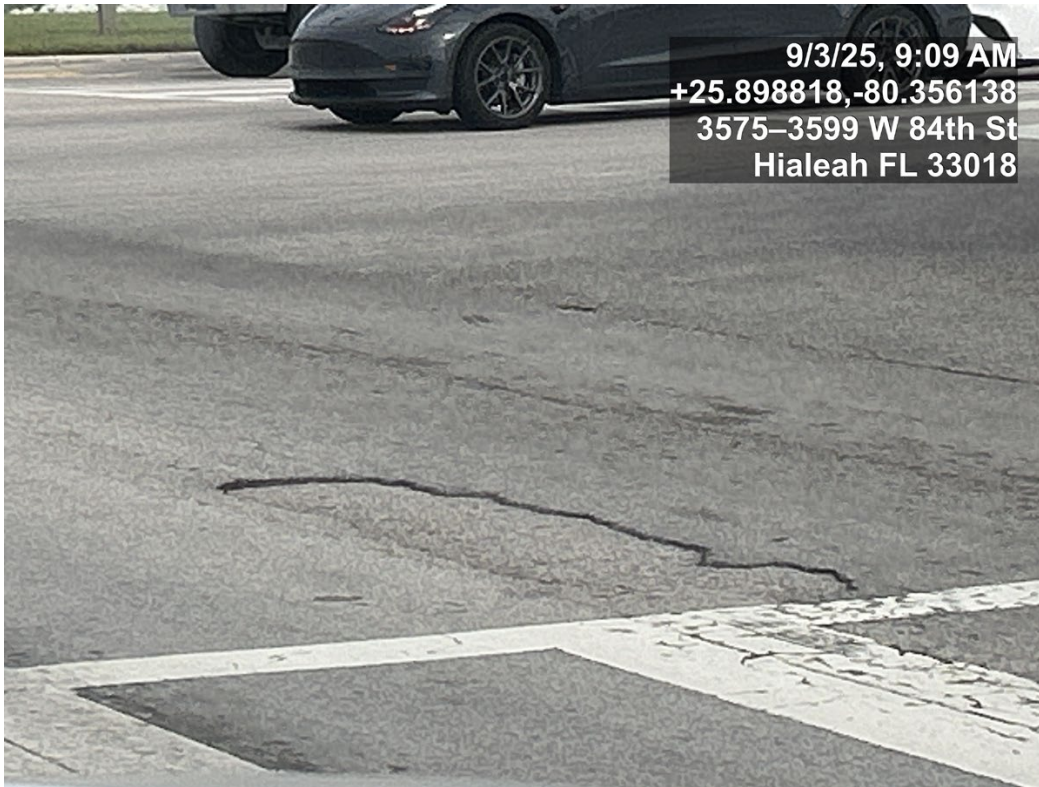
**PHOTO NO.: WB-009  
DATE: 9-3-2025**

**ROADWAY INSPECTION  
LOCATION: WESTBOUND AT NW 97<sup>th</sup> AVENUE**

**DETERIORATED PAVEMENT**

**ITEM NOTED TO BE ADDRESSED BY GMX WORK PROGRAM 30061**

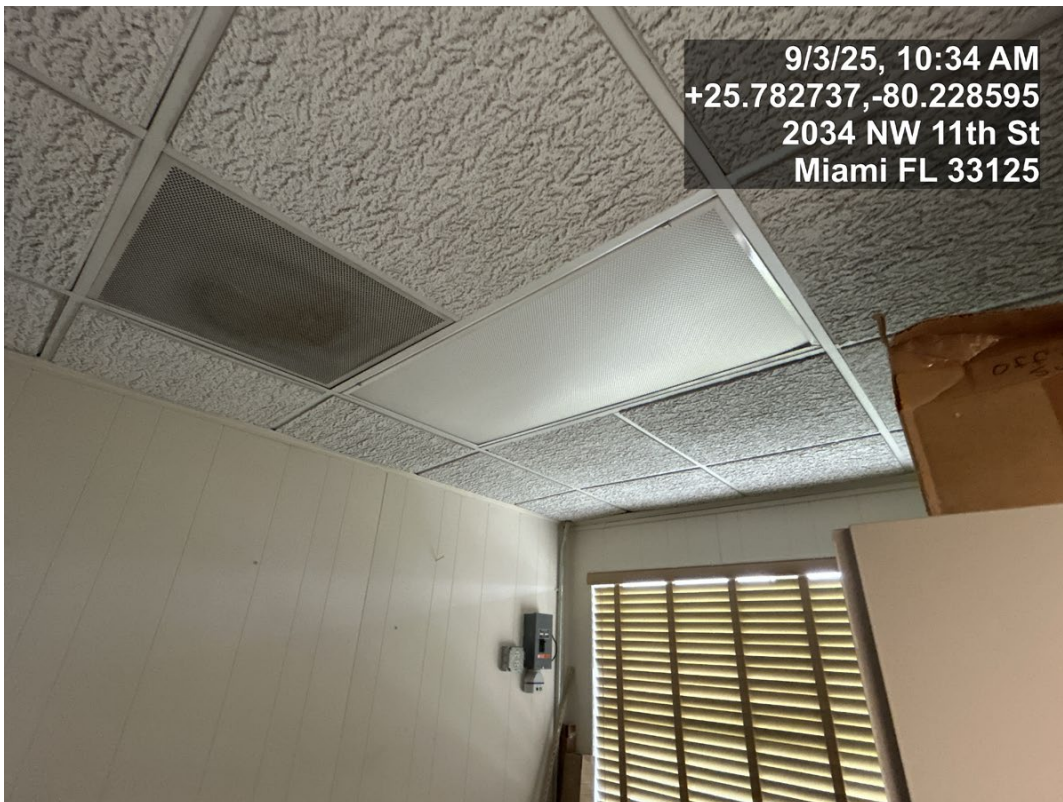
**PHOTO NO.: A-002  
DATE: 9-3-2025**

**ARCHITECTURAL INSPECTION  
LOCATION: SR-836 MAIN ADMINISTRATION BUILDING  
KITCHEN AREA**

**BURNT OUT INTERIOR LIGHTING**

**ITEM NOTED TO BE ADDRESSED BY GMX MAINTENANCE ITB-23-12**
